Suitability of brewery buildings for re-use

Condition

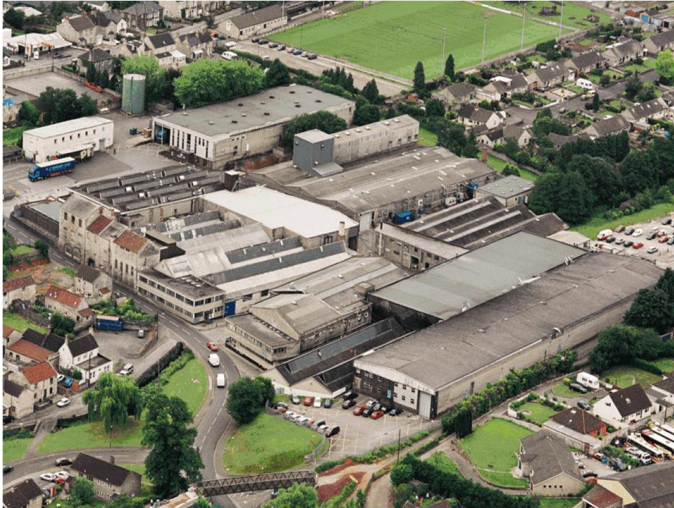
The three interlinked former brewery buildings form part of a stepped terrace running parallel with Station Road and retain a section of the highway along Station Road.

All of the former brewery buildings are constructed of load bearing rubble stonework with limestone dressings around window openings. The 3 storey building has steel columns and beams on ground and first floors only. Metal framed windows are set within openings, most of which are supported by brick arch lintels. Many of these have been blocked up in the past with concrete blockwork. Two large arched openings are provided on the ground floor front elevation, dressed with large rock faced sandstone pennants. Roofs are of pitched design and were originally finished with clay pantiles some of which still remain on the front plane but the majority of the planes are now clad with a profiled metal sheet.

The brewery buildings have been empty for at least 14 years and were out of use prior to the factory's relocation. Many of the windows have been blocked up from the outside and remaining windows have been boarded. There has been extensive water penetration and whilst attempts have been made to rectify this by overcladding the existing roof with profiled metal sheeting, a lot of damage has taken place resulting in large parts of the structure failing or being rendered unsafe. Access is no longer possible to the first and second floors due to failure of the floor structure. Externally there is evidence of stepped fractures in the stonework particularly on the gable ends, erosion of the stonework's mortar jointing and movement on the front elevation suggests that timber lintels are beginning to fail as demonstrated by the dropped sections of stonework above window openings.
