Site Number 23388-4
Description Bathwick Hill, West of Cleveland Walk
Direction Eastbound

Site Number 23388-4
Description Bathwick Hill, West of Cleveland Walk
Direction Eastbound
Posted Speed Limit(mph) 20mph

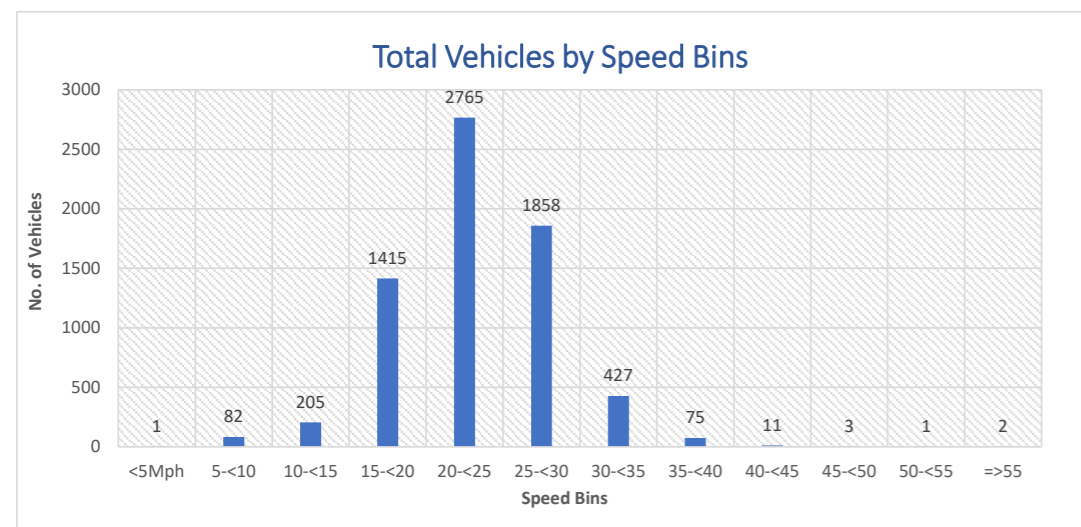
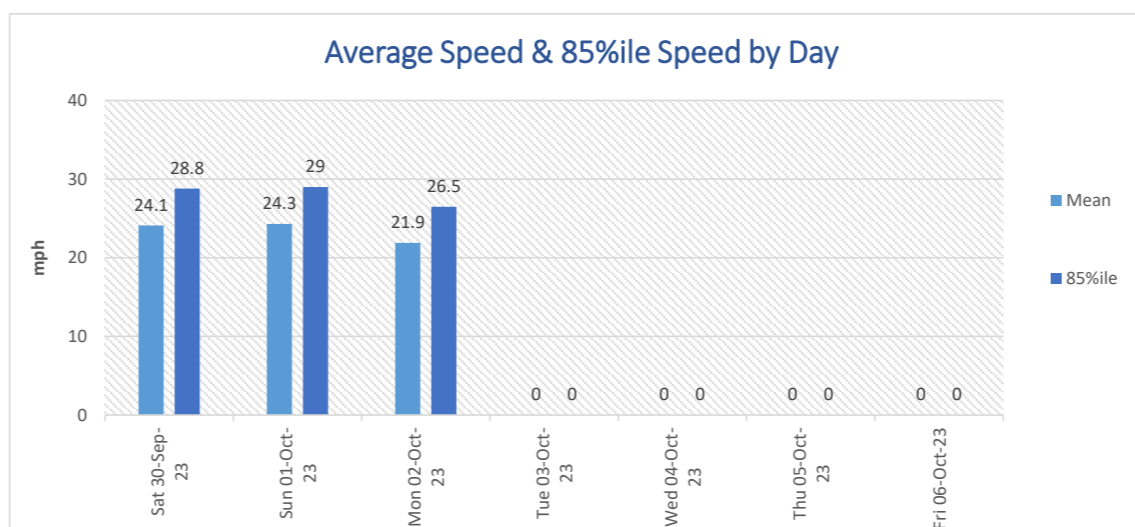
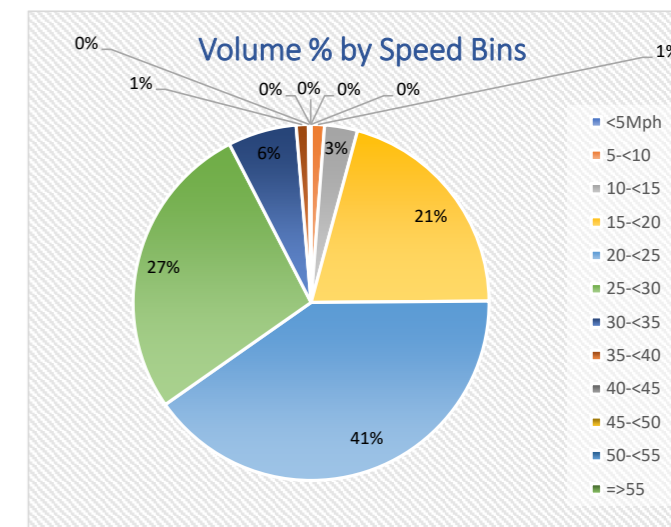
Start Date	End Date	Total Vehicles	5 Day Ave.	7 Day Ave.	Average 85%ile Speed	Average Mean Speed	Standard Dev.
Sat 30-Sep-23	Fri 06-Oct-23	6845	580	978	28.1	23.2	5.0

Time Period	Total Vehicles	85%ile Speed	Mean Speed	Stand Dev.	<5Mph	5-<10	10-<15	15-<20	20-<25	25-<30	30-<35	35-<40	40-<45	45-<50	50-<55	=>55
Sat 30-Sep-23	2183	28.8	24.1	4.9	0	20	32	348	856	711	182	29	3	1	0	1
Sun 01-Oct-23	1764	29	24.3	5	1	7	27	303	667	575	140	37	5	2	0	0
Mon 02-Oct-23	2898	26.5	21.9	4.9	0	55	146	764	1242	572	105	9	3	0	1	1
Tue 03-Oct-23	0	-	-	-	0	0	0	0	0	0	0	0	0	0	0	0
Wed 04-Oct-23	0	-	-	-	0	0	0	0	0	0	0	0	0	0	0	0
Thu 05-Oct-23	0	-	-	-	0	0	0	0	0	0	0	0	0	0	0	0
Fri 06-Oct-23	0	-	-	-	0	0	0	0	0	0	0	0	0	0	0	0
Total Vehicles																
[--]	6845	28.1	23.2	5.0	1	82	205	1415	2765	1858	427	75	11	3	1	2

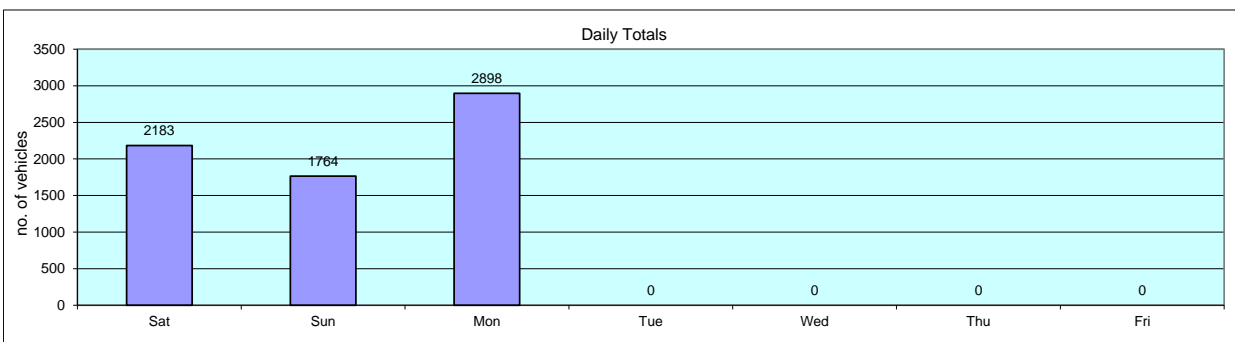
Time	Sat 30-Sep-23	Sun 01-Oct-23	Mon 02-Oct-23	Tue 03-Oct-23	Wed 04-Oct-23	Thu 05-Oct-23	Fri 06-Oct-23	Weekday Av.	7day Av.
0100	34	0	1	0	0	0	0	0	5
0200	30	2	0	0	0	0	0	0	5
0300	28	1	0	0	0	0	0	0	4
0400	22	1	0	0	0	0	0	0	3
0500	10	0	1	0	0	0	0	0	2
0600	10	0	1	0	0	0	0	0	2
0700	10	1	0	0	0	0	0	0	2
0800	44	0	3	0	0	0	0	1	7
0900	89	0	9	0	0	0	0	2	14
1000	128	0	10	0	0	0	0	2	20
1100	152	0	5	0	0	0	0	1	22
1200	175	0	6	0	0	0	0	1	26
1300	173	0	4	0	0	0	0	1	25
1400	190	1	1	0	0	0	0	0	27
1500	156	2	1	0	0	0	0	0	23
1600	168	0	3	0	0	0	0	1	24
1700	156	3	6	0	0	0	0	1	24
1800	169	0	4	0	0	0	0	1	25
1900	125	0	0	0	0	0	0	0	18
2000	78	1	1	0	0	0	0	0	11
2100	73	1	3	0	0	0	0	1	11
2200	56	0	0	0	0	0	0	0	8
2300	56	1	1	0	0	0	0	0	8
2400	51	1	0	0	0	0	0	0	7
08-09	89	0	9	0	0	0	0	2	14
17-18	169	140	191	0	0	0	0	38	71
07-19	1725	1384	2482	0	0	0	0	496	799
07-23	1988	1613	2780	0	0	0	0	556	912
00-24	2183	1764	2898	0	0	0	0	580	978

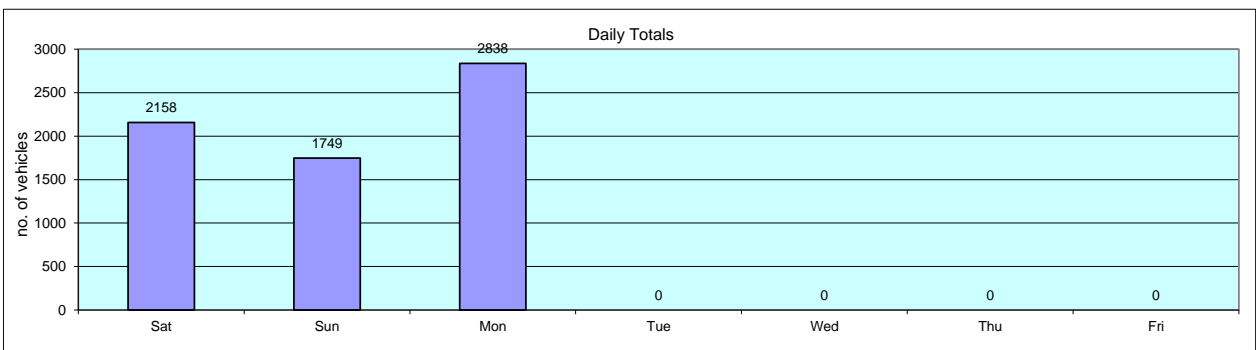
Volumetric Summary - Motorised Vehicles									
Time	Sat 30-Sep-23	Sun 01-Oct-23	Mon 02-Oct-23	Tue 03-Oct-23	Wed 04-Oct-23	Thu 05-Oct-23	Fri 06-Oct-23	Weekday Av.	7day Av.
0100	34	30	15	0	0	0	0	3	11
0200	29	27	5	0	0	0	0	1	9
0300	27	24	1	0	0	0	0	0	7
0400	22	20	2	0	0	0	0	0	6
0500	10	11	6	0	0	0	0	1	4
0600	10	7	15	0	0	0	0	3	5
0700	10	9	48	0	0	0	0	10	10
0800	44	28	176	0	0	0	0	35	35
0900	86	54	458	0	0	0	0	92	85
1000	128	70	262	0	0	0	0	52	66
1100	151	125	193	0	0	0	0	39	67
1200	173	138	168	0	0	0	0	34	68
1300	170	141	144	0	0	0	0	29	65
1400	189	135	157	0	0	0	0	31	69
1500	155	142	150	0	0	0	0	30	64
1600	165	140	178	0	0	0	0	36	69
1700	153	166	214	0	0	0	0	43	76
1800	169	140	187	0	0	0	0	37	71
1900	121	99	143	0	0	0	0	29	52
2000	78	77	124	0	0	0	0	25	40
2100	73	70	88	0	0	0	0	18	33
2200	54	51	50	0	0	0	0	10	22
2300	56	28	31	0	0	0	0	6	16
2400	51	17	23	0	0	0	0	5	13
08-09	86	54	458	0	0	0	0	92	85
17-18	169	140	187	0	0	0	0	37	71
07-19	1704	1378	2430	0	0	0	0	486	787

07-23	1965	1604	2723	0	0	0	0	545	899
00-24	2158	1749	2838	0	0	0	0	568	964
