STREETScape AND DETAILS

1-3 BATH HILL, KEYNSHAM

5 BATH HILL, KEYNSHAM

7 BATH HILL, KEYNSHAM

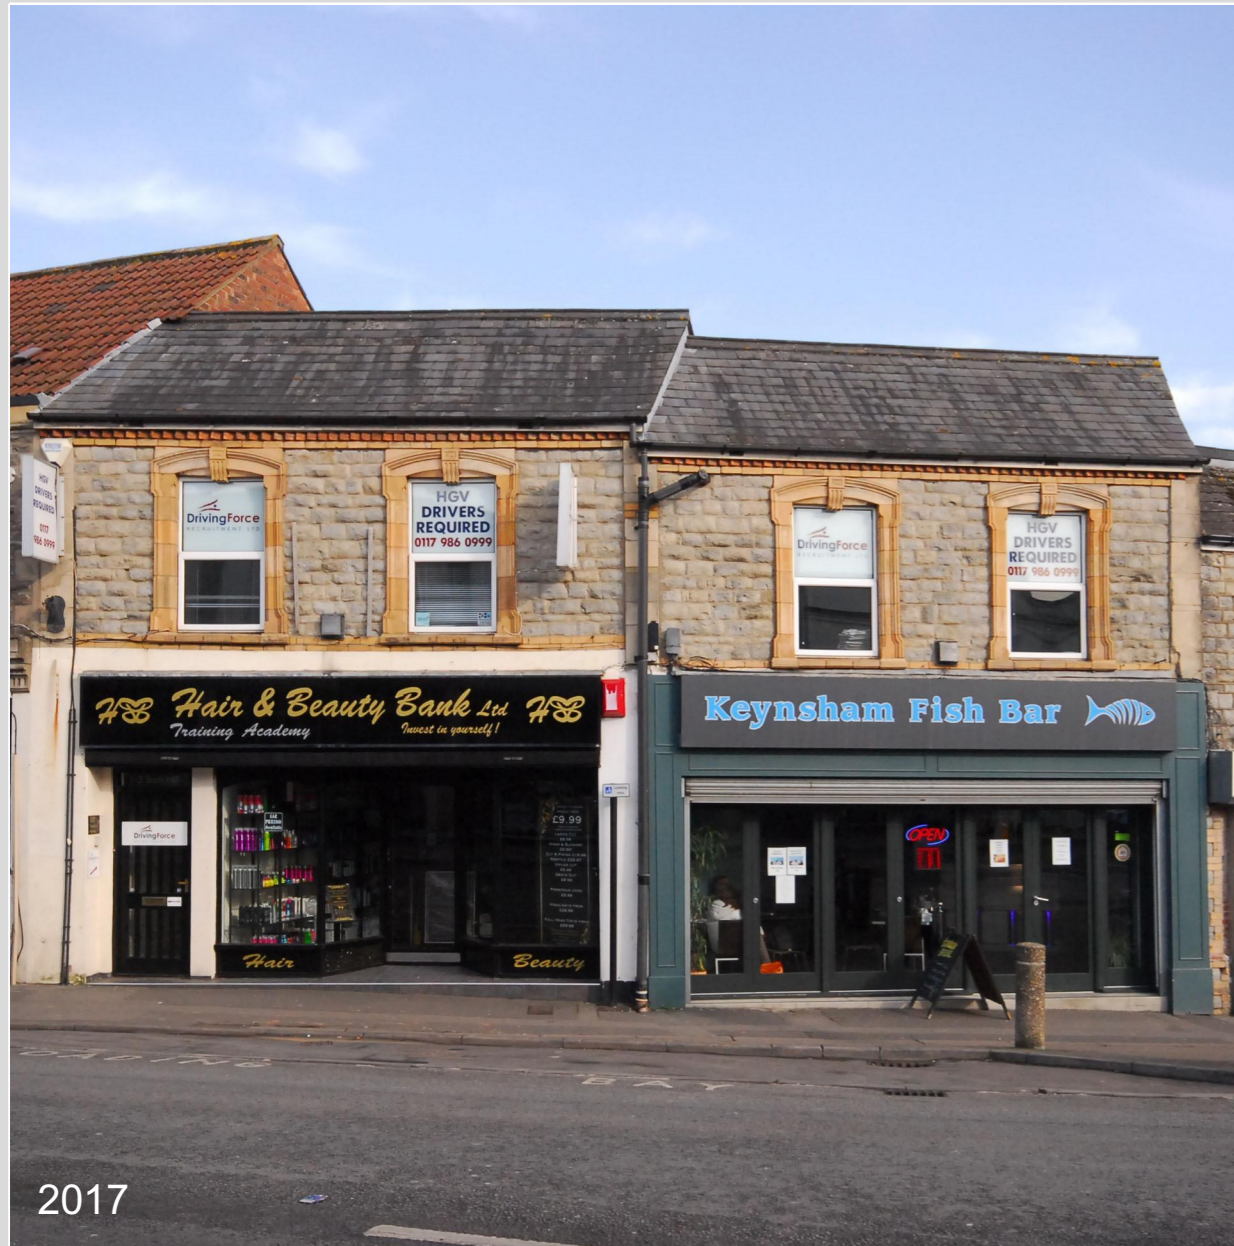
2017

With the exception of the windows which are now uPVC the building retains its original form at roof and first floor level. The ground floors have been reconfigured in both instances with the heightening of the shop fronts resulting in the loss of the string course. 1 now has a central recessed doorway and 3 has a planted timber frontage to with roller shutters. In both instances the signage sits awkwardly on the elevations and the loss of stall risers has changed the balance of the elevations.

These buildings were designed as shops and there was always a deliberate and distinct difference between the two floors. This was historically delineated by either a string course or cornices over the signage which ran the width of the frontage.

- Replace uPVC windows with margined timber sashes at first floor.
- Replace plastic rainwater goods with cast metal
- Replace right hand door to No 1 with partially glazed timber door
- In both instances reduce height of signage and move away from sills
- Pull shop fronts away from ashlar pilasters and reinstate stonework to ground level
- Set shop fronts within confines of pilasters
- Remove excess wiring from shop front
- Confine sign to 1 to width of shop front and replace with traditional painted signage
- Replace shop front to 3 locating security shutter internally

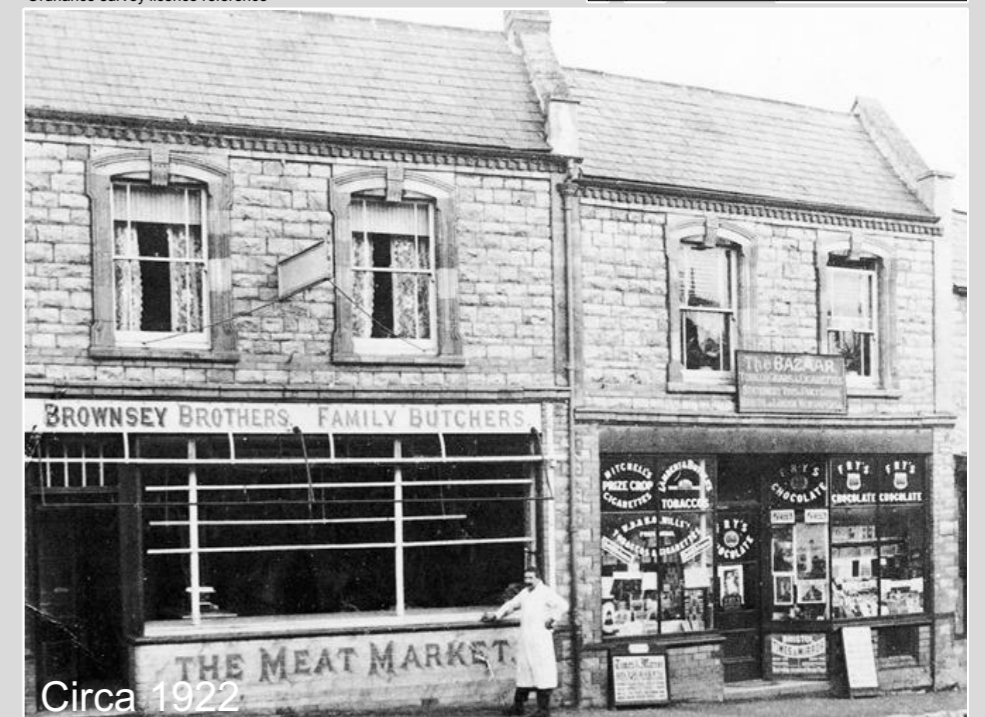
Circa 1922

Roofed with slates the elevations are coursed lias stone with brick and terracotta window architraves and strings. Original windows were margined timber sashes. At ground floor the shop fronts extended practically the full width of the elevations and were terminated at high level by a projecting string course. No 1's shop front was asymmetric with a door to the left and significant stall riser whereas No 3 was more traditional with a central recessed door and lesser stall riser.

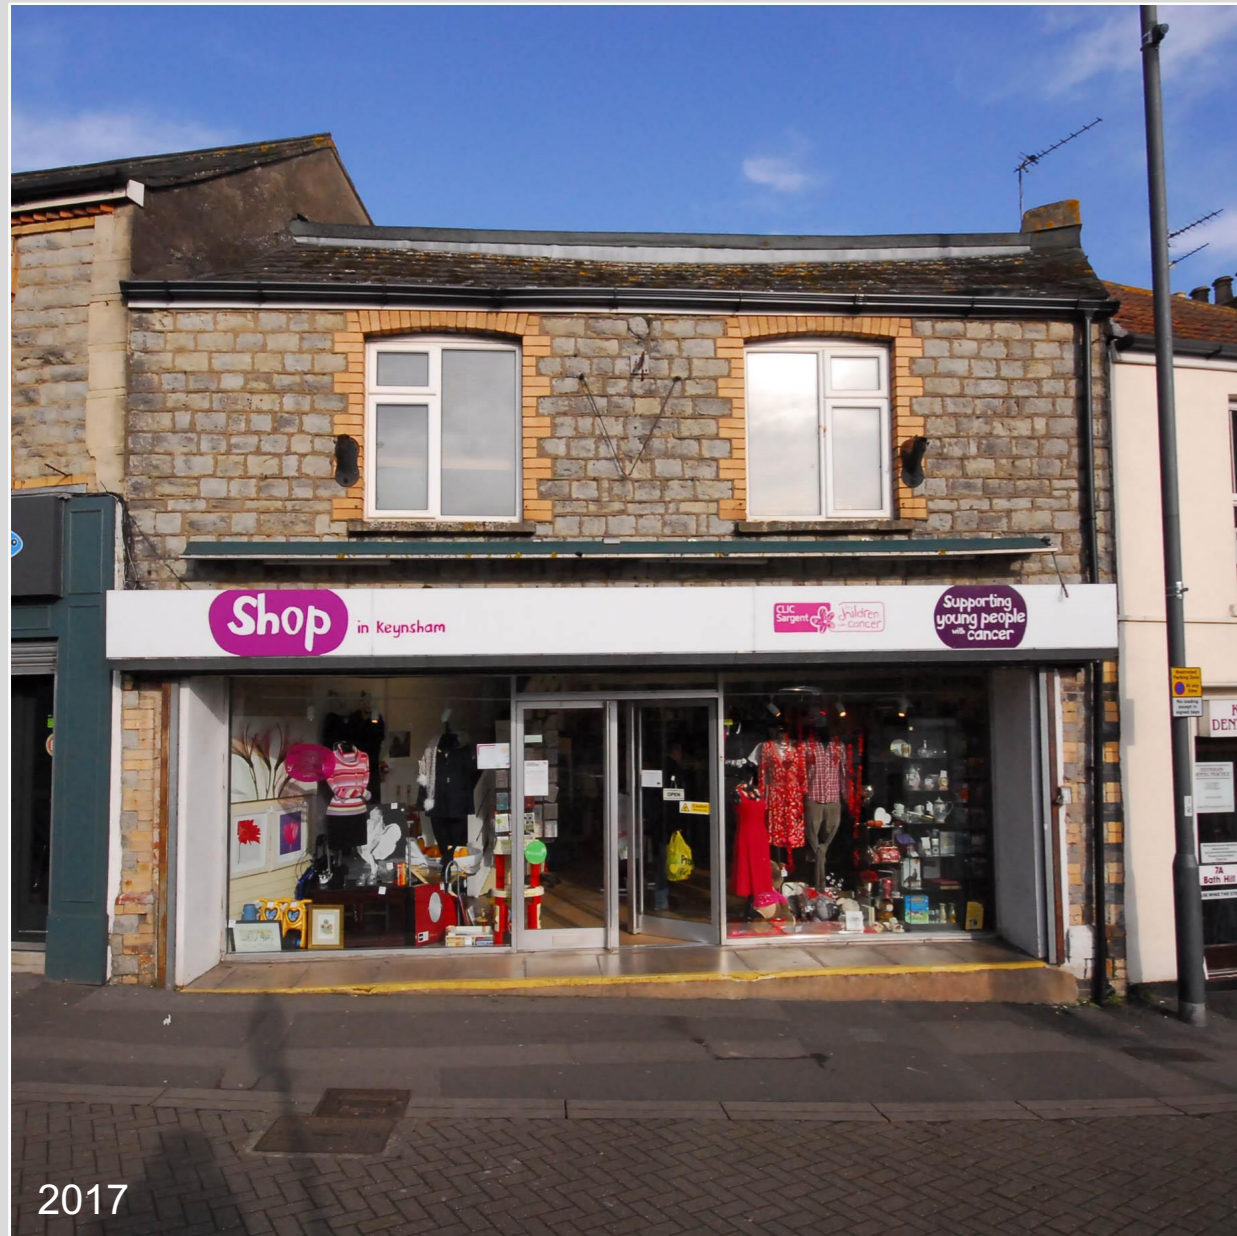
2017

With the exception of the windows which are asymmetric UPVC the building retains its original form at roof and first floor level. The ground floor has changed significantly with the loss of the original shop fronts and the formation of a single opening with a central front door unrelated to the windows above. The glazing line has been recessed across the full frontage by nearly 1m and a boxed security shutter/ sign have been placed over the opening further emphasising its depth. The rainwater goods are now plastic and there are a number of redundant fittings on the elevation that are unsightly.

This building was designed as shops and there was always a deliberate and distinct difference between the two floors. The complete loss of the historic shop fronts and the recent recessing of the glazing line have done little to unify the elevation and street scene. There are a number of improvements that could be made.

- Replace uPVC windows with timber sashes to the original design
- Remove the redundant timber below windows
- Replace shop front with planted frontage
- Pull the glazing line forwards creating more retail space
- Install internal security shutters
- Replace rainwater goods in cast metal

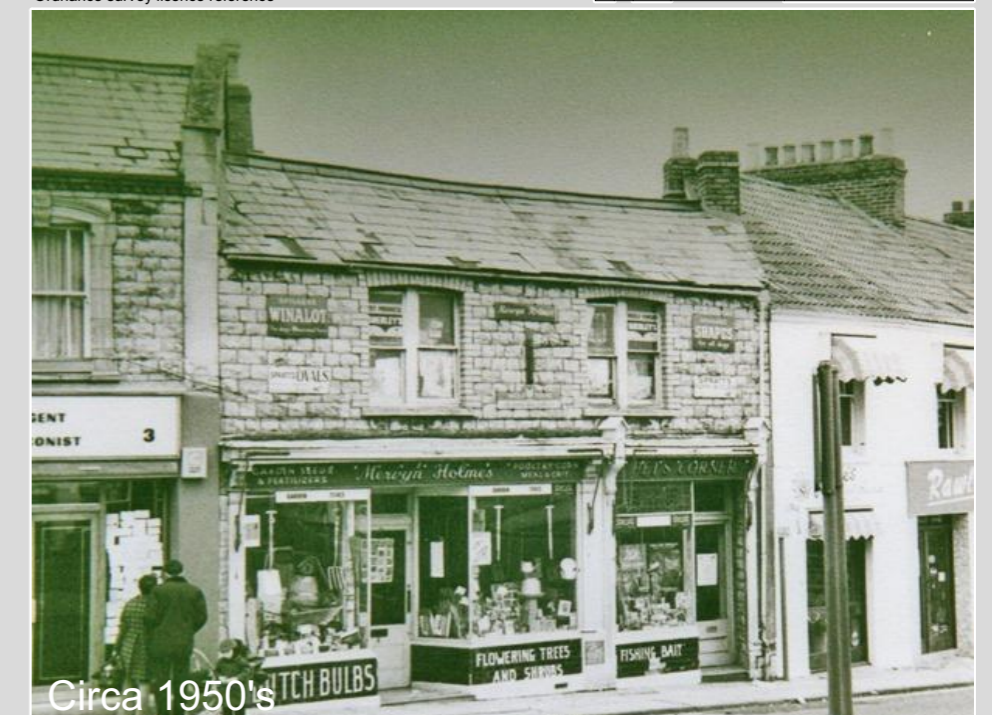
Circa 1950's

Roofed with slates the elevation is coursed Lias stone with brick detailing. The upper floor originally comprised 2 distinctive pairs of sash windows divided by a central mullion. At ground floor there were two shop fronts extending practically the full width of the elevation. The shop frontages themselves were traditionally detailed with cornices, console brackets and capping pieces at awning level and a dividing pier between the two shop fronts. The larger of the shop fronts which occupied 3/5th of the elevation with a central recessed door with undivided plate glass windows over stall risers. The front door sat symmetrically below the left hand first floor window. The smaller shop front had a door to the right and a similar glazing configuration over a stall riser.

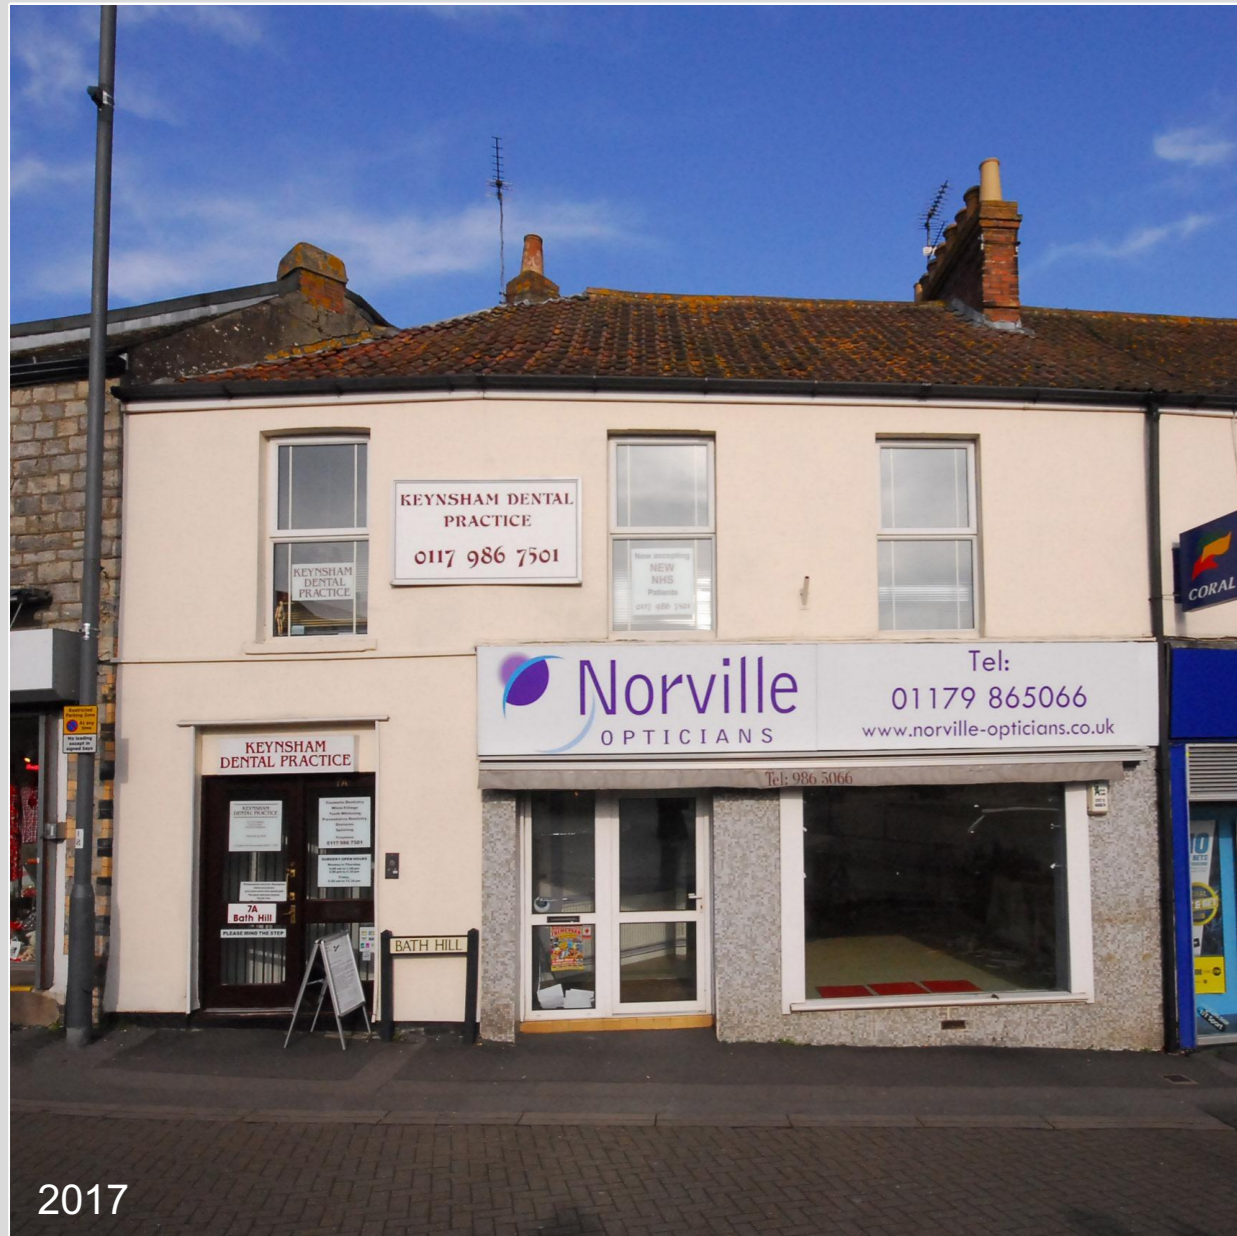
2017

With the exception of the windows which have changed to UPVC the building retains its original form at roof and first floor level. The ground floor has been reconfigured. The former shop front is now an access stair. A new shop front has been added to the right of the central door. Areas of coloured tiling have also been introduced to sides of the shop front further delineating between ground and first floor visually splitting the building into a lower and upper band.

This building was deliberately designed with a shop. The original design has been lost due to poorly considered alterations however the building retains its form and could be enhanced with some considered adjustments and rebalancing of the elevation.

- Replace the uPVC windows with margined light timber sashes
- Form planted shop front to Keynsham dental practice w with separate door access
- Remove rendering / tiling to elevation
- Form planted shopfront to rest of building elevation relating to openings above
- The signage should be pulled away from the first floor windows to reveal the sills and at least 150mm of masonry below
- Change shop signage to traditional painted timber
- Remove Bath Hill sign and replace with metal plate fixed directly to wall.

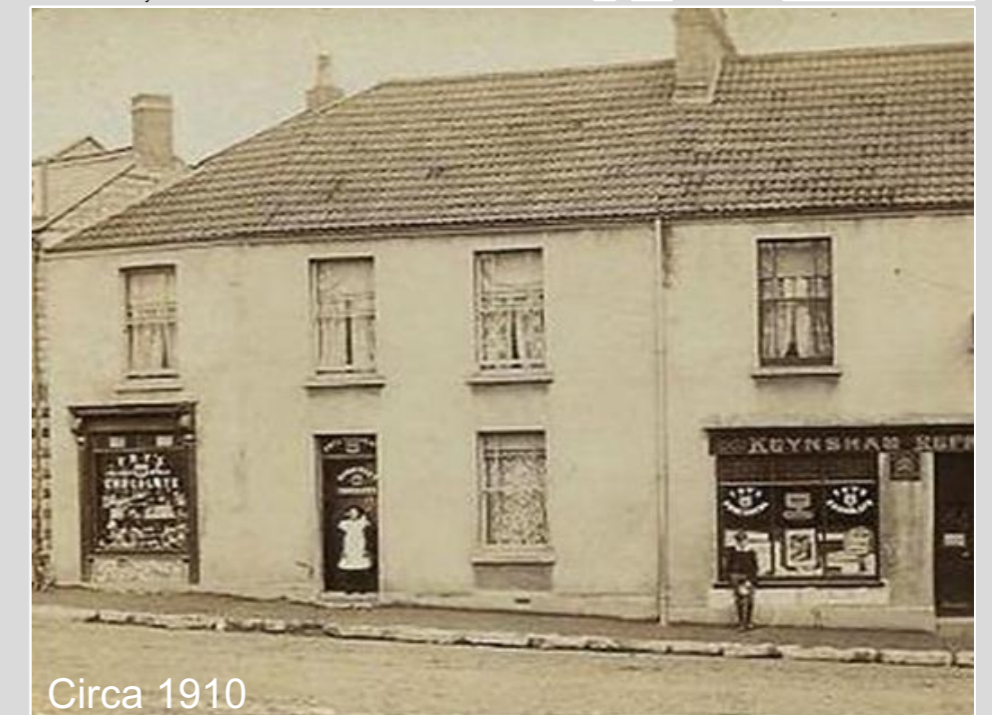
Circa 1910

Roofed with double Roman tiles, the elevation rendered. The upper floor comprises 3 margin light sash windows. At ground floor the shop door sat directly below the central window. The original shop appears to have been confined to the left of the building with the right hand side domestic. The rendering extended below the windows visually grounding the elevation and making it feel of a piece.

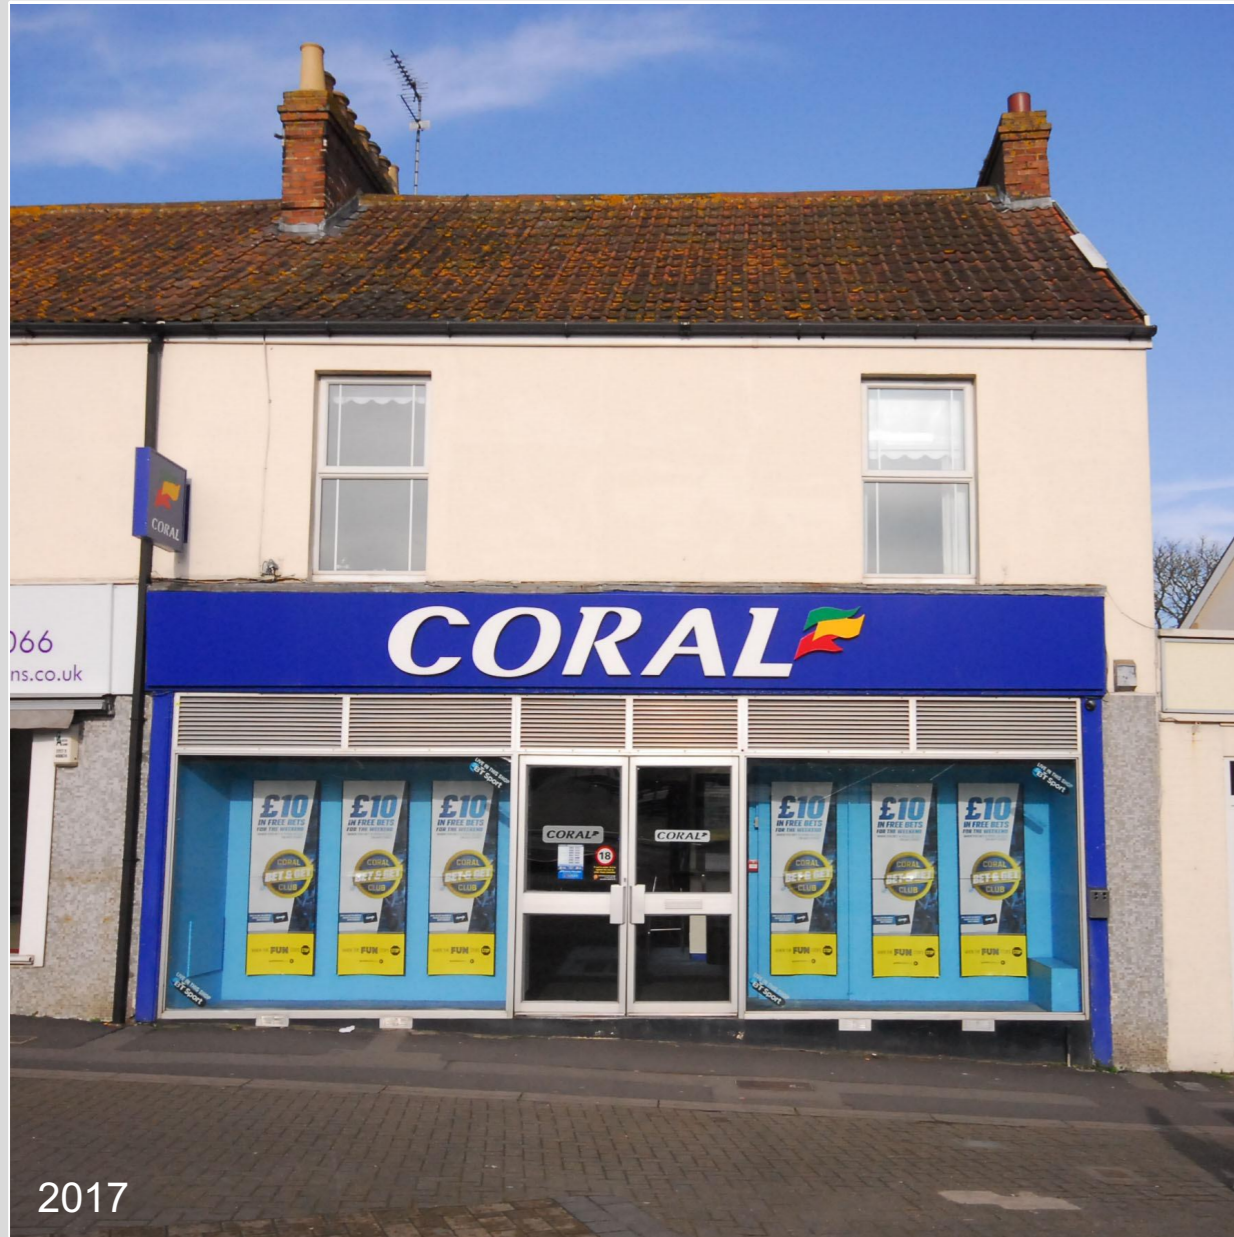
2017

With the exception of the windows which have been changed to UPVC the building retains its original form at roof and first floor level. At ground level the original fenestration and doorway have been replaced with plate glass windows metal double doors and extensive plastic corporate signage extending nearly the full width of the building, dominating the elevation. Coloured tiling to the sides of the shop front visually splits the building into a lower and upper band.

This building was deliberately designed as a shop. The original design has been lost due to poorly considered alterations however the building retains its form and could be enhanced with some considered adjustments and rebalancing of the elevation.

- Replace uPVC windows with margin light timber sashes
- Replace plastic rainwater goods with cast metal
- Reinstate shop front completely reducing it in size and separating it from the window sills and party wall to form a symmetrical design reflecting the original elevational treatment
- Divide fenestration into smaller vertical panes
- Introduce stall risers to eliminate awkward junction with the pavement
- Remove all traces of tiles and decorate the elevation so that the upper floor decorations extend to ground level

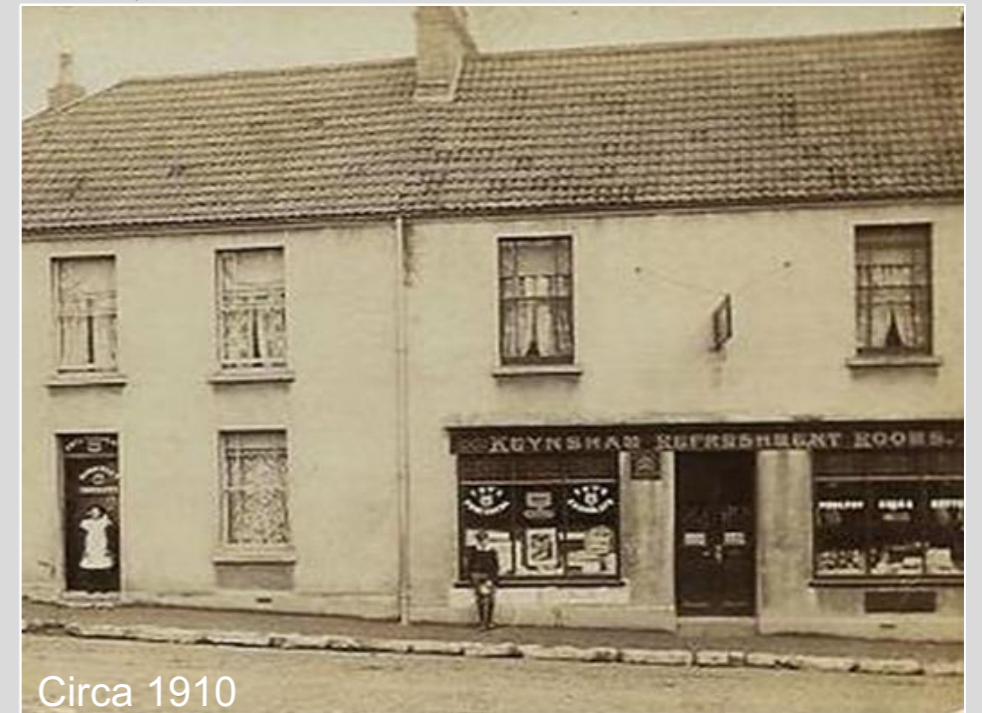
Circa 1910

Roofed with double Roman tiles the elevation is rendered. The upper floor windows were originally margined timber sashes. The original shop front assumed a central door and tripartite timber display windows either side which sat symmetrically below the upper windows giving the elevation balance. The rendering extended below the windows visually grounding the elevation and making it feel homogenous.
