STREETScape AND DETAILS

1 HIGH STREET, KEYNSHAM

2-4 HIGH STREET, KEYNSHAM

3 HIGH STREET, KEYNSHAM

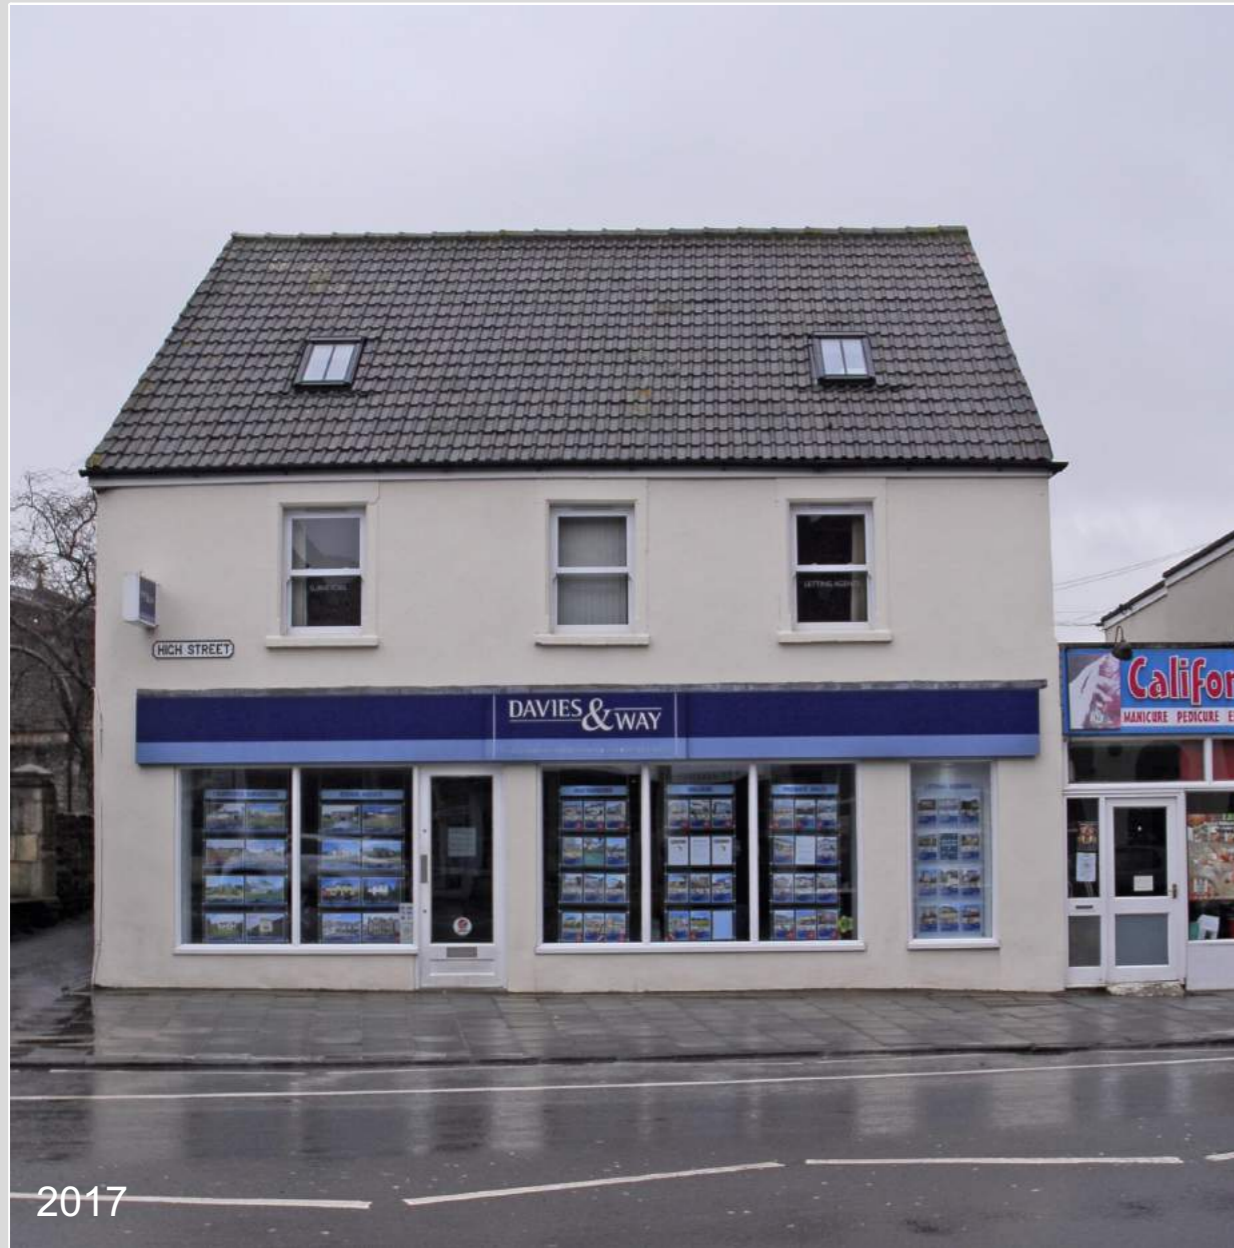
2017

Whilst elements of the original building form remain the character of the symmetrical building has been lost with the ill-considered reworking of the fenestration at street level which no longer relates to the upper floor. The use of materials has such as plastic gutters, fascia boards, sash windows, signage and low level fenestration have resulted in a poor quality commercial finish. Whilst in good repair the building has lost a lot of its original character.

The conversion of the building from a Public house through a number of stages to the current retail outlet has resulted in some damaging incremental changes. Whilst there is no traditional shop front to work with the elevation could be considerably enhanced by addressing the quality of the materials and certain aspects of the design.

- Replace plastic gutters and fascia boards with traditional materials
- Replace UPVC sashes with timber
- Reduce signage to width of street level glazing
- Re-centre front door
- Remove paint from masonry window surrounds
- Construct projecting frontage
- Use contrasting colours to define shop frontage

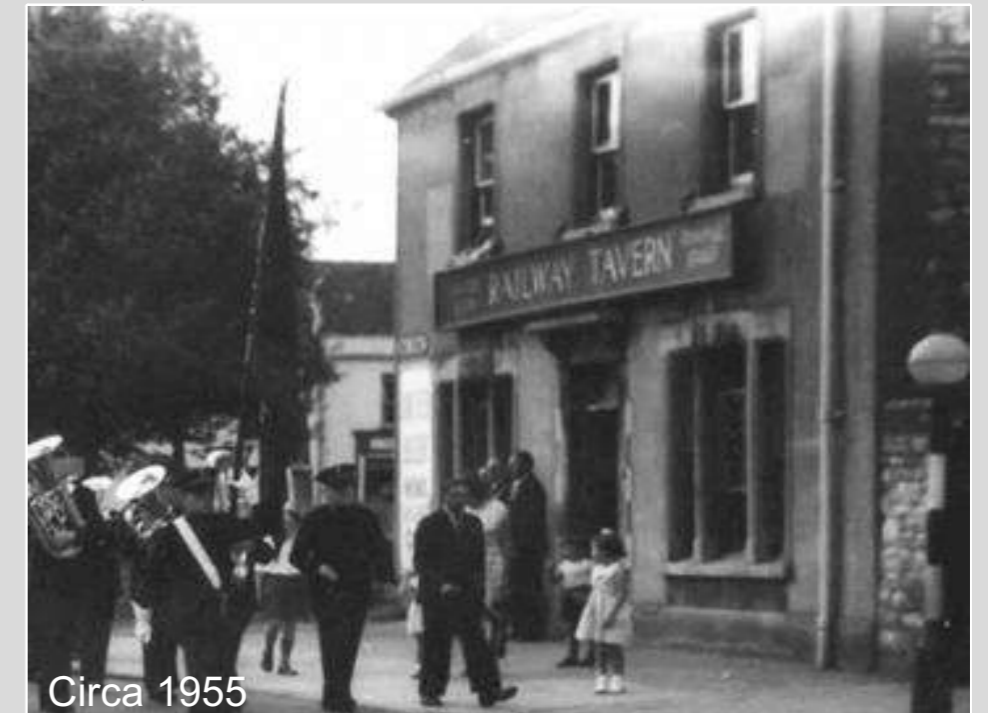
Circa 1955

In the 1950's the traditional ground floor fenestration and entrance were removed and replaced by a number of irregular openings and stone cladding applied over the lower elevation in an attempt to modernise the building. In more recent years this cladding has been removed and the elevation has been further altered resulting in its current configuration.

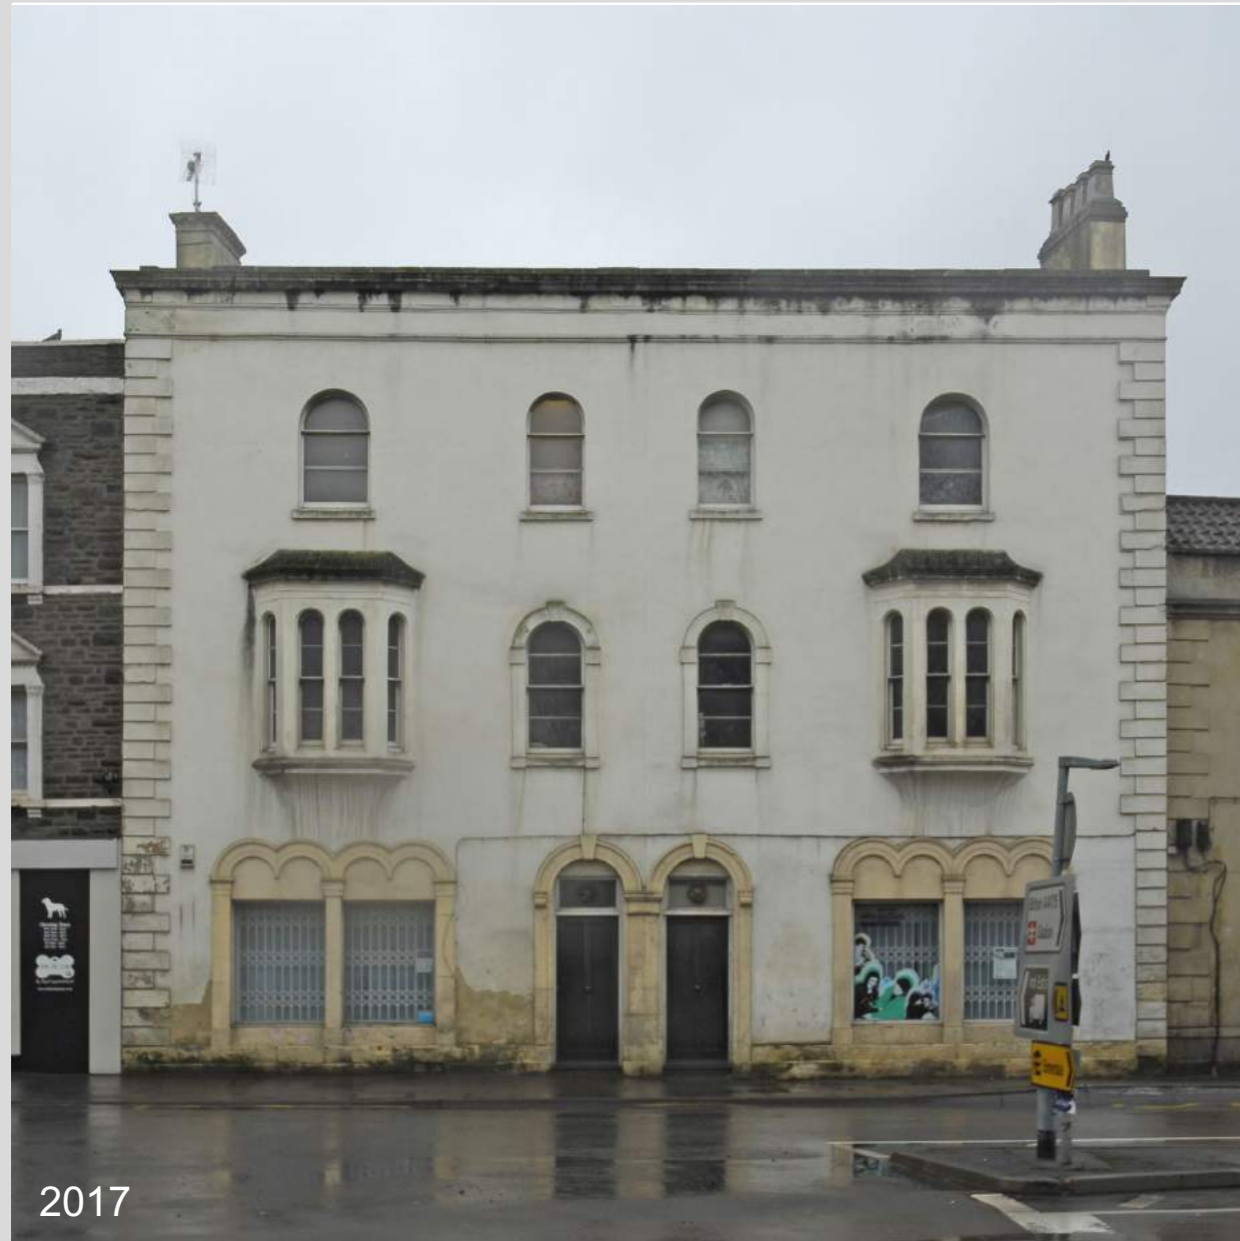
2017

The photograph of circa 1950's shows the post office had a C19th/early C20th shopfront removed by 1991. The ground floor surrounds are conjectural replacements of around 1995 of the original 2 light surrounds. The modern double arches to the ground floor are clumsy and the fanlights to the doors are of poor quality. There is some deterioration of the render at low level to No 4 and some of the stonework at high level is in need of repointing. The render and natural stonework is covered in cementitious paint.

This building has significant street presence. It is currently vacant and has no active shop frontage. The ground floor requires further research into the original design and comprehensive enhancement.

- Research the original ground floor design.
- Replace existing shop frontage with evidence based ashlar design with mullions.
- Remove paint from stonework, repair render and re-decorate render with lime based paint
- Remove surface wires from building face
- Introduce divided fanlights over doors
- Remove internal security grilles from visible front of window display area

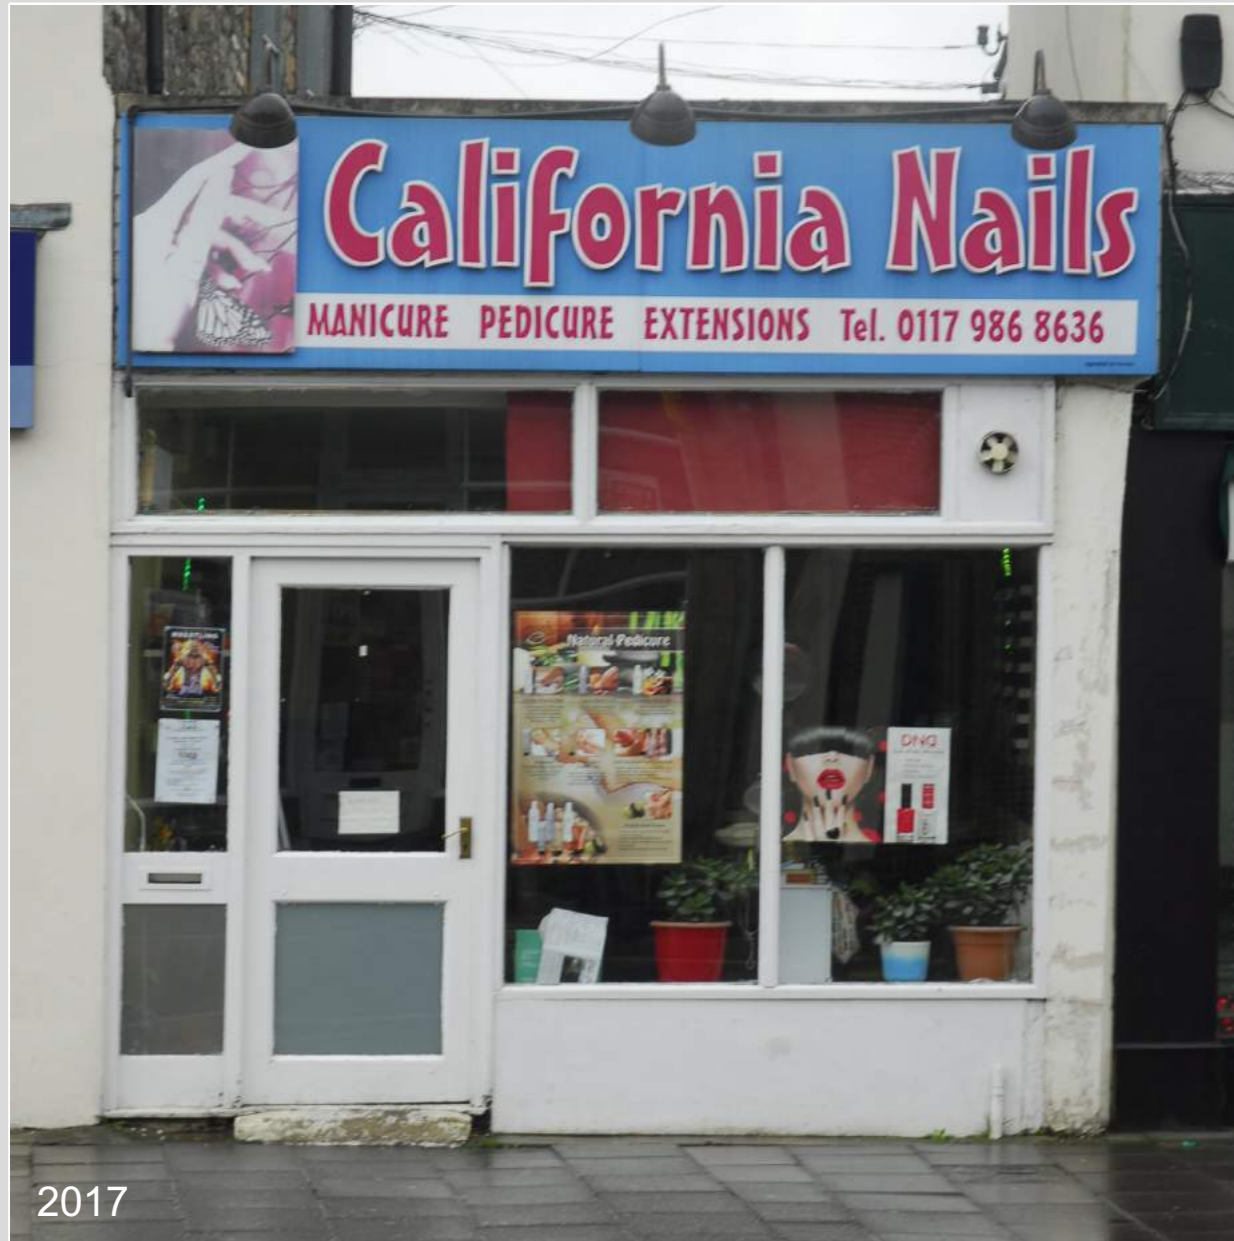
2017

The building is poor quality and there appears to be no design consideration. It has been configured so as not to block light into the side windows No 1 High Street

This building although likely to be nearly 100 years old is of little quality and as a single storey building is incongruous in the street scene which is predominantly two storeys.

- Redevelop frontage completely and construct two storey building
- Replace plastic signage with painted signage
- Use contrasting colours to define extent of shop frontage

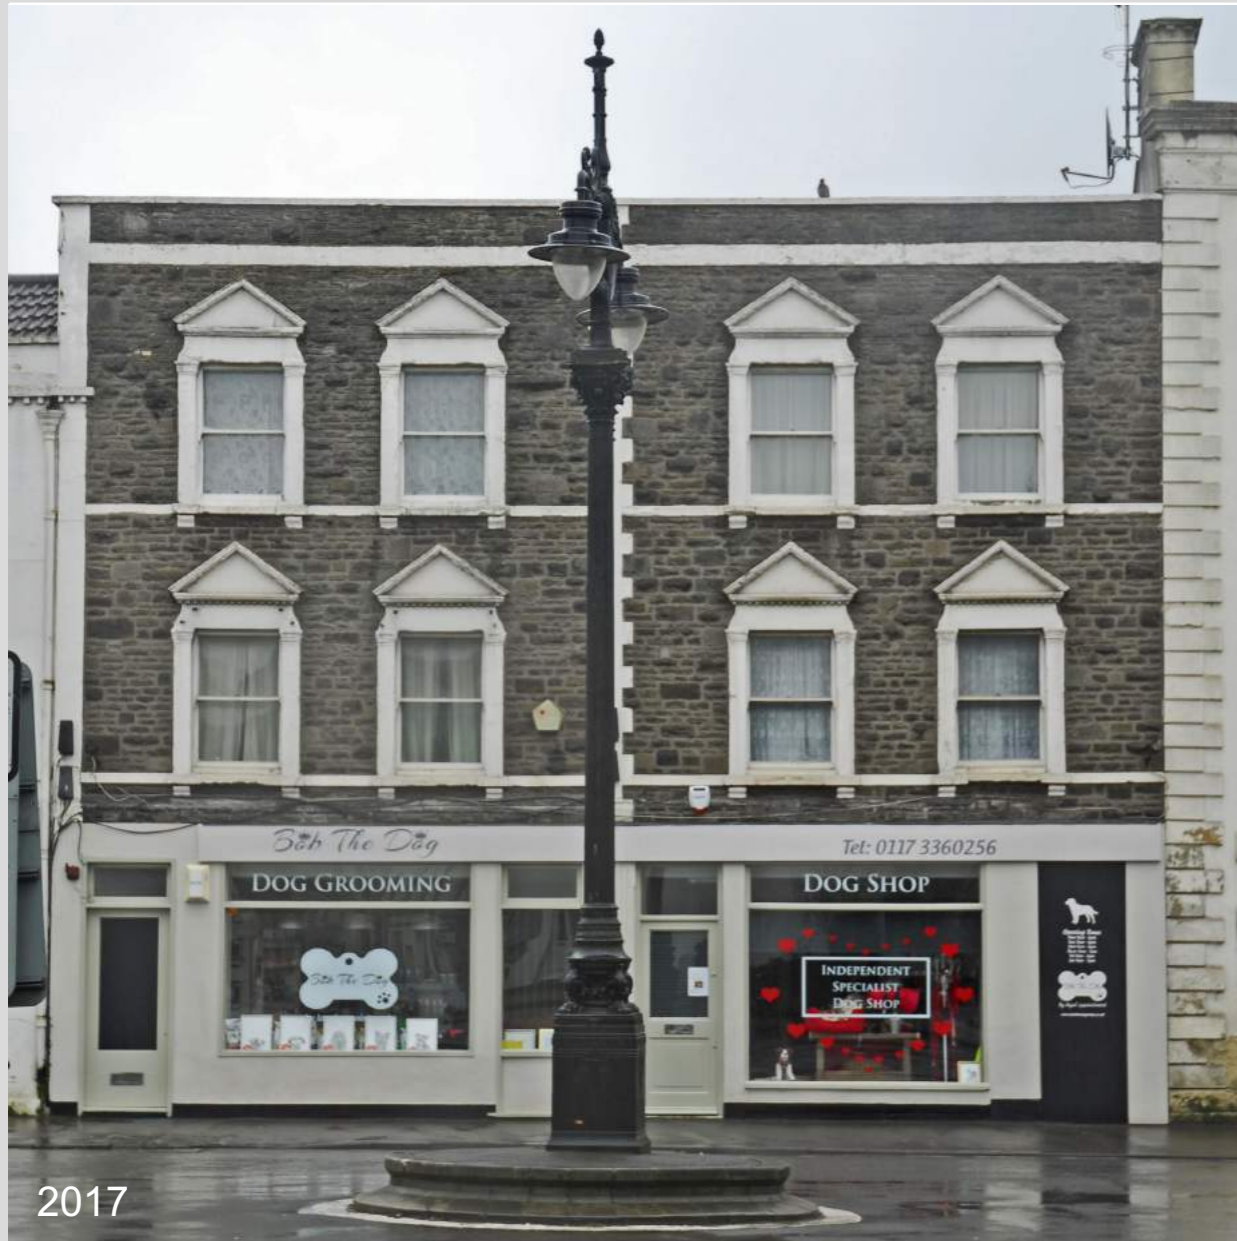
Good appearance and well maintained but with considerable service runs on the elevation. Loss of heritage fabric when planted shopfront removed in the late C19th Century and modern plate glass windows to upper floors also installed. Occupies a key position at junction of Station Road and Upper High Street opposite Church

This is a key building of generally of good appearance. Further enhancements could be made including:

- Remove surface wires from face of building
- Matching doors at ground floor
- Replace cementitious paint from stone dressings and repaint ground render with lime based paint
- Reintroduce glazing mullion subdivision to shopfronts
- Raise cill to no 6 to form stall-riser

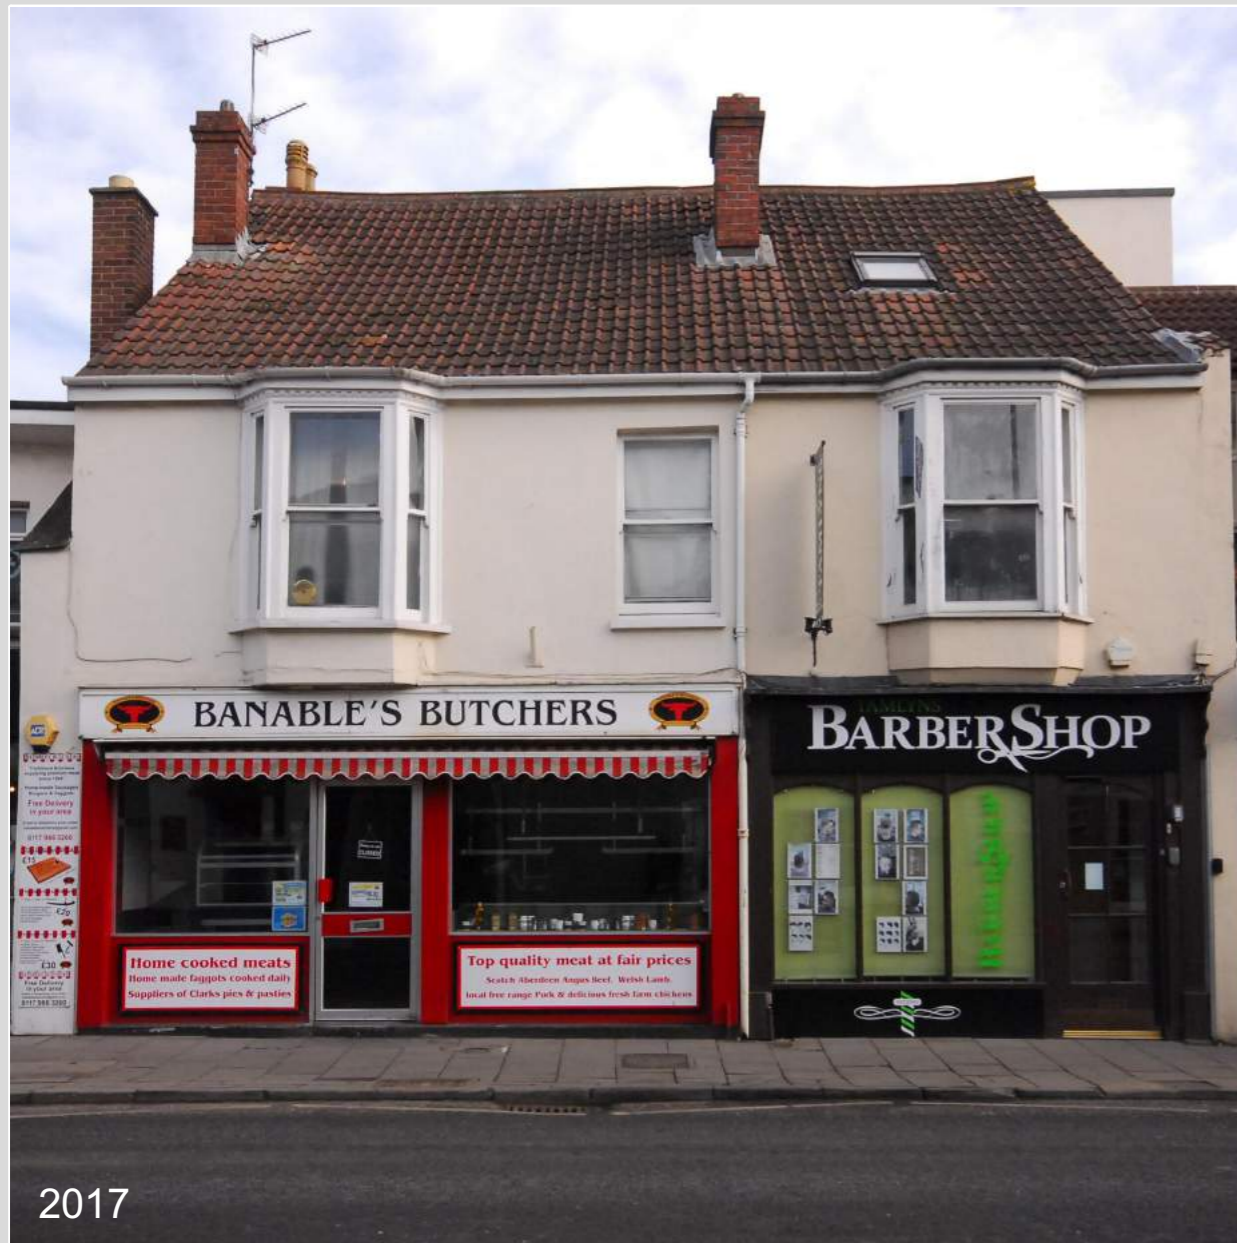
2017

Although built as a unified frontage separate ownership has resulted in different trading shopfront treatments of each side. The use of different coloured guttering and paint on the upper elevation also reduces the unified character. Both are capable of improvement when redecorated and the shopfront changes co-ordinated.

The Bridgewater double roman tiled roof with brick stacks and a skylight has a number of open ridge joints to the half round ridges. The roof drains into cast iron rainwater goods via plastic gutters fixed to timber fascia. The decorations are failing to the right bay and there are also a number of service cables surface mounted across the elevation.

This building has a strong street presence sitting between two unsightly 1960's developments. Visually unifying the two buildings will significantly enhance its character.

- Redecorate bay windows in the same colour
- Redecorate front façade in one colour
- Change guttering to cast metal and unify in one colour.
- Reinstate traditional timber shopfronts based on historic evidence with hand painted signage.
- Rationalise advertisements
- Remove surface wires from face of building

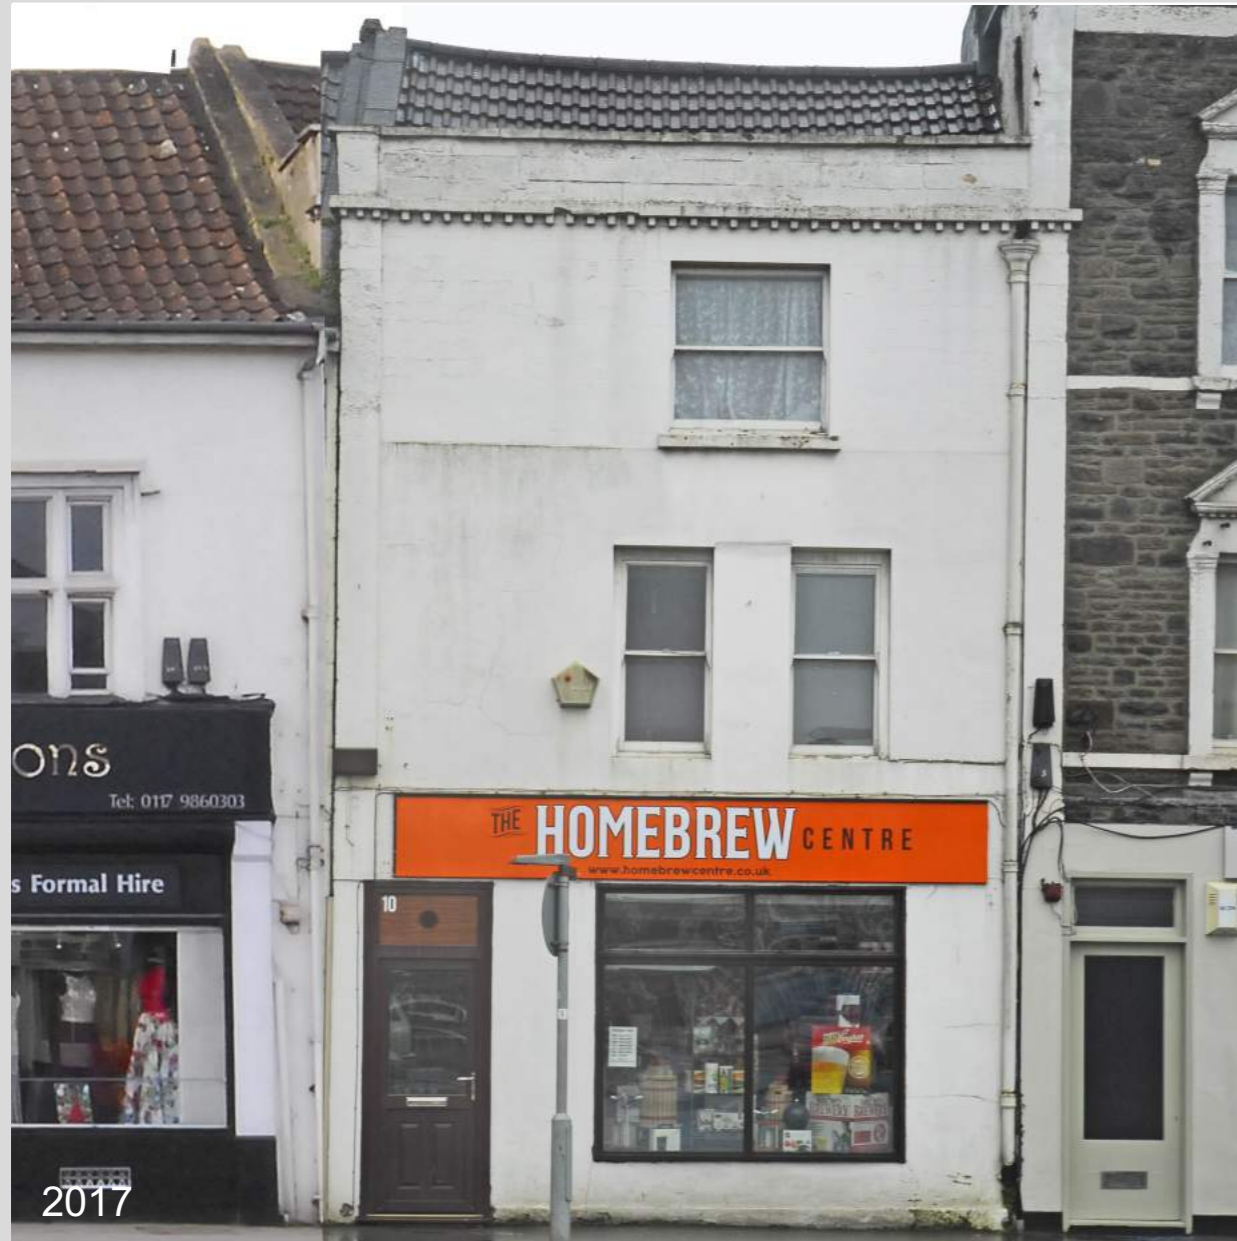
The original canted oriel at first floor and square projecting shopfront removed by 1975 gave the elevation a strong vertical order and articulation which has now been lost. The modern fascia sign extends beyond the shopfront window and is overly deep and brash. The use of smooth render and removal of glazing bars to upper floor windows and lack of sills to the new windows is also a negative attribute. The modern shopfront joinery and front door has punched through the front wall and lack any moulding detail which has essentially flattened the elevation. The front door has also been cut into the pilaster. The whole is in need of redecoration and possibly joinery repairs to the upper floor.

This building would be significantly enhanced by the reinstatement of missing architectural elements repair and redecoration.

- Reinstatement of projecting shop front and first floor oriel windows as detailed in 1911 image
- Replace plastic signage with painted timber fascia
- Re-instatement of 4/8 glazing bars to second floor sash
- Replacement of front door with 6 panel timber door and over-light
- Re-rendering of front elevation in lime based roughcast render

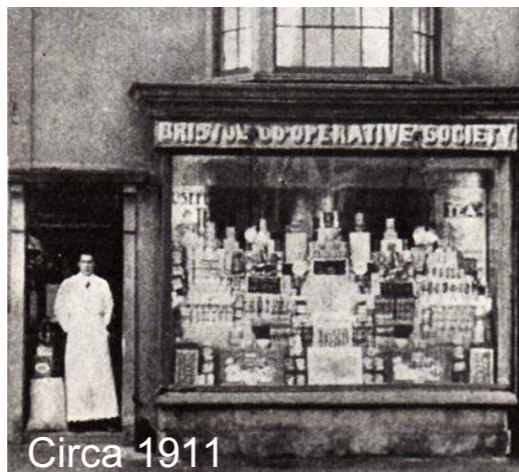
Circa 1911

Up until the late 1960's the building had a first floor oriel window supported on a projecting shop front and a bracketed hood to the front door. These have subsequently been replaced at first floor by two double hung plate glass sash windows without sills and at ground floor with a modern inserted door and shopfront with a rendered stall riser and acrylic fascia signboard. At second floor a double hung plate glass sash has replaced the original 4/8 sash.

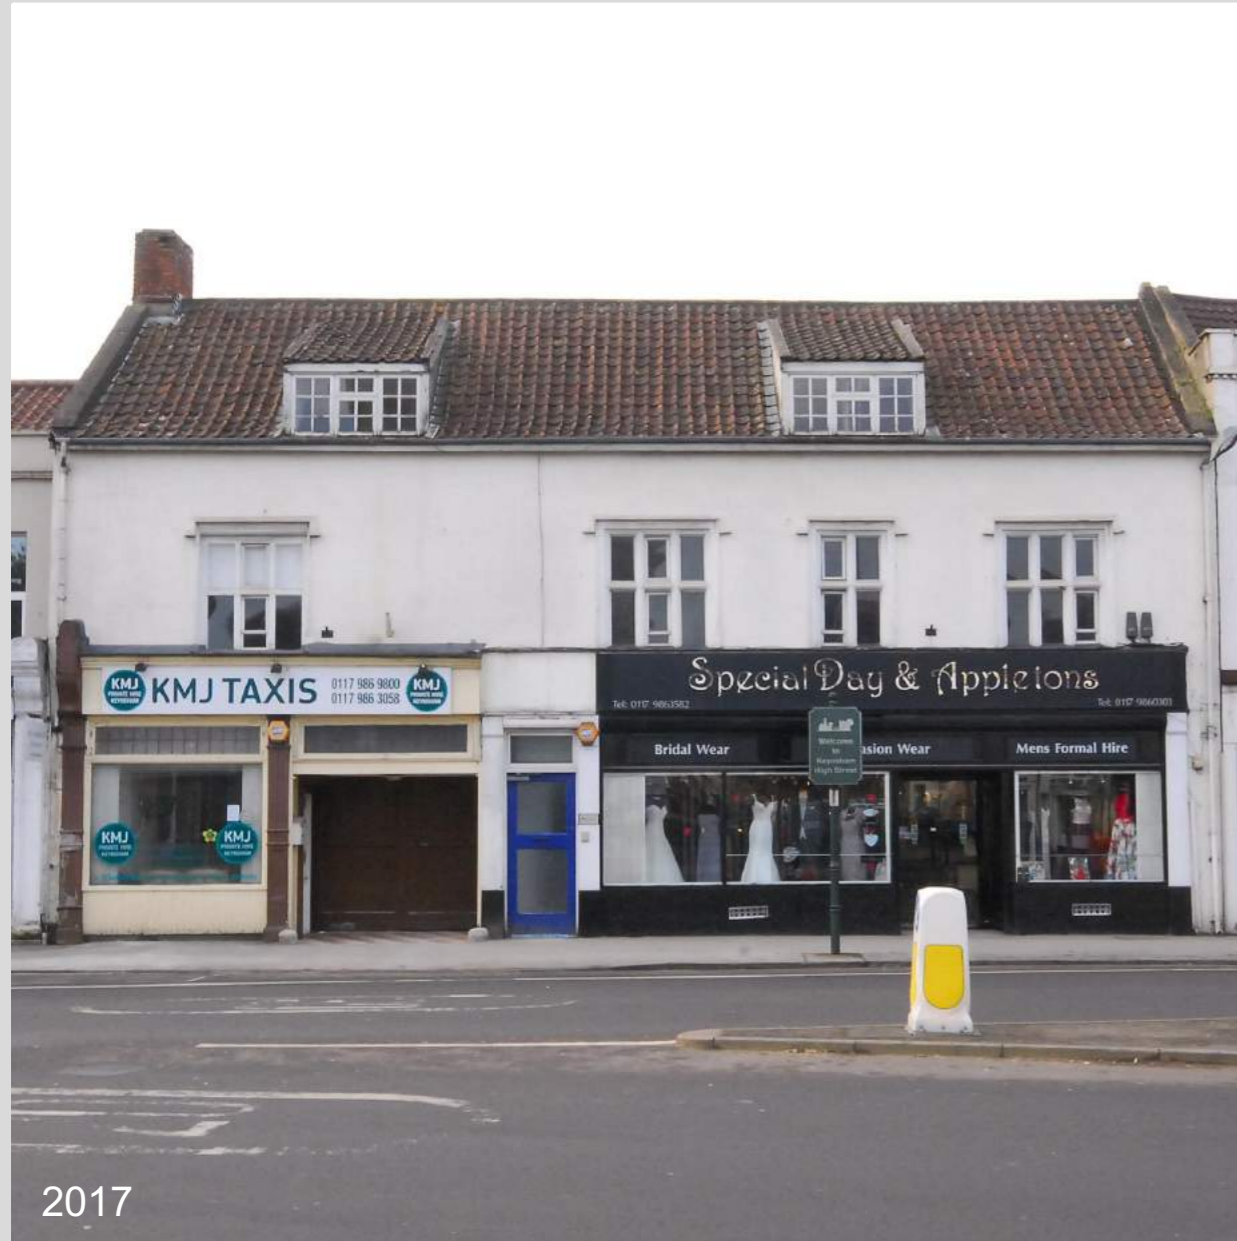
2017

One of the earliest and historically important buildings in Keynsham. Historic shopfront attractive. (see photo of about 1940). Upper floors look unmaintained. Shopfront to KMJ Taxis in poor condition

A substantial amount of the original shopfront to 12a remains but it has lost certain elements and requires urgent repair. General improvements to design of façade would benefit the entire street scene.

- Reintroduce pilasters and console brackets to right of 12a and 12 to complete frontage.
- Change glazed door between shops to something more solid and fitting.
- New rendered stall risers in lieu of marble
- Replacement of missing shopfront mullions
- Replace fascia's in timber with hand painted lettering
- Re-instate lead casements to first floor window mullions and transoms
- Replace uPVC rainwater goods with cast metal

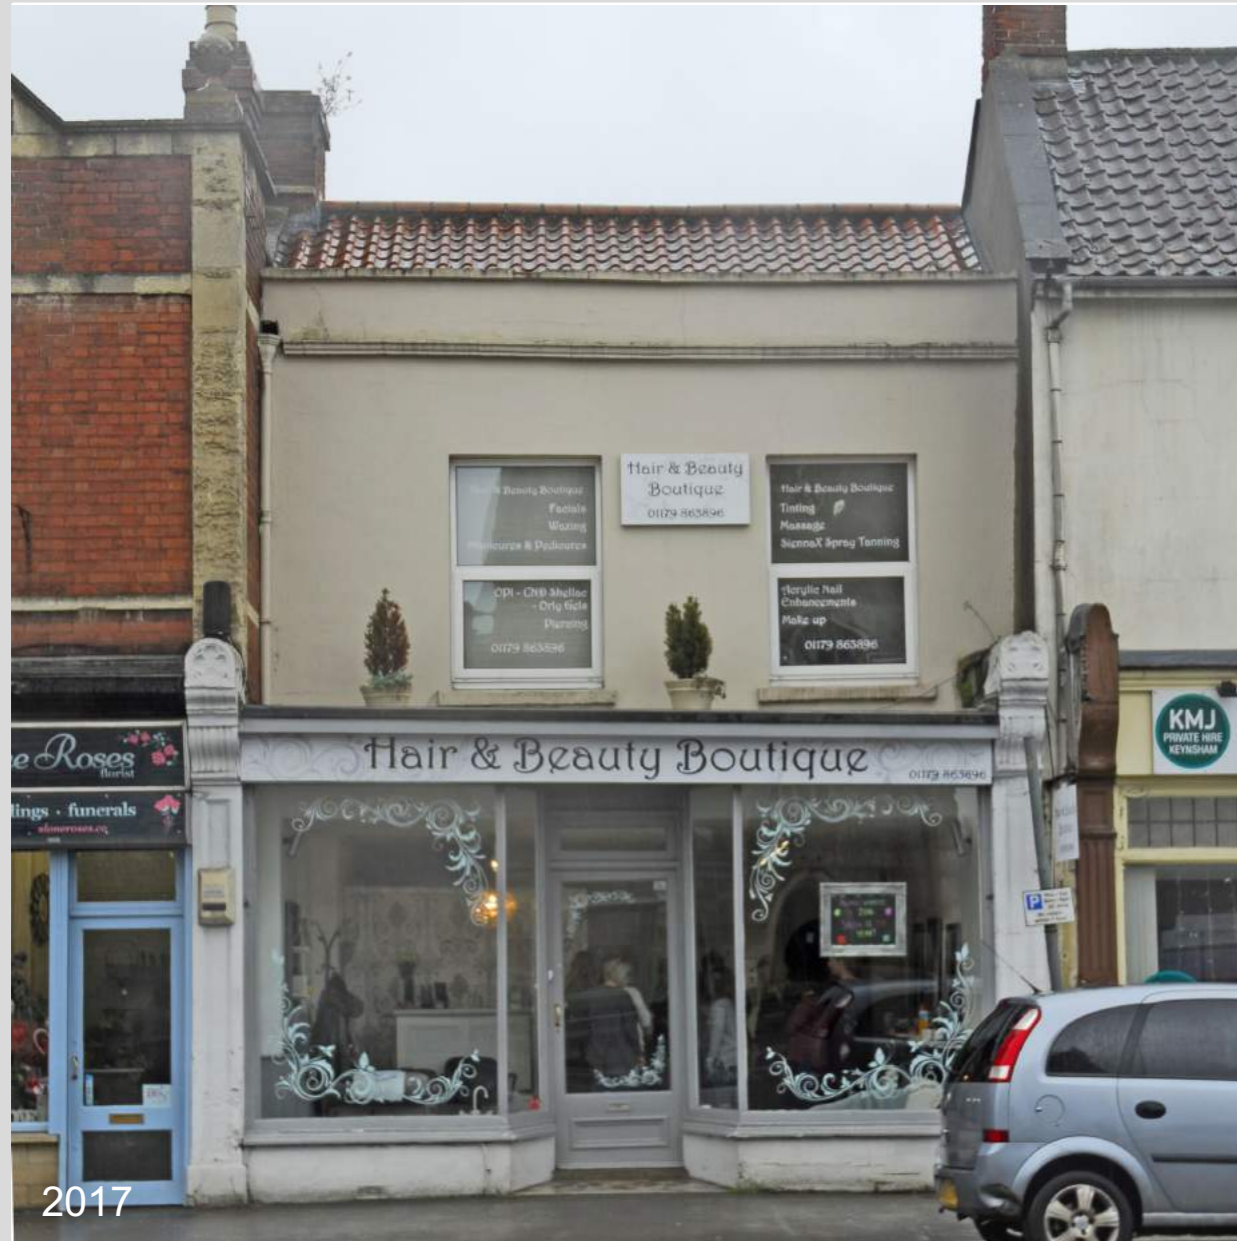
2017

The shopfront constructed to no 14 circa 1890 formed part of the development to 16, 16a and 18 which have matching shop fronts. As such they should be treated as a group. The shop front is in good condition but there is some concern about the flat roof. The introduction uPVC first floor windows and loss of the awning post listing is of concern as this has unbalanced the elevation.

This is a good shopfront in good repair. Further enhancement of the elevation is possible but should be a considered action involving neighbouring shopfronts of the same age.

- Adjust signage to be horizontal
- Check condition of flat roof which appears to be slumping.
- Reintroduce awning
- Development Management action to reinstate sashes
- Reintroduce cast iron upstand skirting above fascia
- Remove window signage
- Remove signage from upper floor

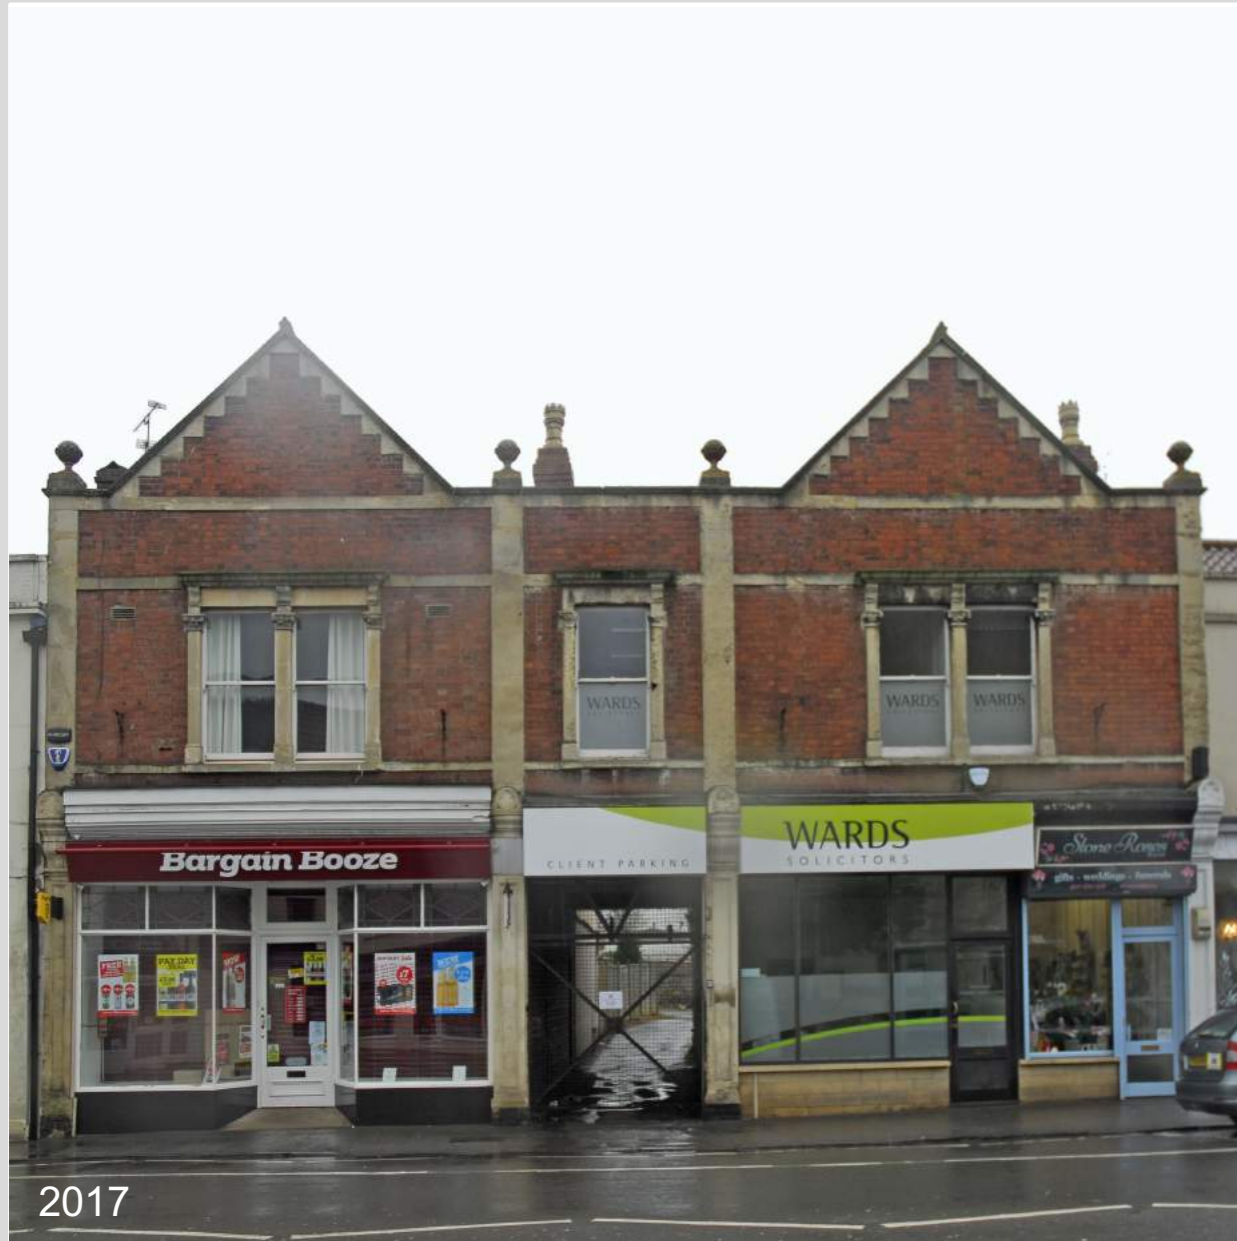
2017

Unusual purpose built pair of shops. Some minor stone surface decay but otherwise the structure in good order and a lot of the original fabric remains behind signage.

This is a key building of generally good appearance. Further enhancements should be made including:

- Remove boxing in above fascia to no 18 High Street awning
- Remove applied signage over front of original shop fascia
- Remove signage over alley completely
- Adopt a consistent approach to signage to both fronts
- Replace modern shop fronts to 16 and 16a with more traditional design
- Rendered stall risers to replace tiling and reconstituted stone

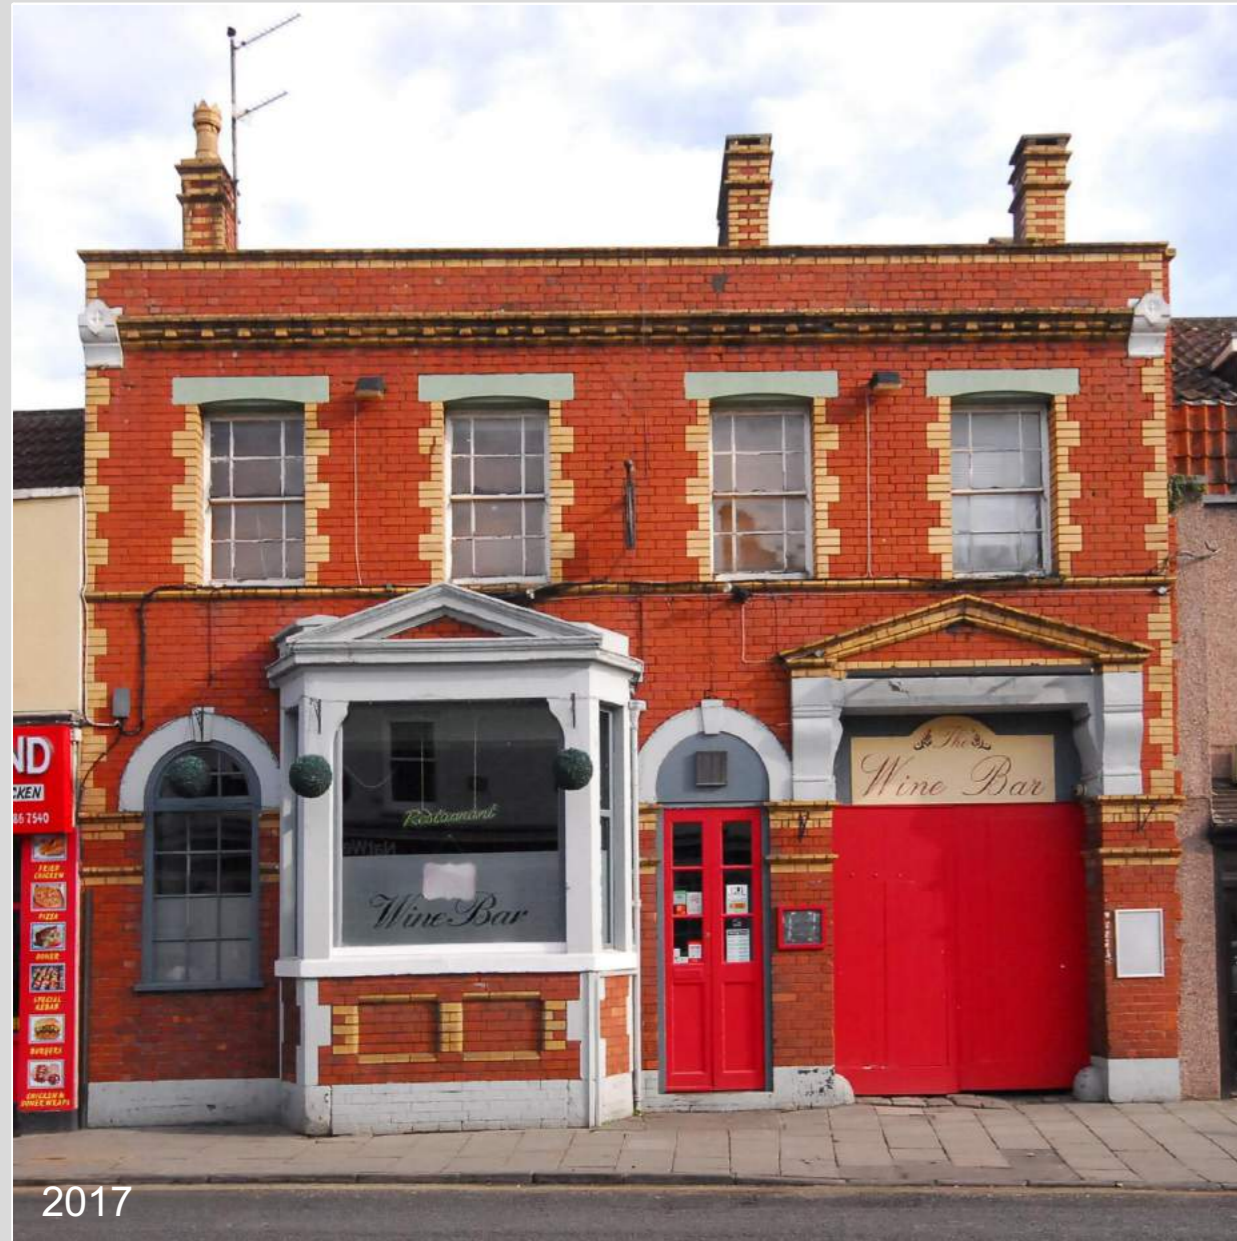
2017

This building is a well preserved example of a Victorian town public house. Its current condition is reasonable at ground level but deteriorates up the building. The upper floor windows are in a poor state of repair and a mixture of paint colours have been used on the stone work across the building at different times.

Although not typical of Keynsham building stock this is a positive contribution to the street scene. Some minor improvements would further enhance this building

- Overhaul upper floor windows
- Paint window heads and architectural detailing a consistent colour
- Clean the brickwork where there has been a degree of atmospheric staining
- Repoint brickwork with lime mortar
- Remove redundant external cable runs.

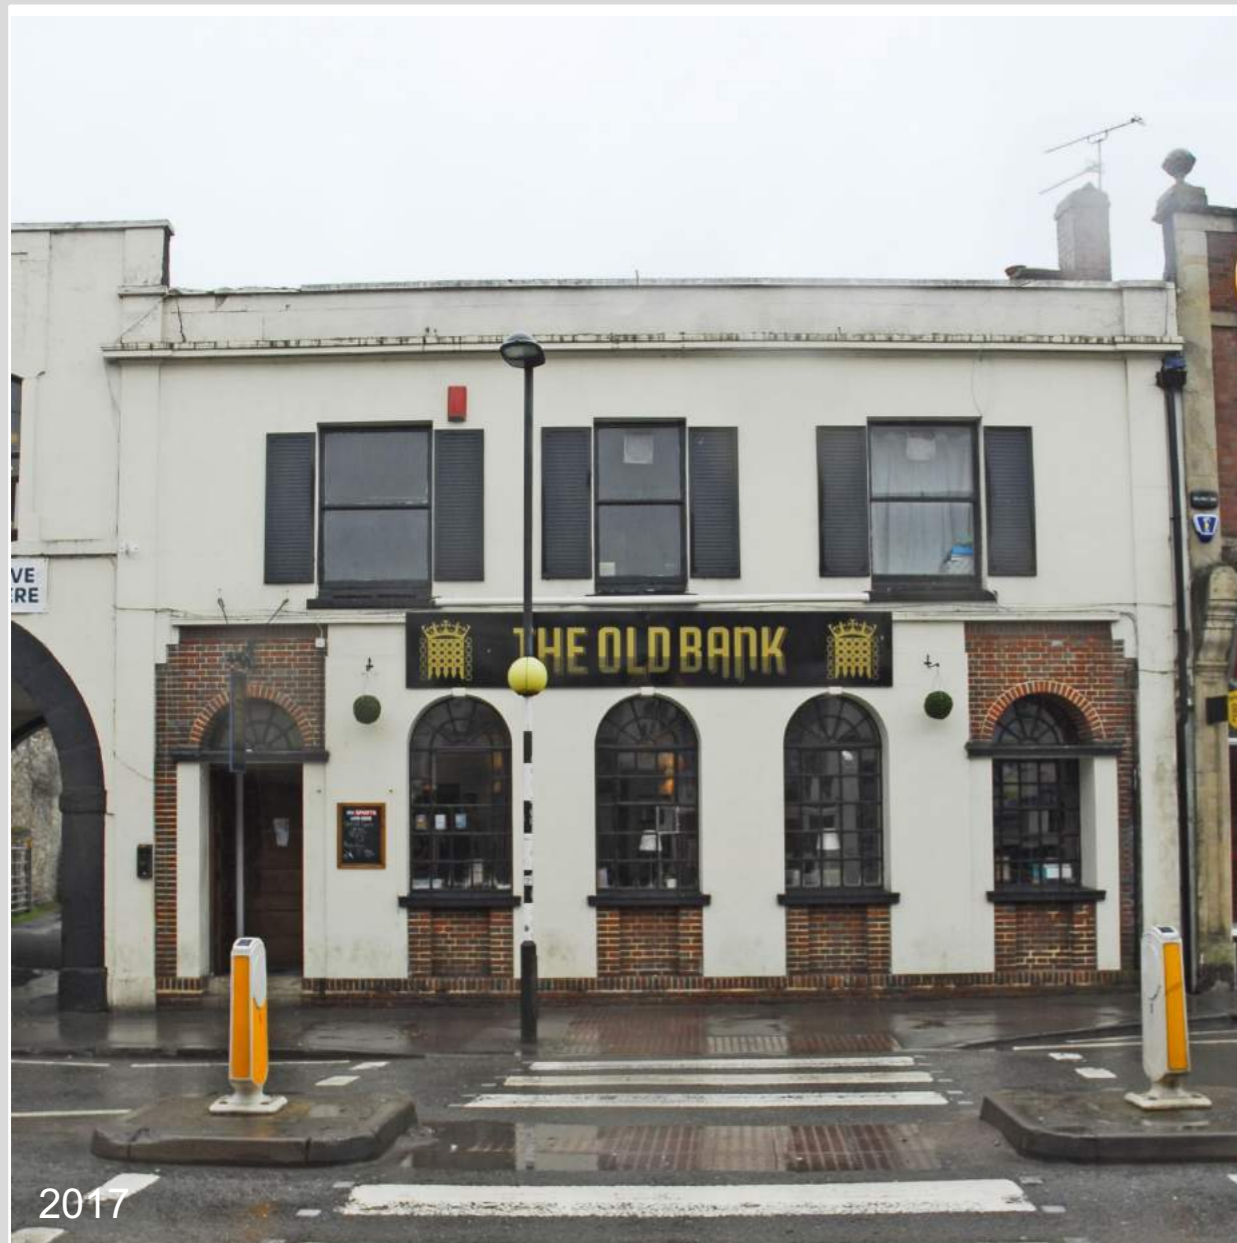
2017

Deep illuminated acrylic fascia sign partially covering string band. Hanging sign over left hand side entrance. Chalkboard sign fixed to wall. Sky Sports plaster banner over carriage entrance. Ashlar covered in modern cementitious paintwork weathered and degrading. Sashes and plate glass with false shutters and large fascia sign looks poor.

Basic structure is good but lack of maintenance and poor control of advertising. Too many signs and depth of sign covers the string course. All joinery requires re-decoration.

The architectural features of the building would be better revealed if:

- Signage reduced and individual lettering applied of appropriate depth below string course
- Redecoration in more appropriate colour scheme
- Development management of unauthorised signage
- Upper floor sashes were replaced with multi-pane sashes
- Remove of shutters and trough lighting
