21 HIGH STREET, KEYNSHAM

22 HIGH STREET, KEYNSHAM

23 HIGH STREET, KEYNSHAM

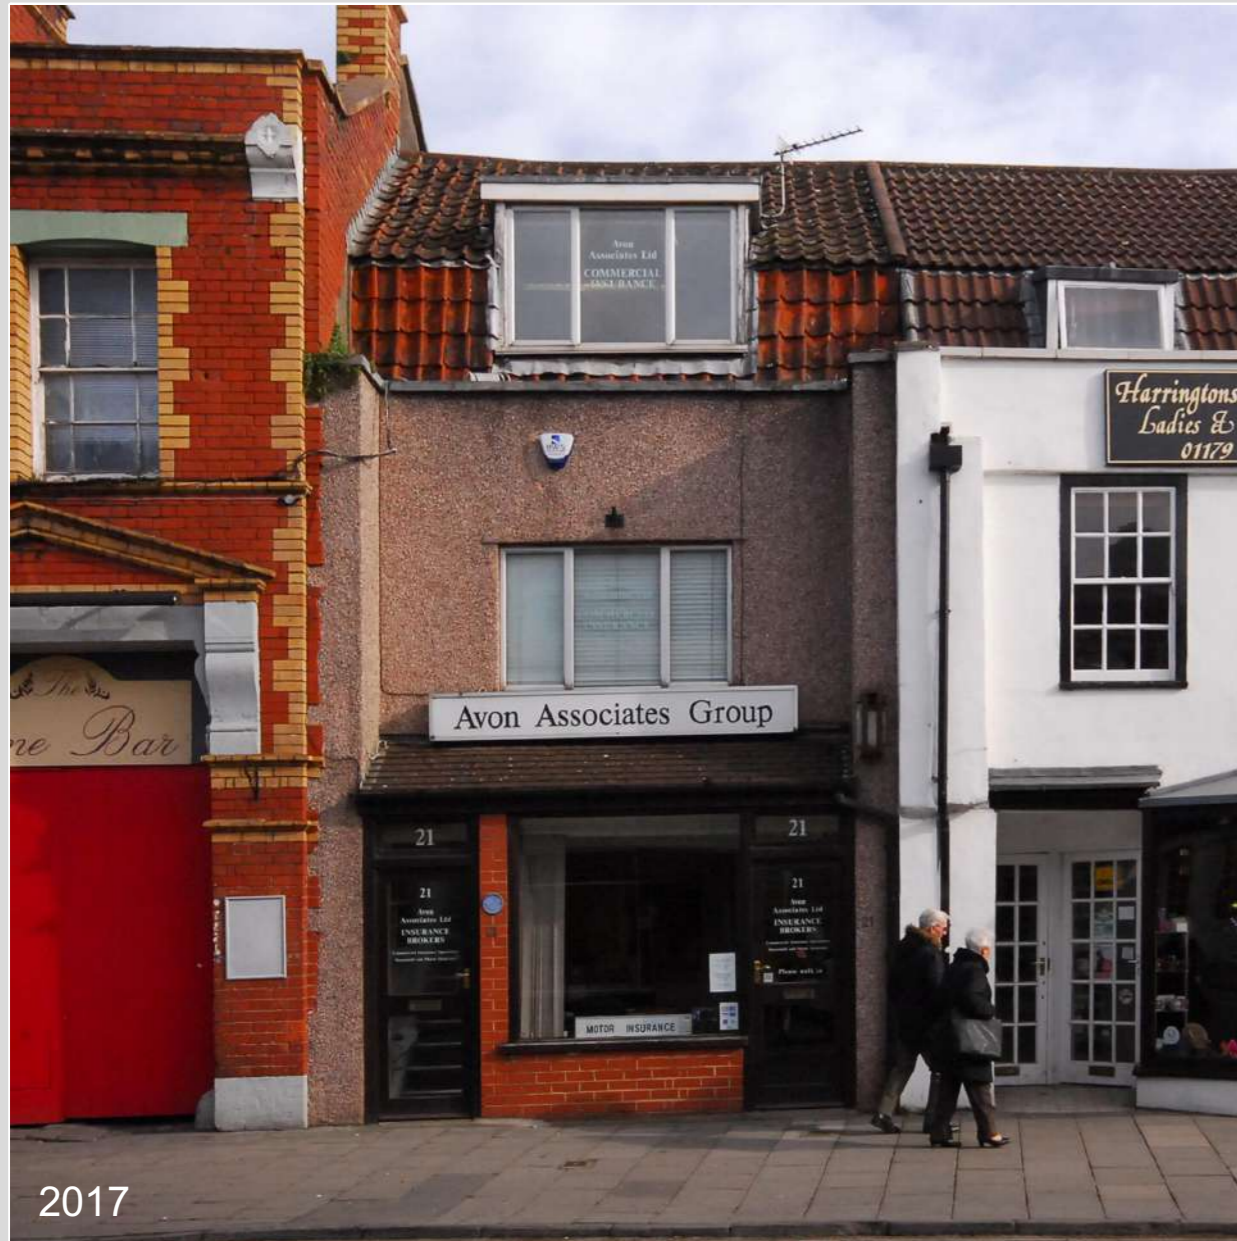
2017

The current building has a very unsightly pebble dash rendered elevation with ill proportioned windows at first and second floor and an extremely awkward clay tile and brick porch construction out of character with any other structure in the street. The signage is cumbersome and the materials used in the reworking of this elevation adversely affect the setting of the listed building at 23 and 19 High Street.

Of all the buildings in the High Street this ranks one of the most denuded of any character and shop frontage. The building whilst in a reasonable condition detracts significantly from the street scene.

There is little that can be done to mitigate the negative impact of this building on the street scene without major intervention.

- Consider the option of complete re-facing elevation back to street line.
- Replace dormer with a more sympathetic design and scale
- Replace first floor windows with a more sympathetic design
- Paint the elevation consistent with 23
- Replace fascia with more traditional signage

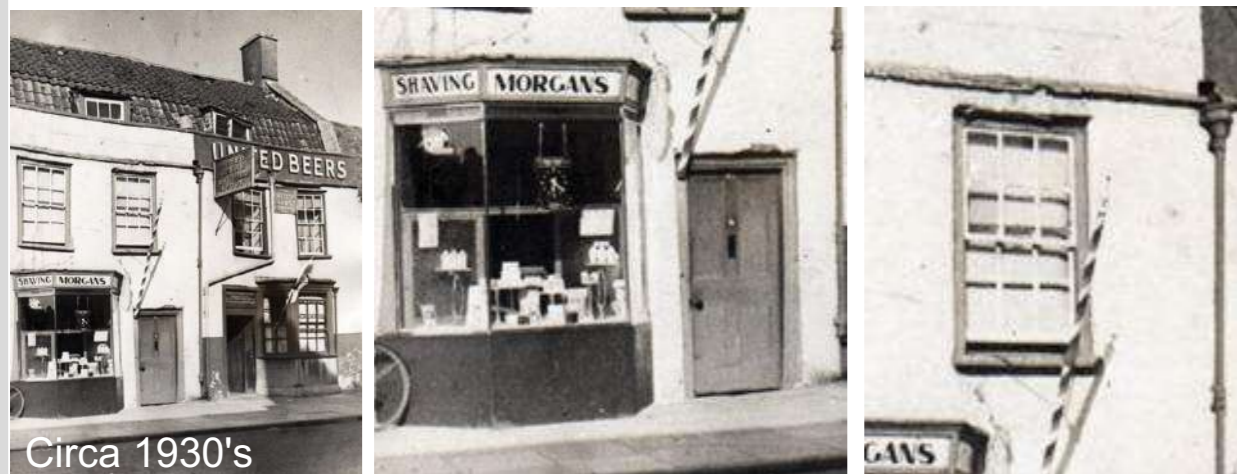
Whilst 23 remains complete 21 has suffered significantly with the wholesale removal of the front elevation back to the gutter line and the formation of a recessed frontage. The original double range 6/6 flush faced windows have been lost as has the bay window shop front and door. The mansard roof construction remains but the original dormer window has been significantly enlarged. The pantiled roof is all that remains of this original frontage.

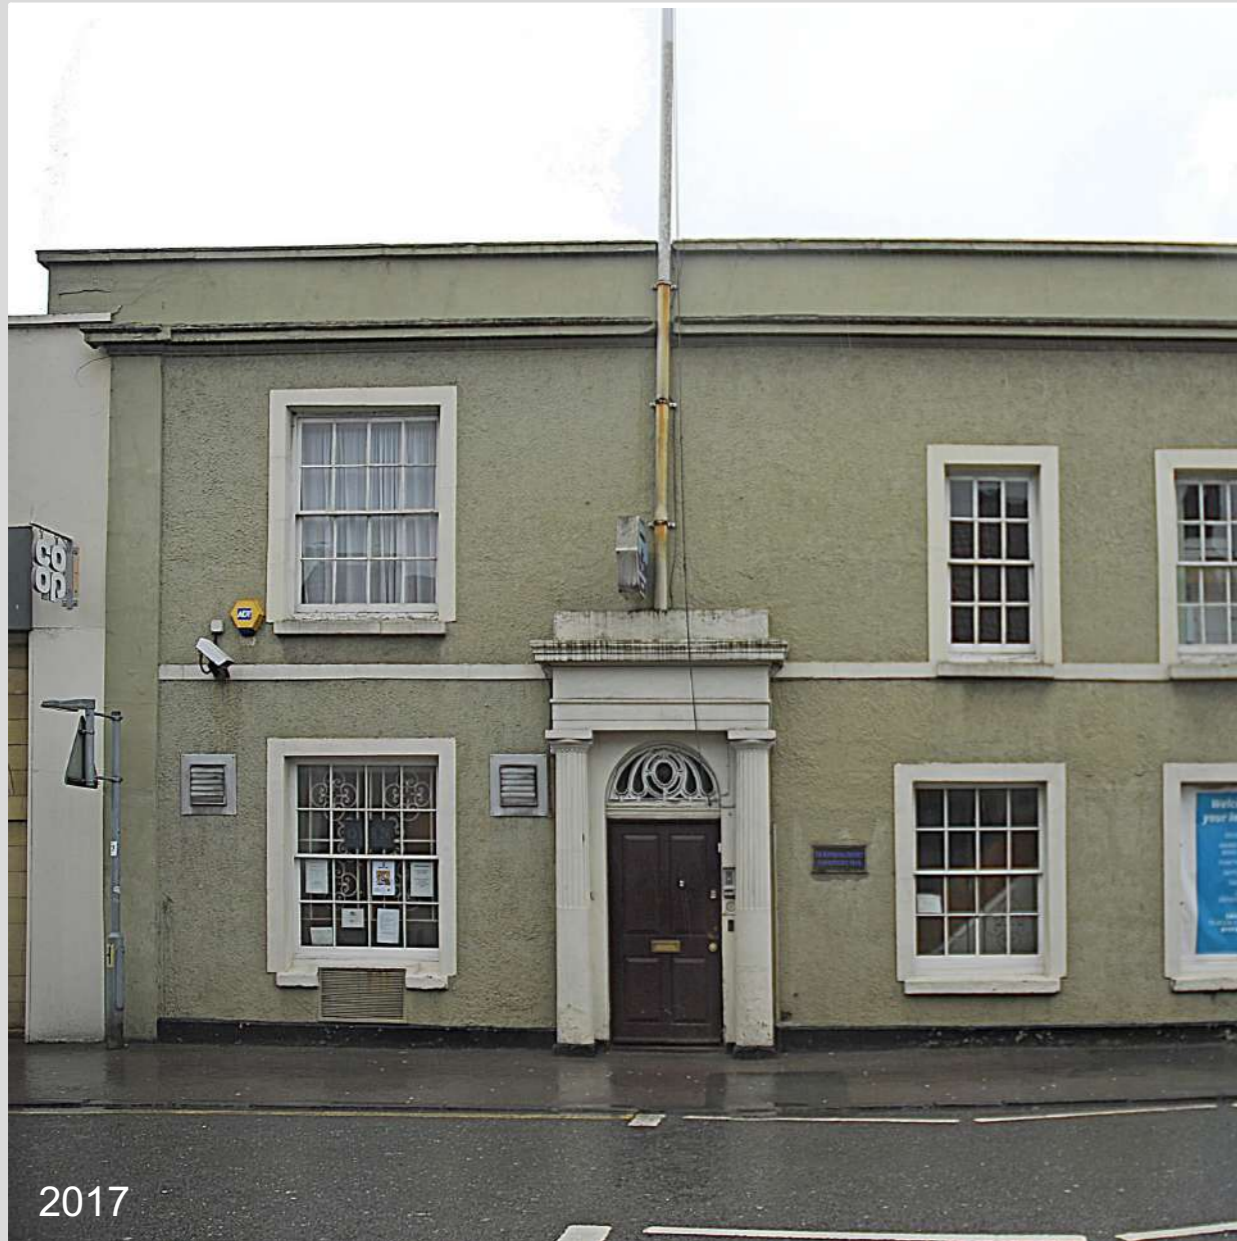
2017

The walls are rendered with a roughcast render which is stopped against masonry window surrounds, sills, strings and copings. There are three vents in the external wall to the left of the front door which are unsightly and inappropriate for a listed building.

The building is generally in good condition but has a display board fixed over one of the windows and there are three vents in the external wall to the left of the front door which are unsightly and inappropriate for a listed building and have caused damage to the fabric.

- Remove inappropriate and potentially unauthorised extract fans to left of front door and hanging sign
- Reinstall window sill to left window
- Decorate security grill to black to lessen visual impact externally
- Remove banner from in front of window and decorate blind window or reinstall window
- Reinstall top of left hand pilaster at parapet level

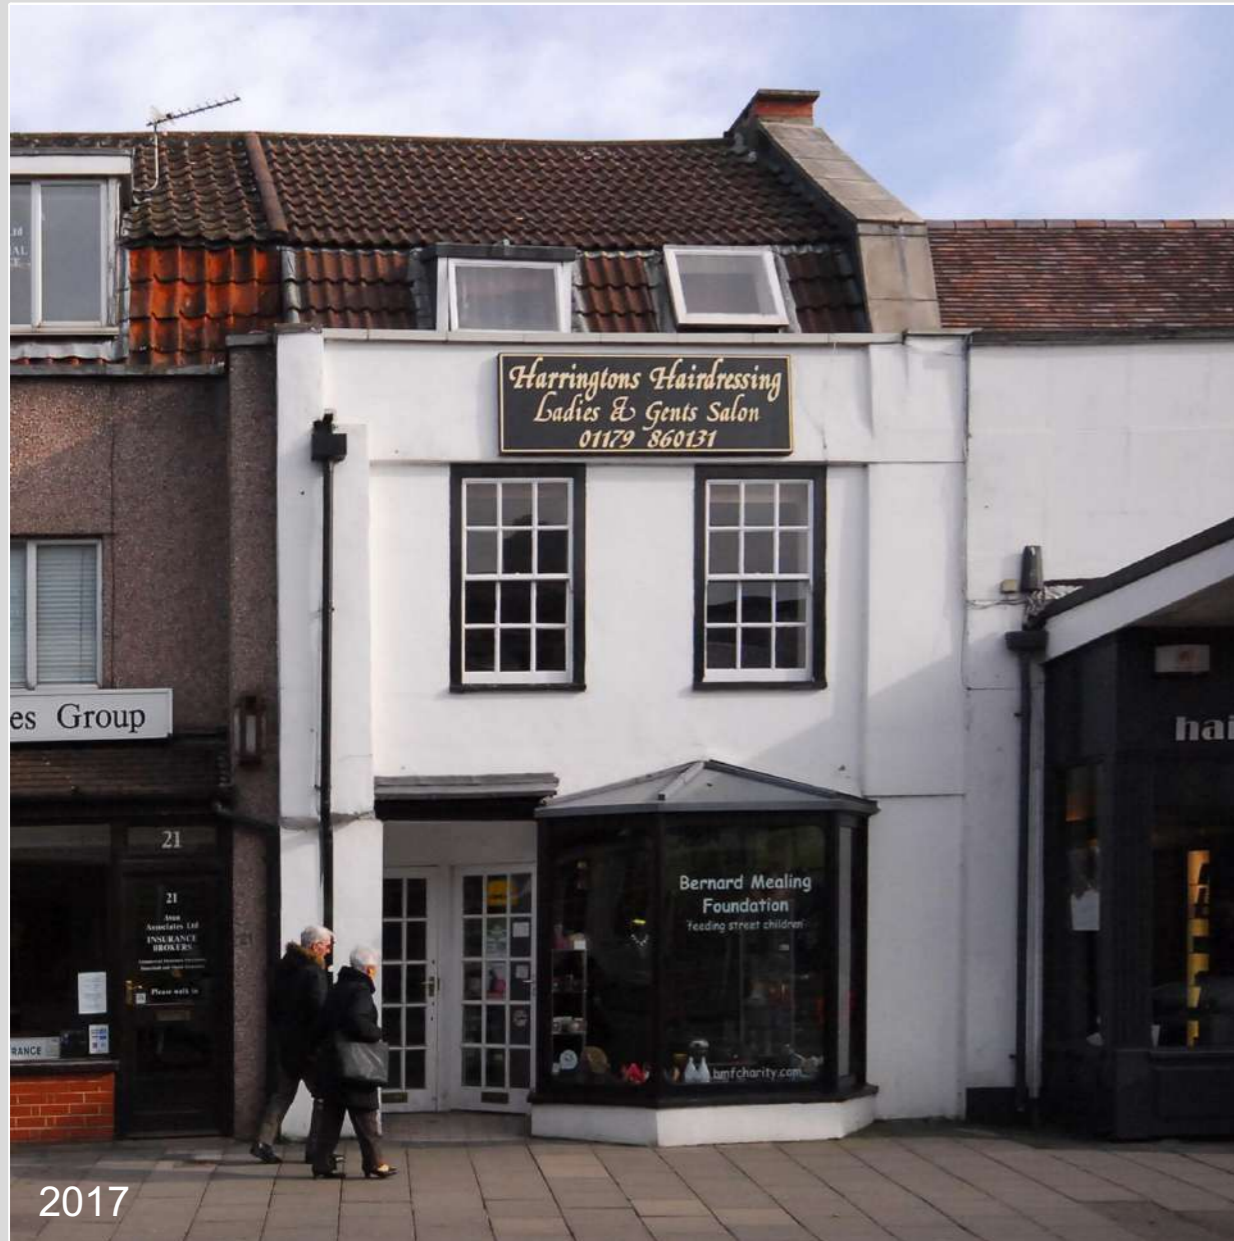
A roof light has been added alongside the original dormer which has been crudely rebuilt. Both look unrefined.

The shop front comprises a relatively modern bay window possibly on the footprint of the original bay but inappropriately designed and detailed for use on a listed building.

Although Listed the building has significantly altered since the c1930's with major structural works to ensure stability. The building is in good repair and decoration. The use of plastic rainwater goods and non-traditional materials on the bay window is distracting.

- Replacing plastic rainwater goods with cast metal goods
- Redesign bay window with reference to historic precedent
- Provide an outer frame to the entrance to help redefine the plane of the elevation
- Remove signage at upper level to span building frontage
- Redesign dormers to be more traditional in form. Should relate to windows below

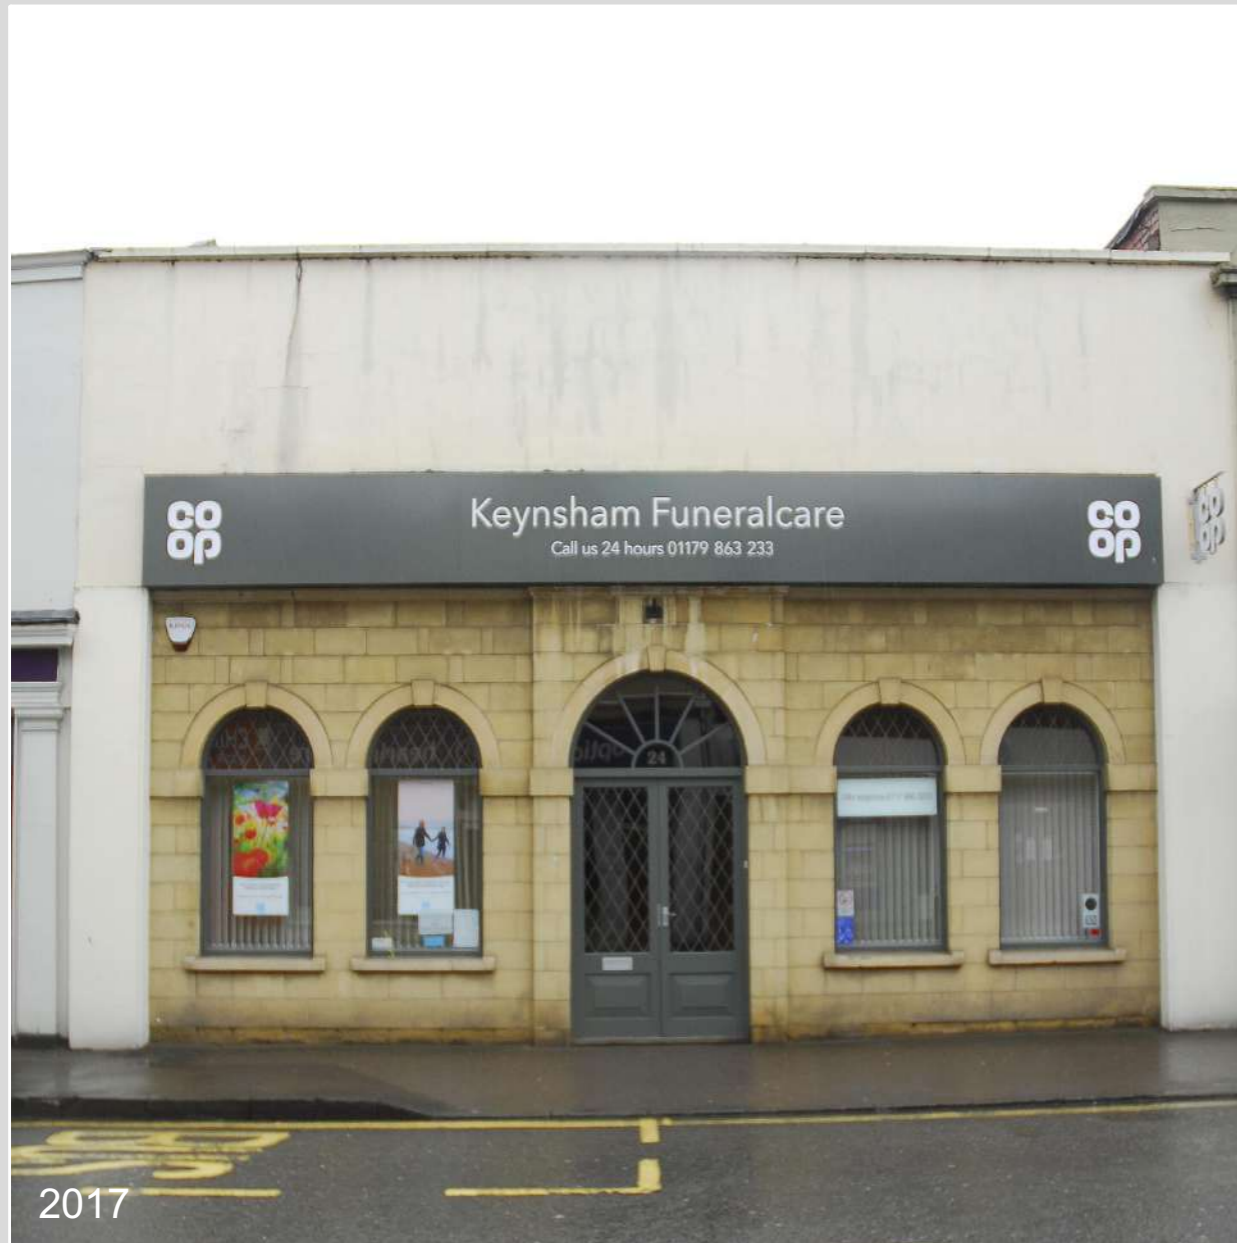
The building on this site has no historic integrity given that it only dates to 1980's. The emphasis on the lower 3m of the elevation has created a bland façade which detracts from the general street scene and has also resulted in the loss of town centre over shop accommodation.

- Candidate for complete redevelopment which could be 2 storeys plus an attic

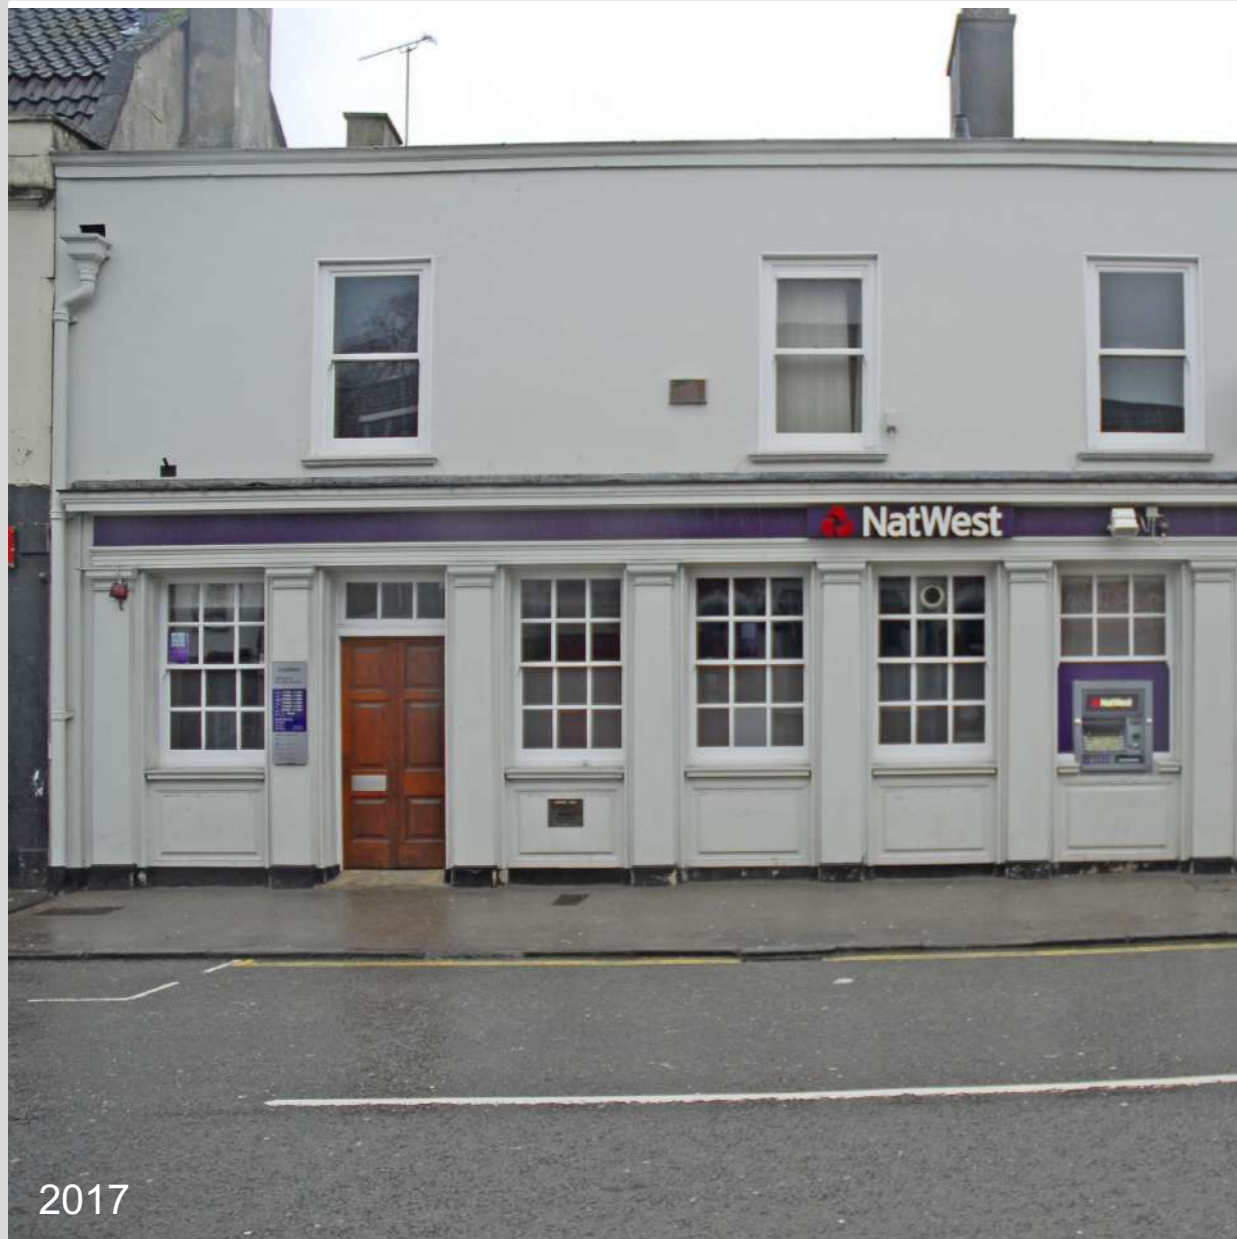
2017

The first floor elevation has 4 windows with plate glass double hung sashes set in a colour washed rendered wall with blind parapet with moulded coping stones. Above this a low pitch clay pantile roof with south rendered stack and ridge stack discharges into face mounted cast iron rainwater goods.

The ground floor is a modern Regency style design with 9 painted stone Doric pilasters and 8 alcoves 6 containing 6/6 wood sashes, with fielded panel stall riser in painted stone below and 2 entrances with modern hardwood joinery at either end. One of the windows has been modified to accommodate a ATM.

The signage fascia runs the full width of the façade with and illuminated (?) acrylic raised box sign.

Fake Regency style, but intact. Only corporate acrylic signage detracts. Whole of façade in good decorative order.

- Intact frontage in good repair and decorative order.
- Signage capable of improvement by replacing acrylic box signage with traditional painted lettering
- Cumbersome placement of ATM machine

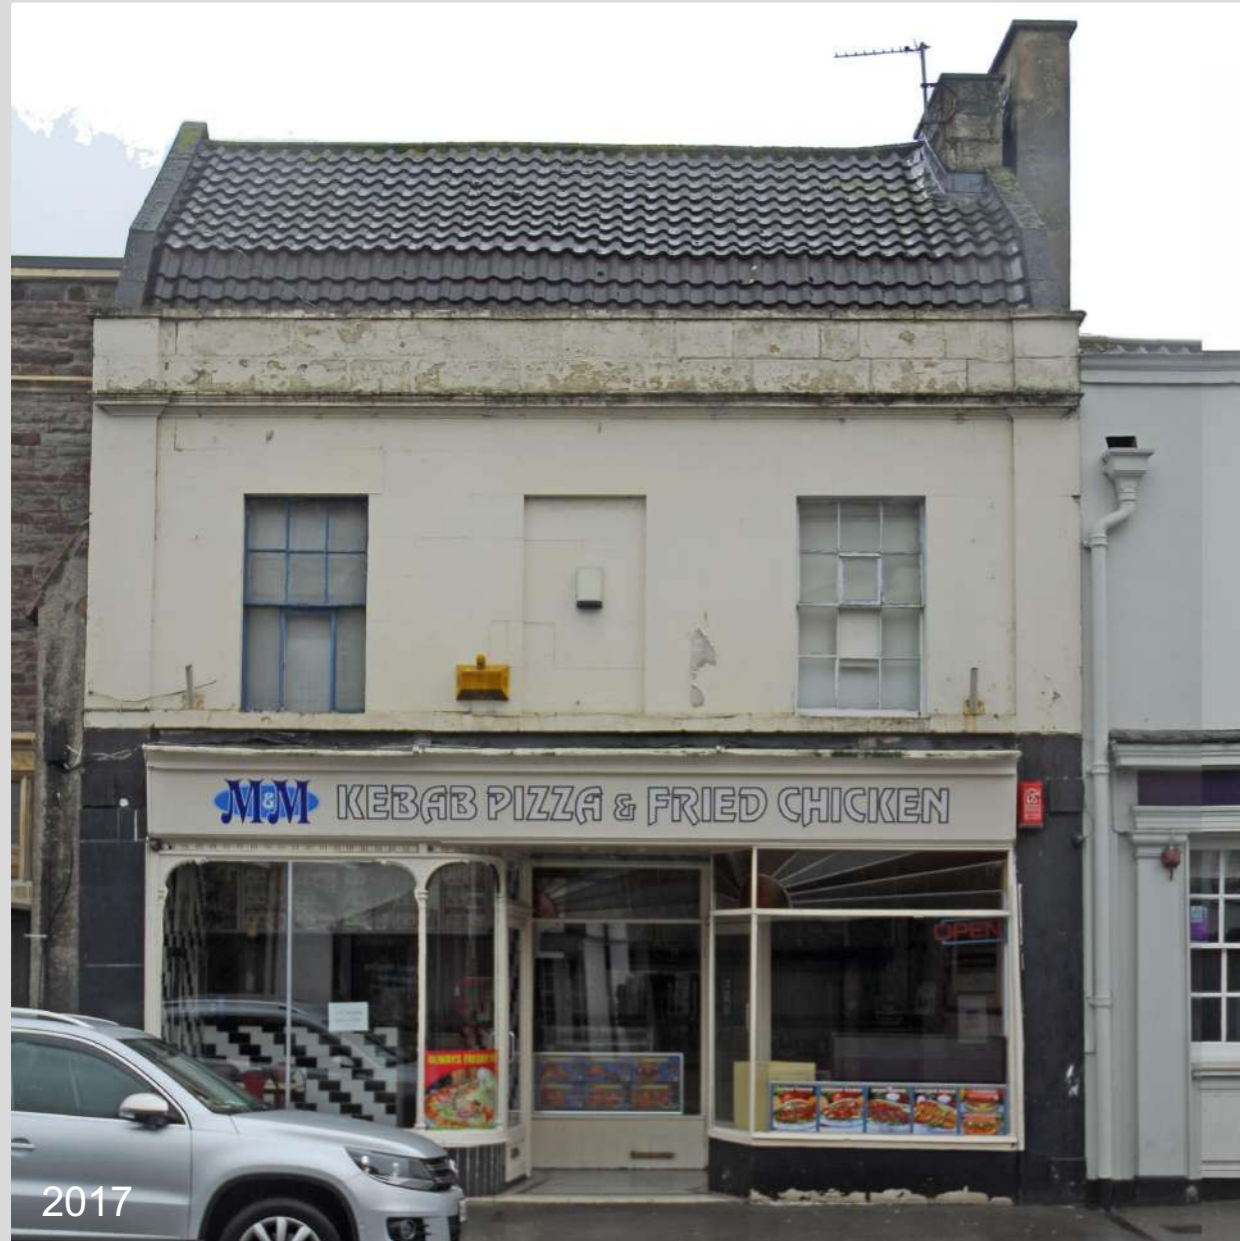
2017

The ashlar elevation is bracketed by pilasters rising to a blind parapet and moulded string cornice all covered in modern cementitious paintwork. Above this is a concrete pantile mansard roof with ashlar copings and north ashlar stack. The First floor windows consist of a blind central opening with 6/6 wood sashes either side. The LHS with lower sash missing transverse glazing bars.

The shop frontage is fully glazed with a central recessed entrance with 2 doors set at slight angle. Above this is a plain timber fascia and painted lettering sign with a lead covered wood moulded cornice. To the sides the pilaster areas are tiled where the console brackets and timber pilasters were removed c 1967 (see Photo c 1965).

The left frontage has original ventilation fretwork to head of shopfront. Possibly denoting butchers use. Timber mullion missing otherwise original timber mouldings and cills. Curved glass to entrance return. Tiled stall riser.

The right frontage has been modified with timber transom and canted return into entrance. All original timberwork removed. Coloured glass in sunset picture with lead comes above transom probably 1930 to 40's with Art Deco references. Tiled stall riser. Recessed entrance doors mid 20th century fully glazed. Lobby with concrete terrazzo and black border

Whilst some of the original shop front has been lost the frontage retains significant character worth preserving and enhancing. The general condition however is weathered and degraded.

- Reinstatement of pilasters and console brackets to fascia
- Redecoration of façade with a consistent colour down to ground level using lime based paint
- Careful unpicking of overpainting to left hand shop front windows
- Repairs to rain water goods
- Repairs to sashes and reintroducing blind window decoration
- Remove tiles and re-render stall riser

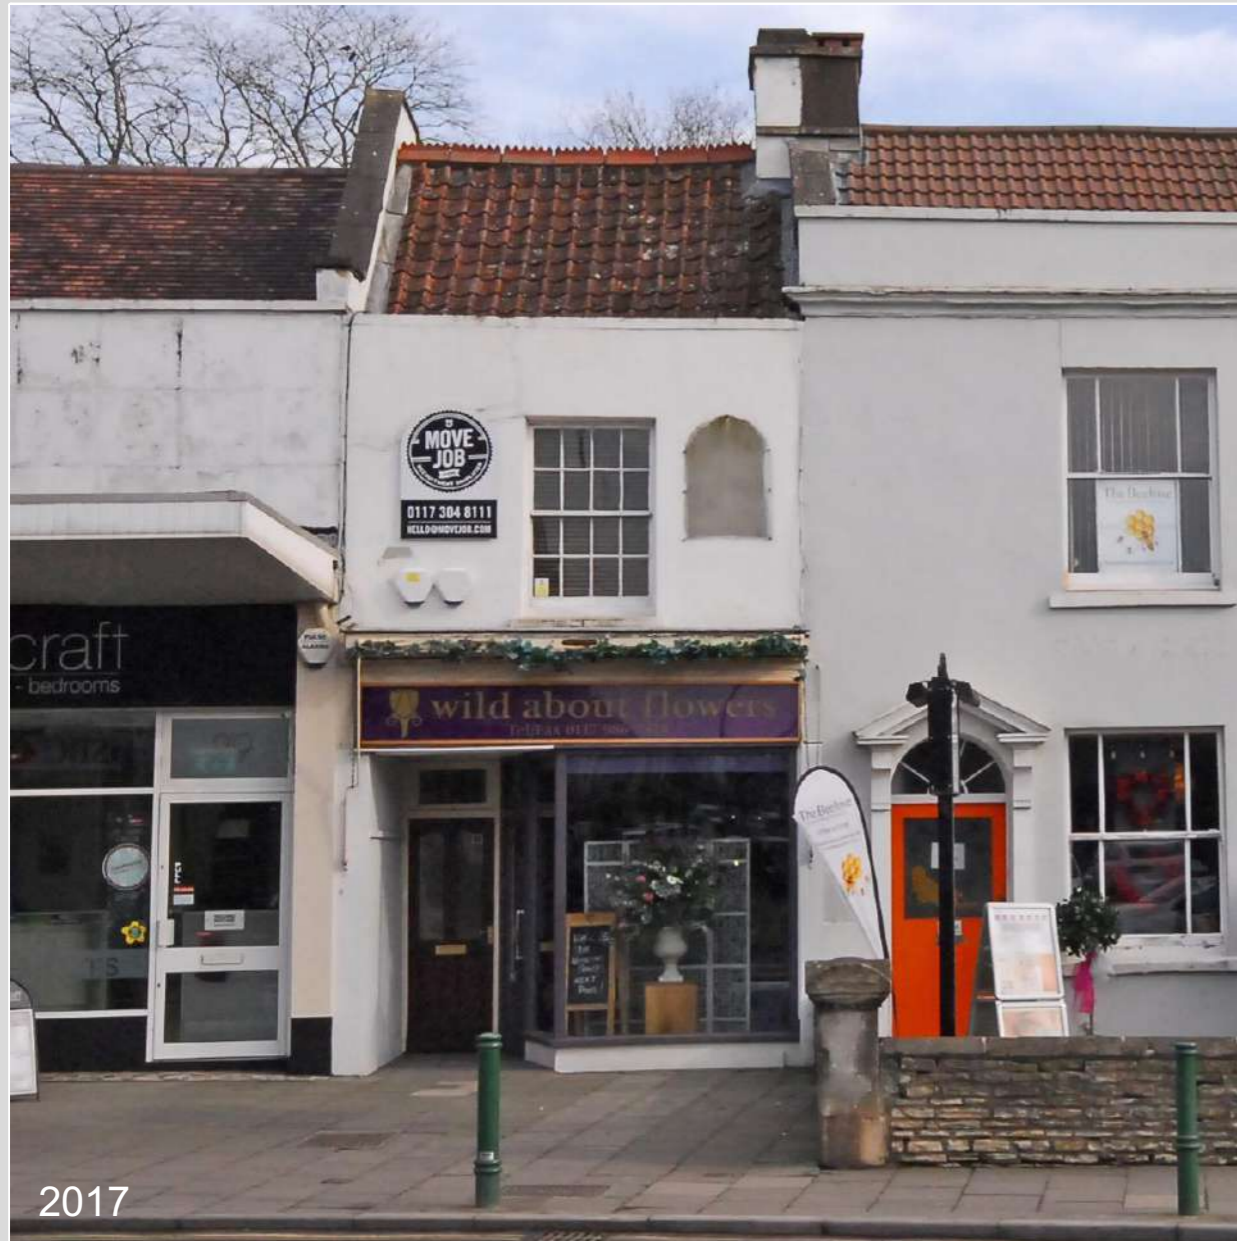
2017

The elevation is simple and symmetrical about a single first floor 8/8 sash window set in a colour washed render which extends up to a blind parapet with stone copings and pantile roof with a dogtooth ridge. To the south end there is a rendered stack adjoining that of No 35. The ground floor has a mid C20 glazed shopfront and recessed glazed door to the left serving the upper floor and a second door angled to serve the ground floor. There is no stall riser and the shop opening extends the full width to the gable with 35 which feels uncomfortable. The fascia is plain with blind still intact.

The modern sign above the shopfront has been fitted over an earlier possibly original timber fascia.

The building has is reasonably intact and in good condition but in need of some minor maintenance works. The extent of the opening for the shop front and the lack of a stall riser make the opening feel awkward and are not a normal configuration. The introduction of a pier to the left and right of the opening should be considered.

- Point up ridge tiles
- Decorate wall to remove signage ghost marks
- Relocate high level signage next to window
- Remove redundant alarms
- Reinstall original fascia board behind plastic signage.
- Consider reforming shop front to a more suitable design with plasters to the sides and a higher stall riser

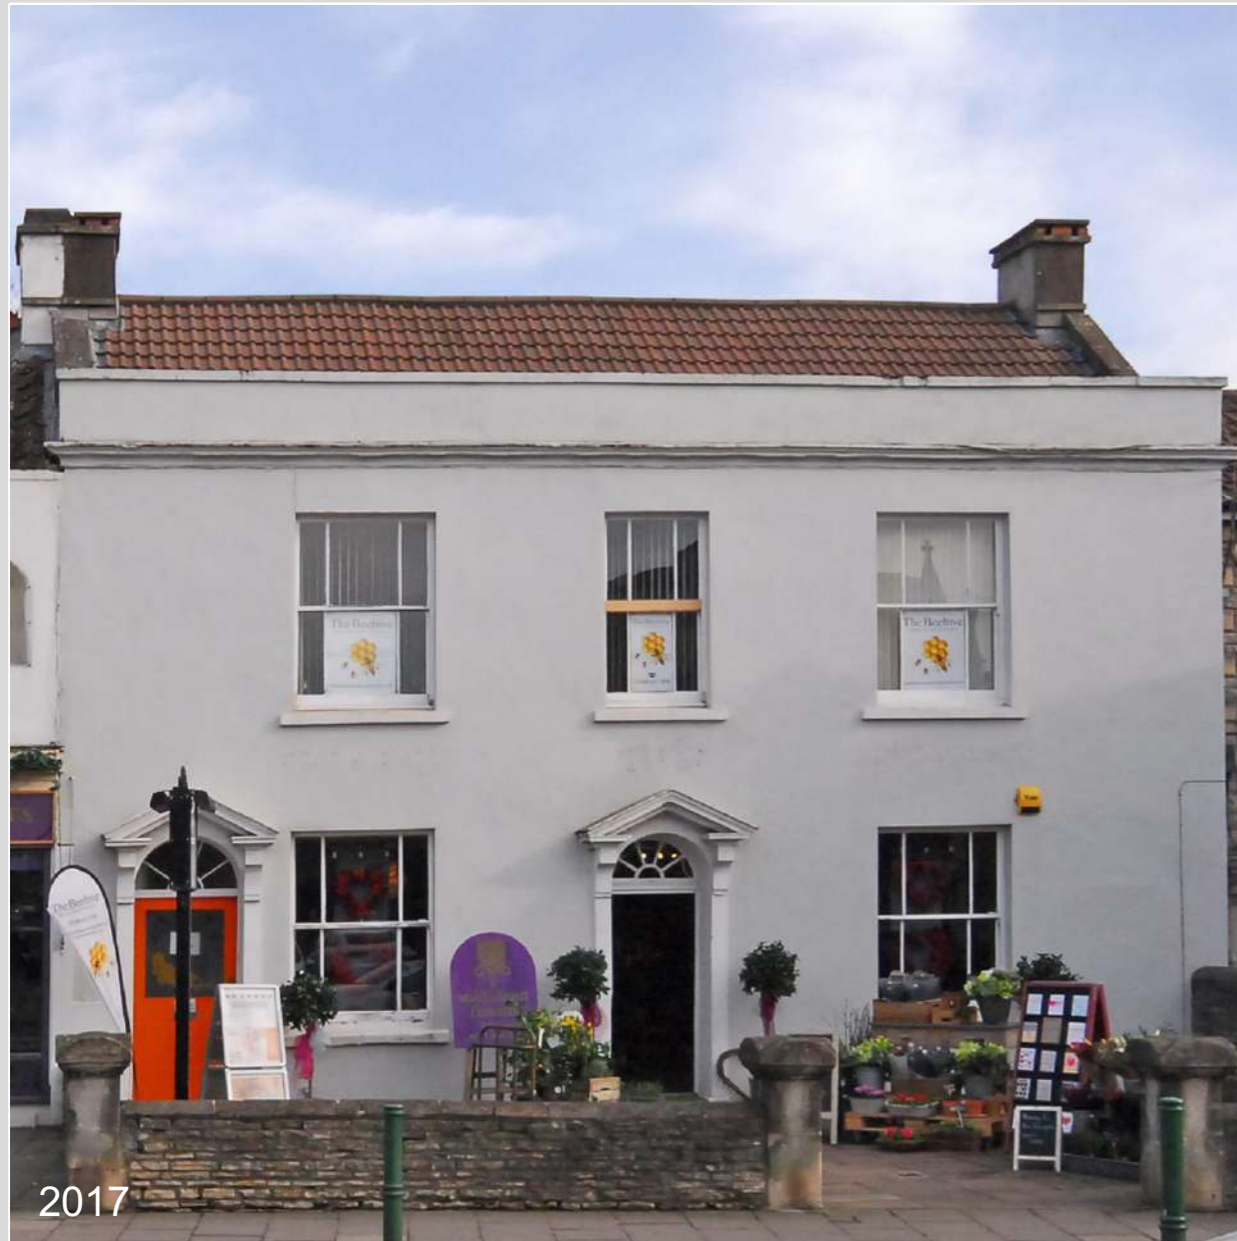
The elevation is generally symmetrical around a central door. The building is 2-storey with a 3-window range. Windows have sills and are mid C19 plate-glass sashes with margin glazing and horns. The central round-arched doorway has an open pediment on brackets, a 6-panel door and radial fanlight. A further doorway to left of the elevation has an identical doorcase and C20 door and fanlight. The elevation has a colour washed render, with a cornice and blind parapet with ashlar copings. The roof is a concrete double Roman tiled roof with rendered end stacks.

The building retains a lot of its original features with the exception of the railings which have been removed and the piers lowered. The entrance door to the left of the elevation is fairly crude and is probably 1970's as it was present post listing. The building is well maintained and makes a positive contribution to the street scene.

- Raise piers to their original height
- Reinstall railing to formalise and enclose the courtyard
- Consider change of paving in courtyard to Pennant stone

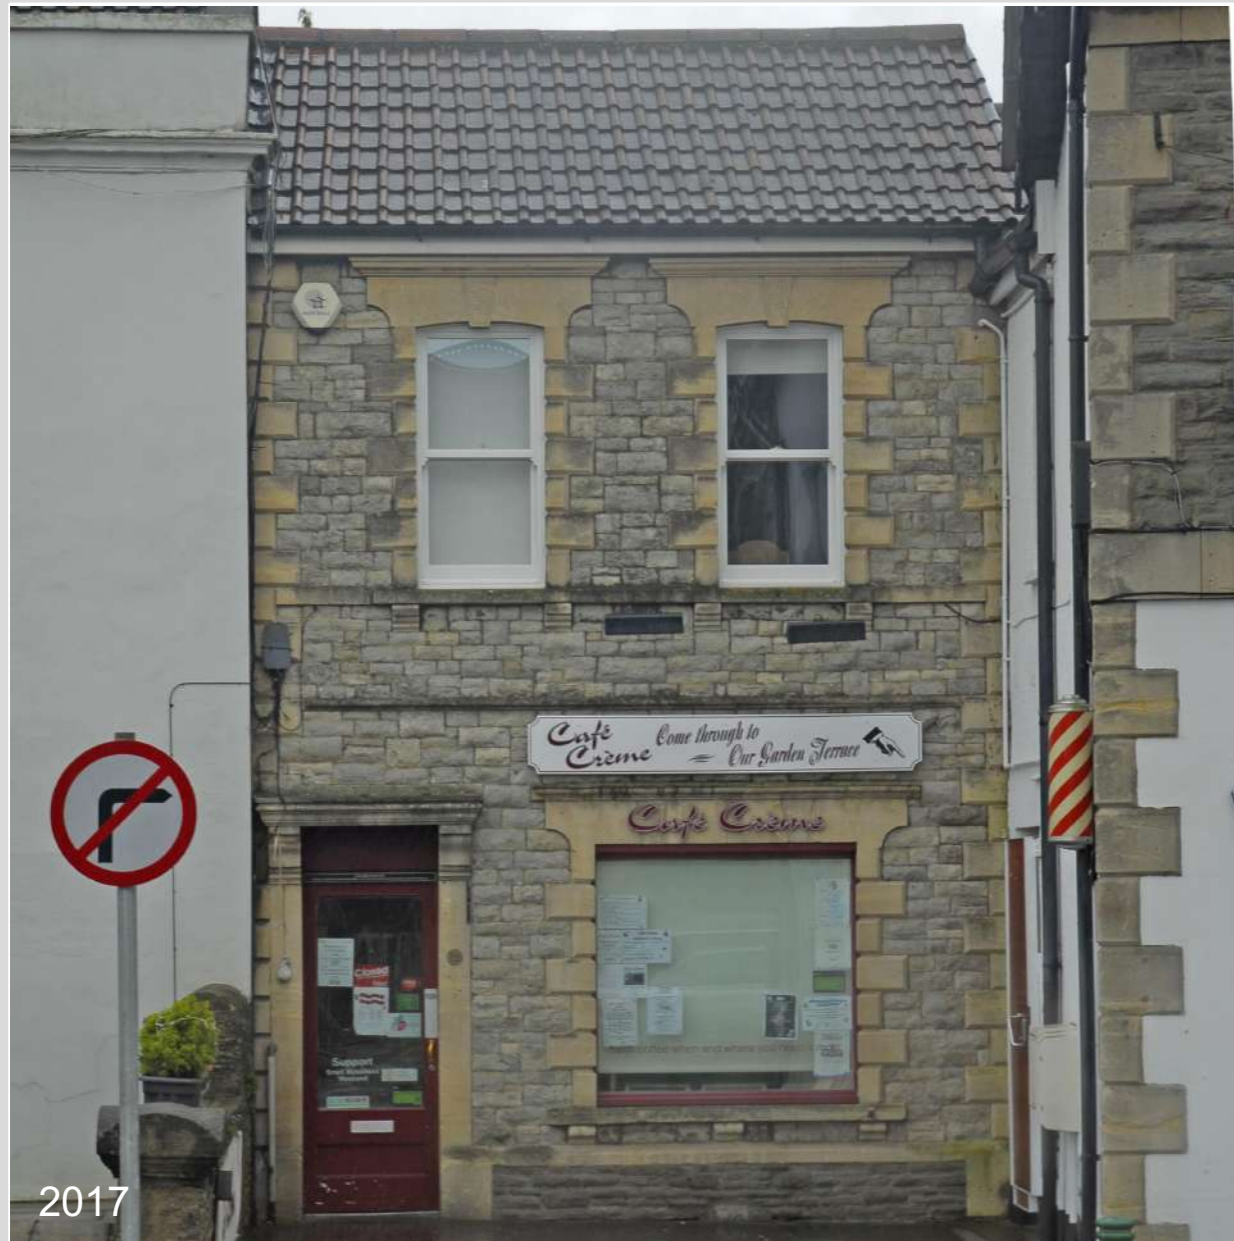
2017

The building has a half round ridge over a pantiled roof discharging into plastic rainwater goods mounted on a plastic fascia. The elevation is predominantly lias with random coursing. There are 2 Bath stone segmental windows with drop keystone to the upper floor with quoined reveals and a string course sill with supporting corbels. Both windows have 1/1 plate glass sashes. At ground floor the shop front is confined to a rectangular plate glass window with similar opening details to the windows above but with a large lintel with a narrow moulded canopy. A similar moulded string line runs the width of the building between the upper window string and the shop window. The doorcase has a simple moulded head and plain Bath stone reveals which may well predate 1900.

Although not the original elevation or roof covering the building appears relatively coherent and well presented. The change of the elevation was a very deliberate act and the original use of slates was a conscious decision which has been reversed in recent years with the introduction of double Roman tiles. These appear too heavy for the elevation.

- Replace fascia board with timber and painted lettering
- Replace rainwater goods with cast metal
- Confine lighting to lower part of the elevation and remove trough lights

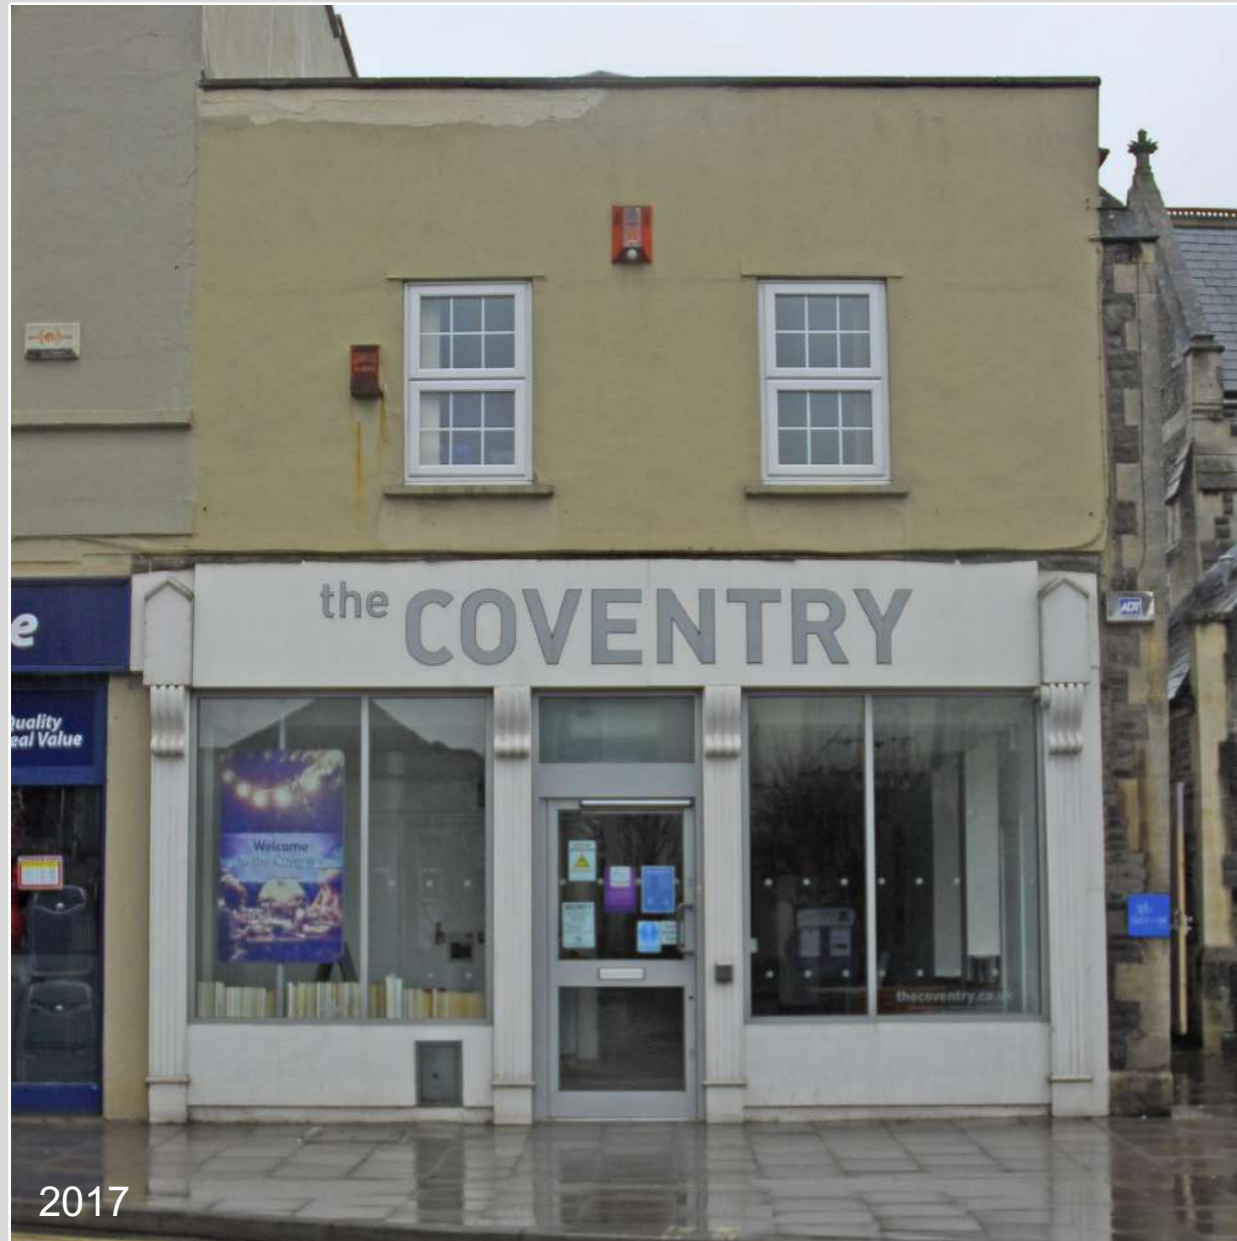
2017

The elevation is approximately square and comprises 2 flush mounted uPVC windows to the upper floor replacing traditional 6/6 recessed sashes with mean sills. The elevation is cement rendered (patched) and terminated at high level with regular sized coping most likely concrete.

Whilst the earlier form of the building remains the building character has been denuded by poor choice of materials and to a lesser extent ill-considered design. The placement of security alarms is poor and the render is clearly in need of attention and redecoration.

- Reconfigure frontage to be symmetrical on the windows above moving left console bracket and pilaster within building line
- Reintroduce recessed timber sashes to first floor
- Remove or relocate alarm boxes (north wall)
- Redecorate render (ideally lime render in traditional roughcast)
- Reduce height of signage to relate to console detailing
- Add canopy over signage to create horizontal line
- Divide large glazed areas with additional transoms

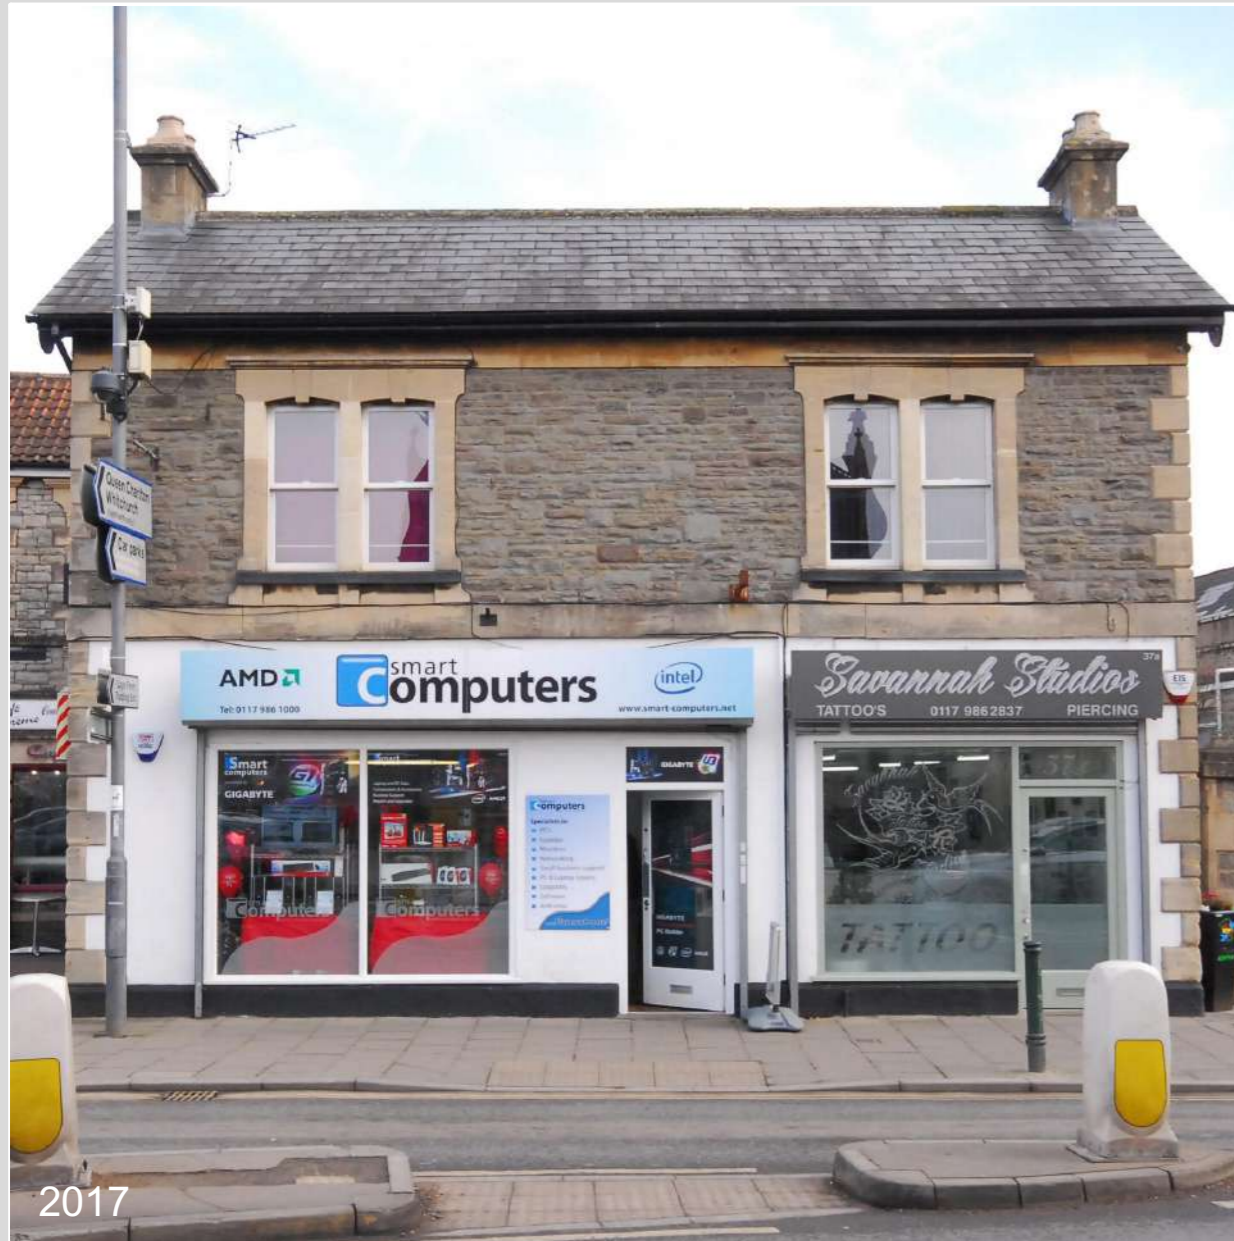
The current building has a slated roof discharging into plastic gutters. The elevation is predominantly lias with Bath stone quoins, string courses, and mouldings to the windows at first floor as 1905. The ground floor openings have changed with the introduction of 2 new shop fronts. Each has a box shutter planted on the face of the building and significant areas of glazing which do not relate to the windows above. All evidence of former shopfronts has been lost.

Currently this building is more discordant than at any time in its history. At high level the building is generally in good condition with a lot of the Edwardian detailing intact. The lower shop fronts are modern interventions and have no historic integrity and or relationship to the upper floor architecture. The use of external shutters, plate glass windows, and the decoration of the ashlar around the shopfronts combined with the asymmetry of the shop front design has emphasised the contrast between floors.

- Remove paint to ground floor masonry back to ashlar
- Install internal security shuttering / remove shutter boxes
- Consider applied shop fronts fenestrated to relate to upper windows incorporating doors signage and stall riser
- Centre No 37 front door (originally double doors)
- Change plastic rainwater goods to cast metal
- Change signage of No 37 to relate to openings and to be more traditional in form
- Reduce visual clutter including signs and window stickers

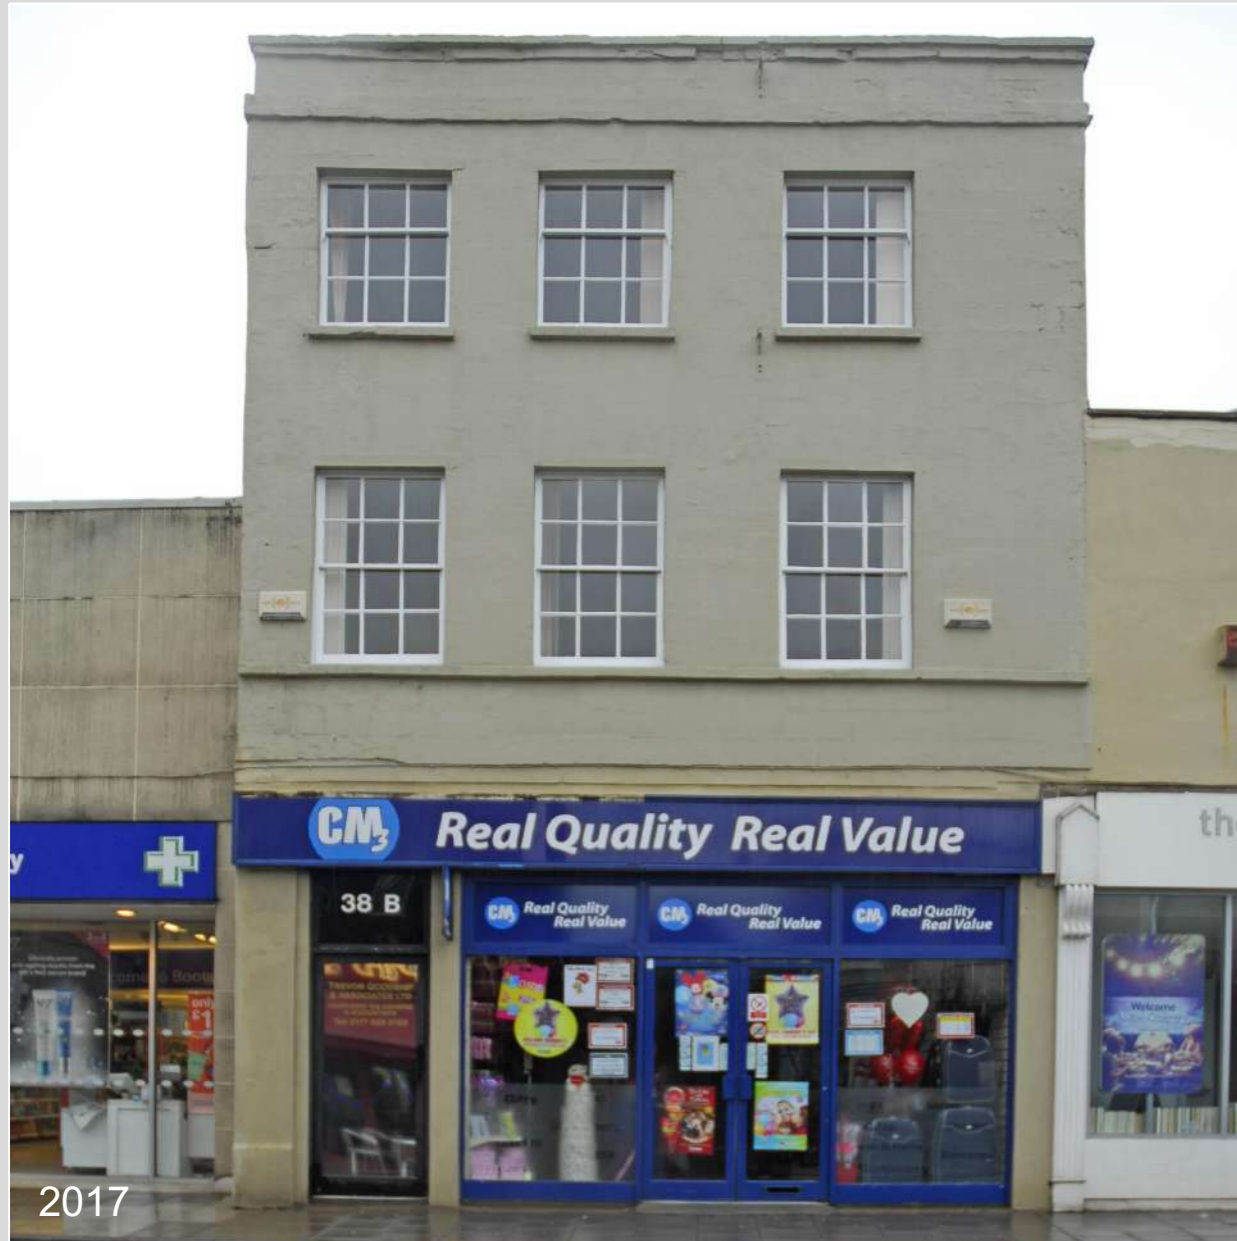
2017

The elevation has a blind parapet & stepped coping above a hacked back cornice. Below this there is 2 storey ashlar with a range of 3 windows. Upper windows 3/6, & lower windows 6/6 timber sashes. The sill of the lower windows form a string course above a panel of masonry which extend down to the shop frontage.

Piers to ground either side of the building with third forming entranceway to 38B. This entrance sits below the left hand window range and is original. Evidence suggests a previous stone pediment doorcase and double doors (see image from 1900)

The modern signage over the shopfront is plastic. Shop frontage is metal frame and patent glazing. The signage extends well beyond the frontage resulting in an awkward elevation made worse by the placement of the Pilaster of No 36.

- Move pilaster from No36 off elevation of No38 to emphasise extent of building
- Confine signage to width of shop front
- Replace signage with painted timber fascia
- Reform doorcase over 38B
- Remove paint decoration from stonework
- Reintroduce cornice line
- Replace shop frontage with timber with stall riser to height of plinth to left of 38B
