21 HIGH STREET, KEYNSHAM

22 HIGH STREET, KEYNSHAM

23 HIGH STREET, KEYNSHAM

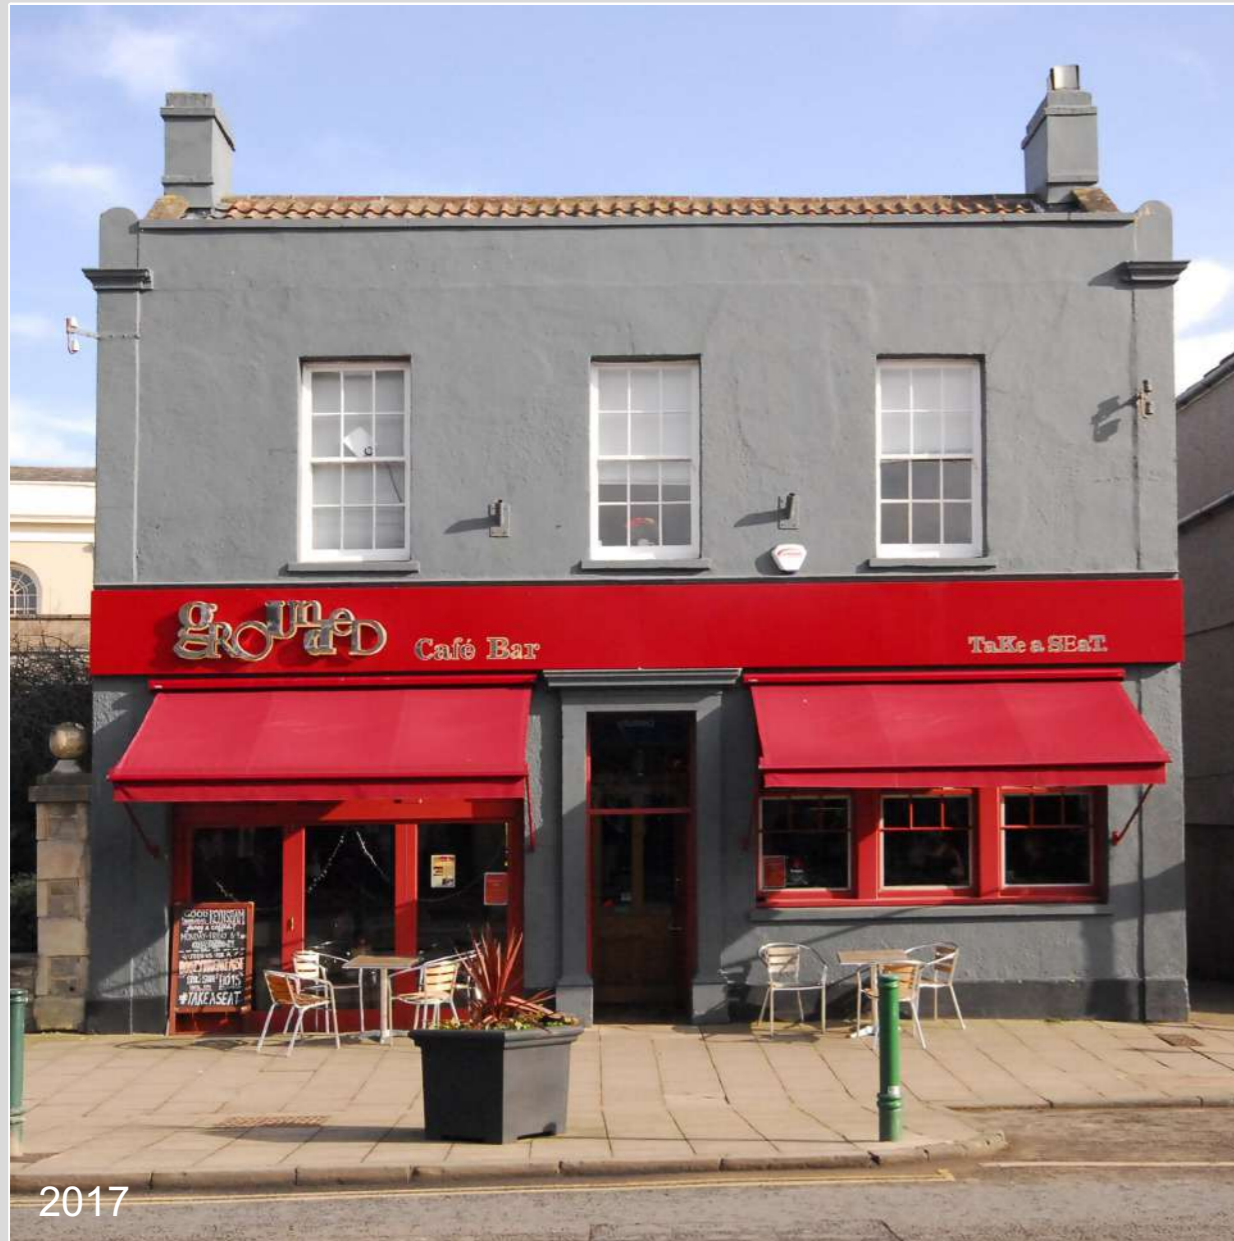
2017

A number of elements of the original building have been lost. This includes the pediment and the cornice which has been replaced by a modern parapet. The application of render to all surfaces has also blurred the architectural intent. The condition of the building is generally good and well maintained and the treatment of the building as a whole is beneficial.

- Reintroduction of pedimented cornice
- Removal of render from stonework
- Reducing signage to sit within pilasters (assuming item above)

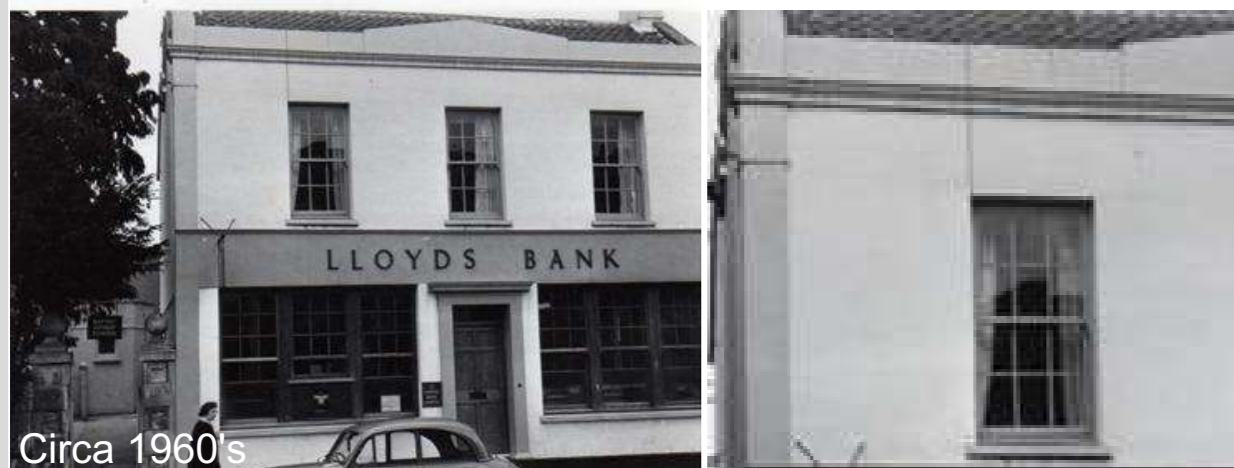
The building retains a lot of original features but by the 1960's the ground floor windows have been replaced with larger openings and in more recent times the cornice and pediment have been removed and the ashlar rendered over losing the architectural intent.
