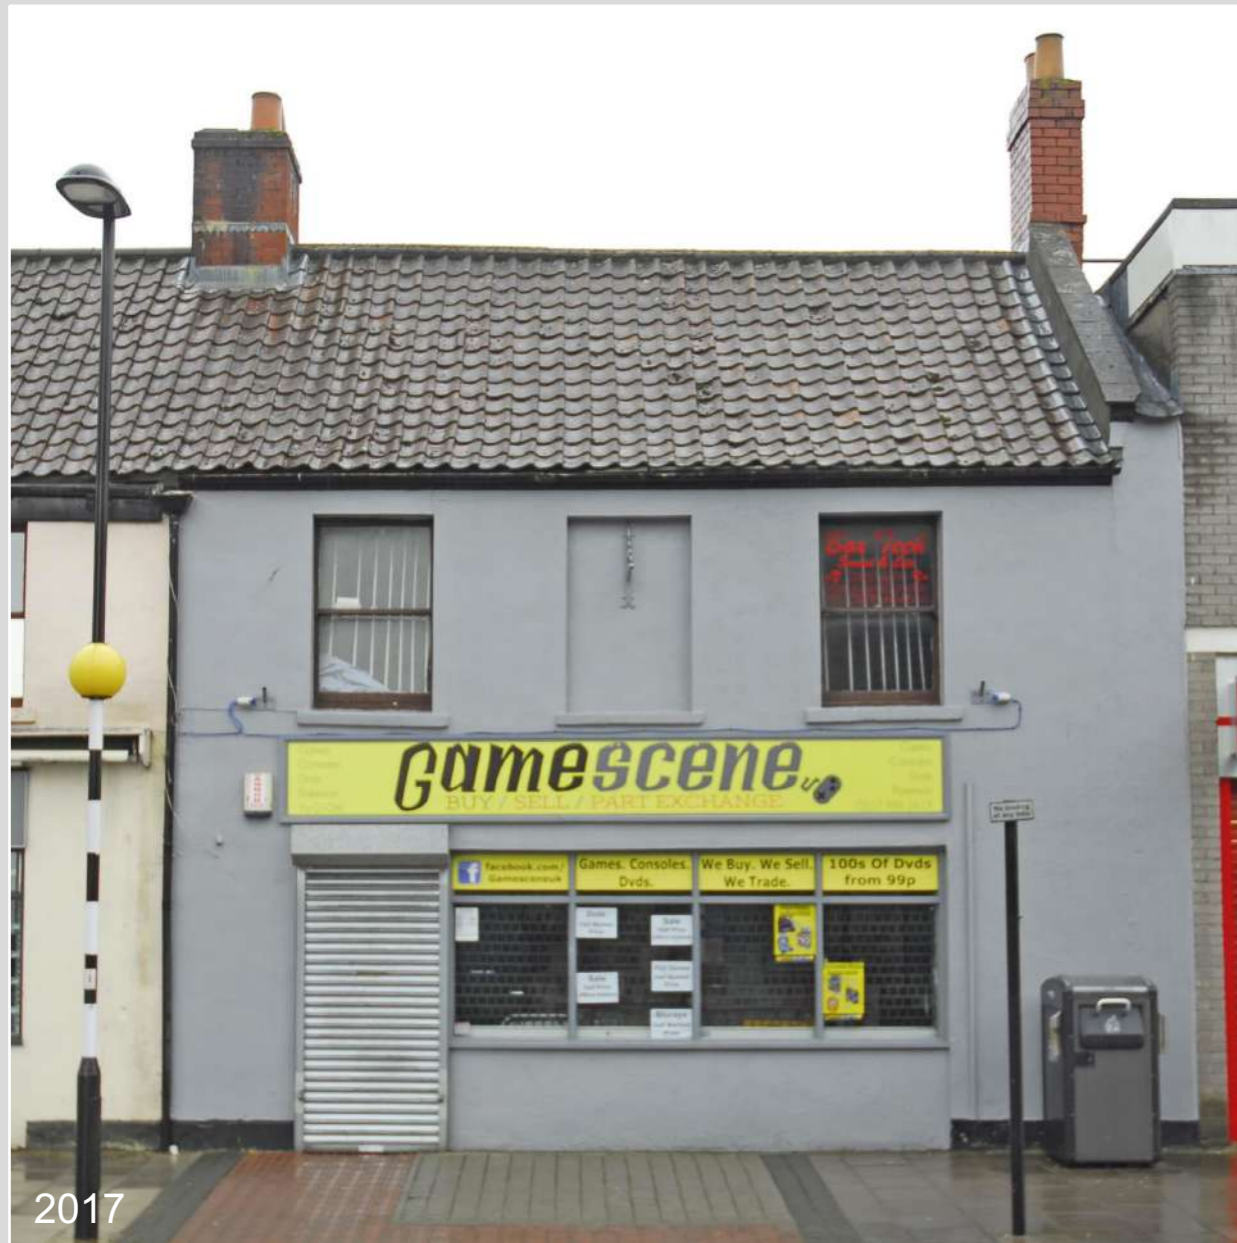
2017

The earlier form of the building is still legible at first floor level. Whilst the recent ground floor alterations have removed the central door, the vertical rhythm of the fenestration has been picked up in the new shop frontage. The use of a stall riser also helps ground the building. The planting of an external shutter is detracting and the nature of the signage is unsympathetic. The decoration of the building with one single colour is unfortunate. The building is generally in reasonable condition.

Generally the alterations to convert this building into a retail unit have been handled with care and consideration for the existing building with an understanding that the elevation needs to be treated as a whole. To enhance the elevation further the following would be appropriate.

- Decoration should contrast between shop front and masonry
- Cills should not be painted.
- Windows should be decorated a more traditional colour
- Lowering of signage away from window cills to meet head of window would consolidate shop frontage
- Remove or conceal surface run services
- Remove the roller security blind or locate internally
- More traditional signage.

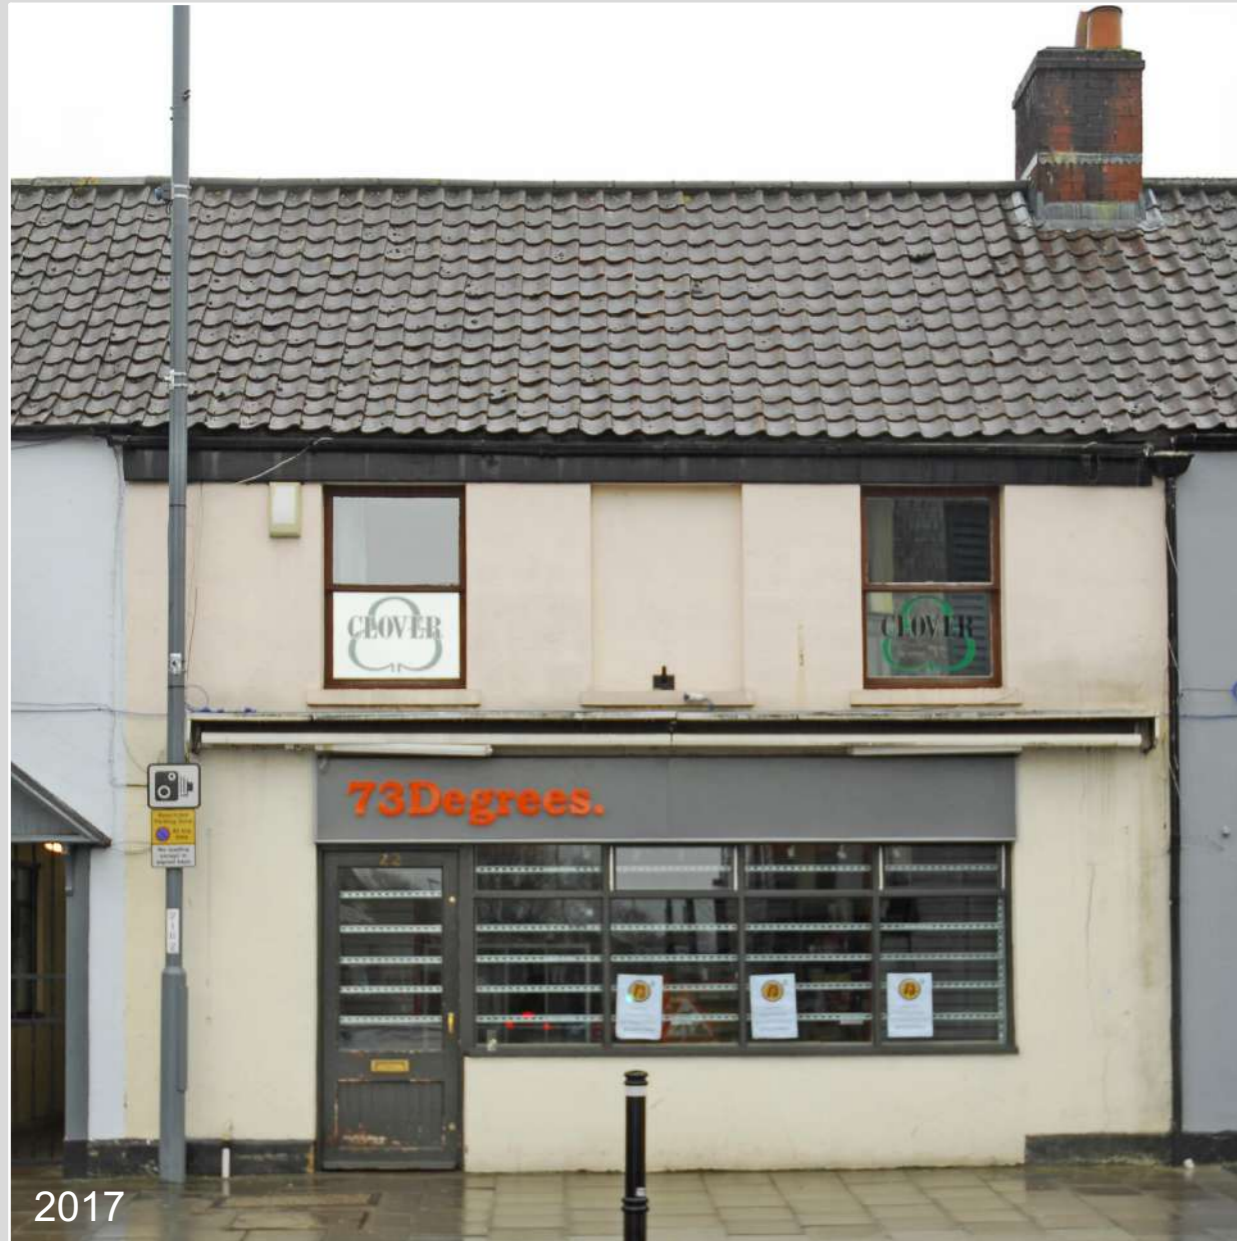
2017

The building has no historic integrity as it is a modern copy of the neighbouring property. Whilst the elevation has been sympathetically designed it has no historic merit.

Generally the alterations to convert this building into a retail unit have been handled with care and consideration for the existing building with an understanding that the elevation needs to be treated as a whole. To enhance the elevation further the following should be considered:

- The fascia board at high level sits uncomfortably over the windows. This should be removed to show the window heads
- The roller blind box should only extend as far as the signage below and not beyond the window reveals
- The joinery throughout needs redecoration
- Remove paint from first floor cills
- Windows should be decorated a more traditional colour and reflective signage removed
- Painting windows and shop front the same colour would be acceptable.
- Remove or conceal surface run services
- More traditional signage

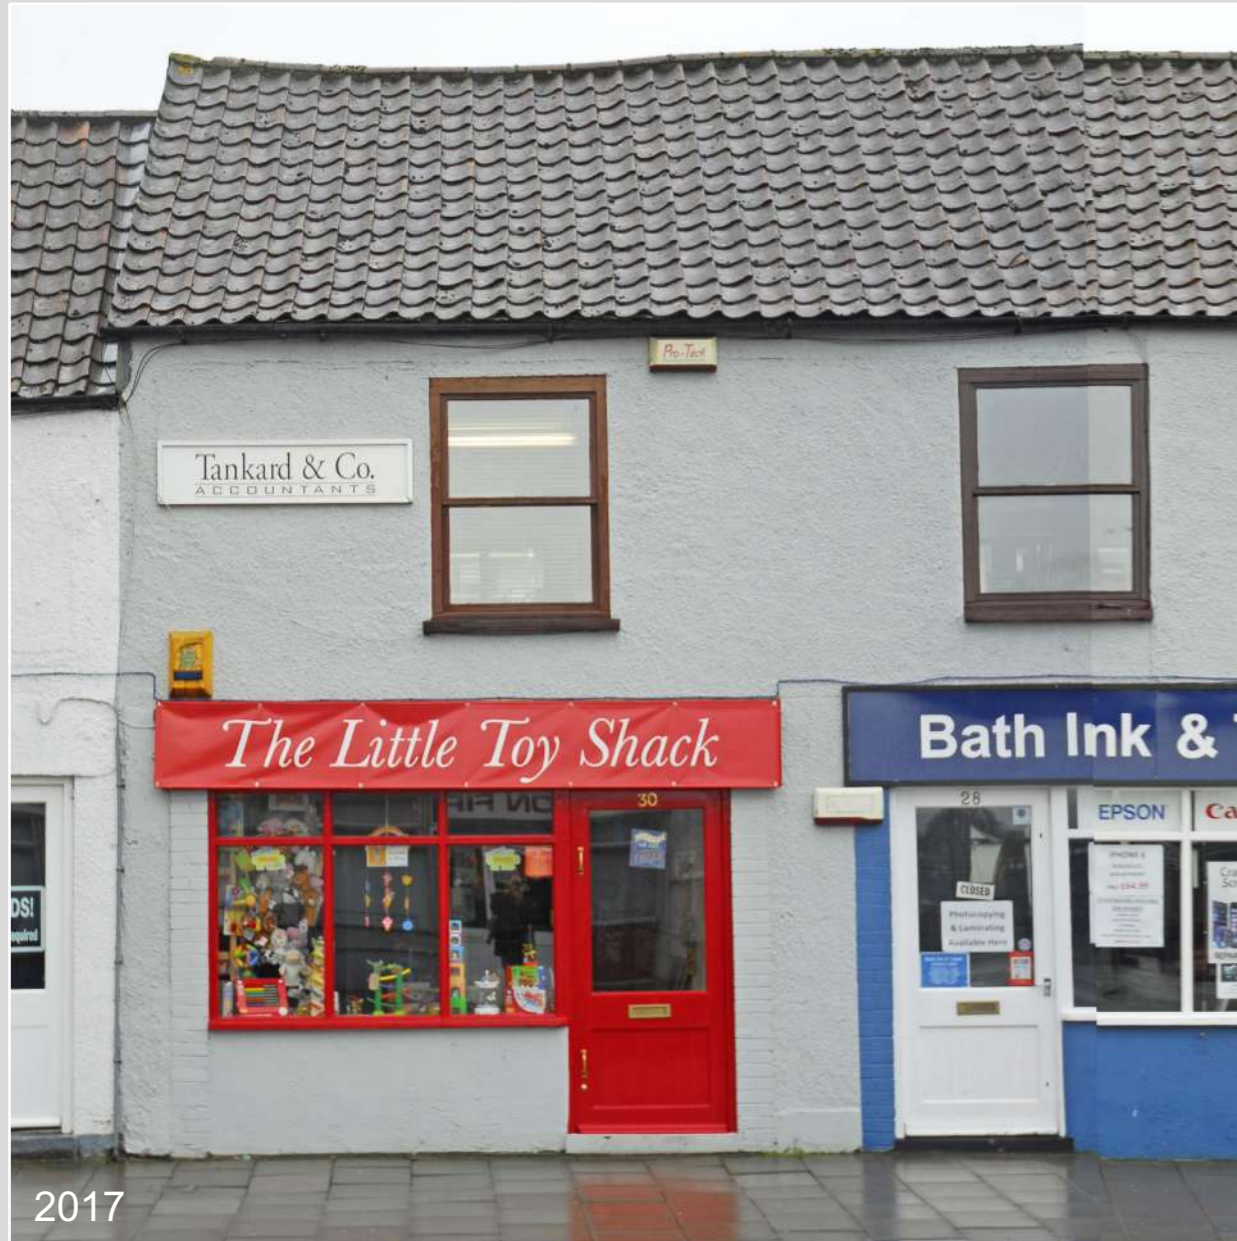
2017

INTEGRITY AND CONDITION: Several elements of the earlier domestic elevation remain including the roof covering, the upper floor fenestration configuration, the render and part of the original plinth line which is still evident on No 26. The replacement of the upper floor windows with modern 1/1 timber sashes has significantly eroded the character of the building.

The modern softwood shop front openings are flanked by brick piers supporting steel lintels over. Detailing of the doors and shopfronts to 28 and 30 are similar to 32 suggesting that these frontages were all formed concurrently. The shop front to 26 is different from the others with a single plate glass window. The windows and shop fronts sit flush with the elevation removing any form of articulation to the frontage although a crude effort has been made to form a pediment over the passageway.

ACTIONS
This is a conversion from dwellings to shops and has resulted in a fragmentation of the elevation made more noticeable by the different paint colours used across the masonry elevation. The shop fronts are honest and generally sympathetic with stall risers and consistent signage sizes. The frontages could be enhanced by some minor alterations:

- Upper floor windows changed to 6/6 sliding timber sashes and decorated a more traditional colour
- Decoration of masonry across all buildings should be consistent
- Pediment should be refined currently clumsy
- A stall riser should be introduced below No 26
- Plate glass window to 26 should be replaced with joinery to match 28 and 30
- Plastic rainwater goods should be replaced with cast metal
- Signage should be traditional painted fascias

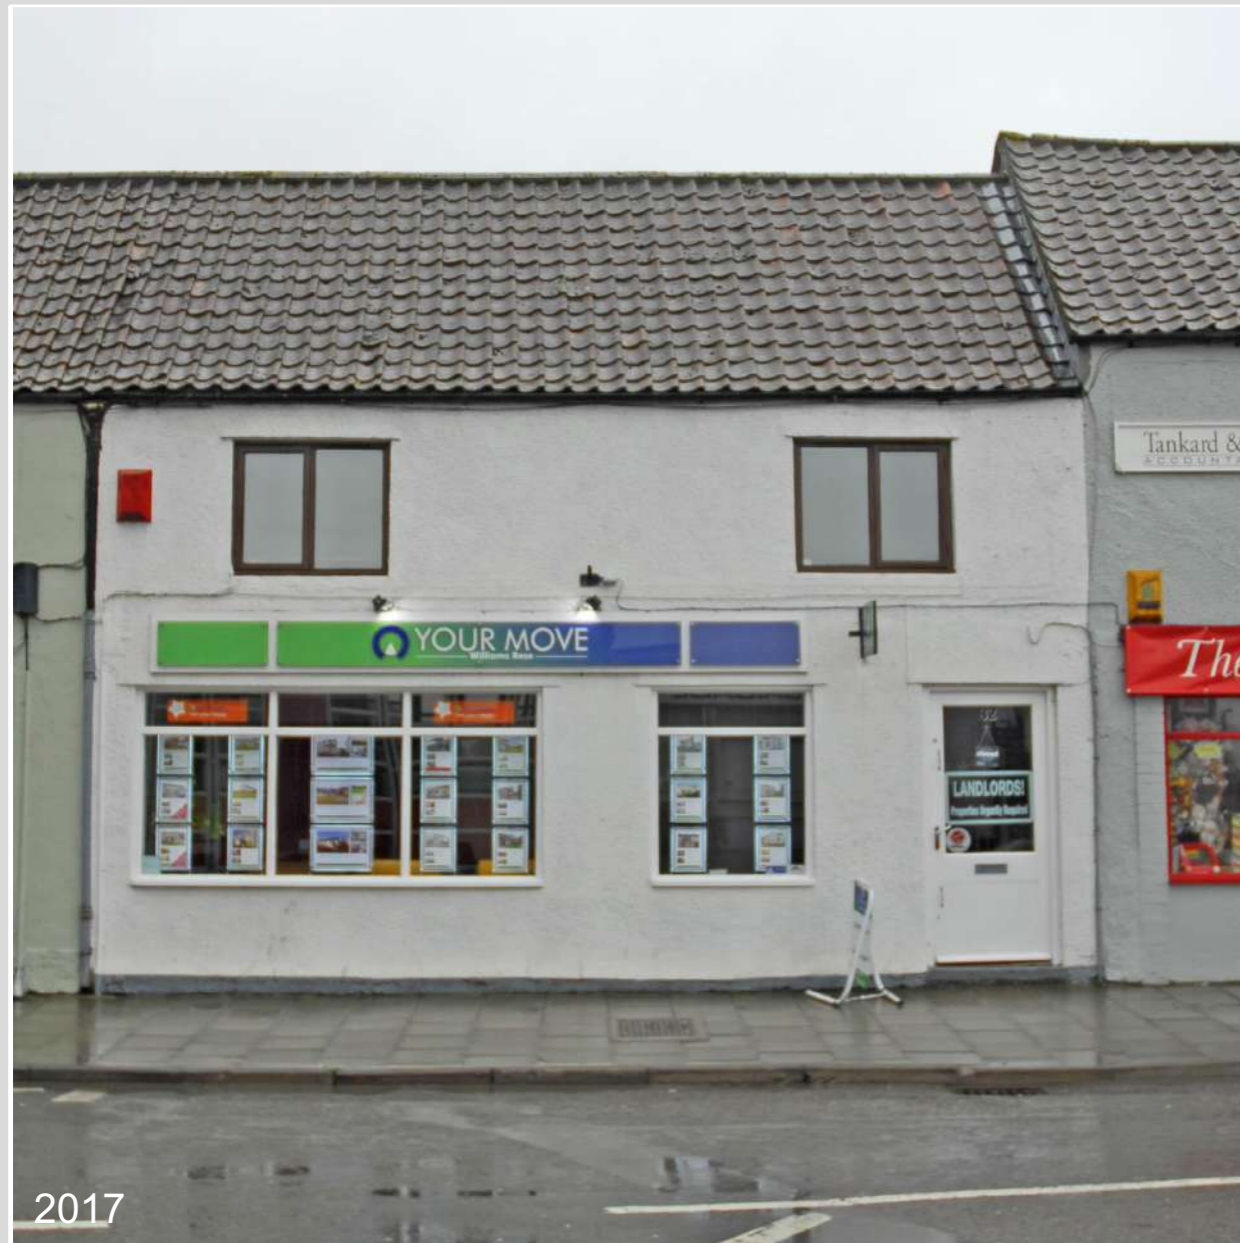
2017

Whilst the earlier first floor configuration remains identifiable, the traditional detailing and refinement has been lost. The current ill-proportioned windows are crude replacements without cills which sit awkwardly in the render. The character of the building at street level has been completely lost due to the insensitive placement of openings resulting in a lack of vertical correlation fragmenting the elevation. The windows to the ground floor are modern units formed in softwood frames and have been styled in a similar way to 30-26 suggesting that these frontages were all contemporary interventions but do not relate to the windows above. The condition of the elevation is generally reasonable.

As this is a poor conversion from a dwelling to a shop there is no historic shop frontage to enhance. The division of the building into a ground floor business and an upper floor unit has resulted in a different treatment of each floor. Future alterations need to help balance the entire elevation. Enhancements should include:

- Change upper floor windows to a more domestic pattern
- Reintroduce cills to the windows
- Introduce a planted frontage over the 2 display windows to define and ground shop front
- Reduce the stall risers giving a larger display area
- Confine the signage to areas above shop windows
- The signage should be more traditional in form
- The decoration of the shop front joinery should contrast with the masonry
- Redundant services should be removed or rationalised

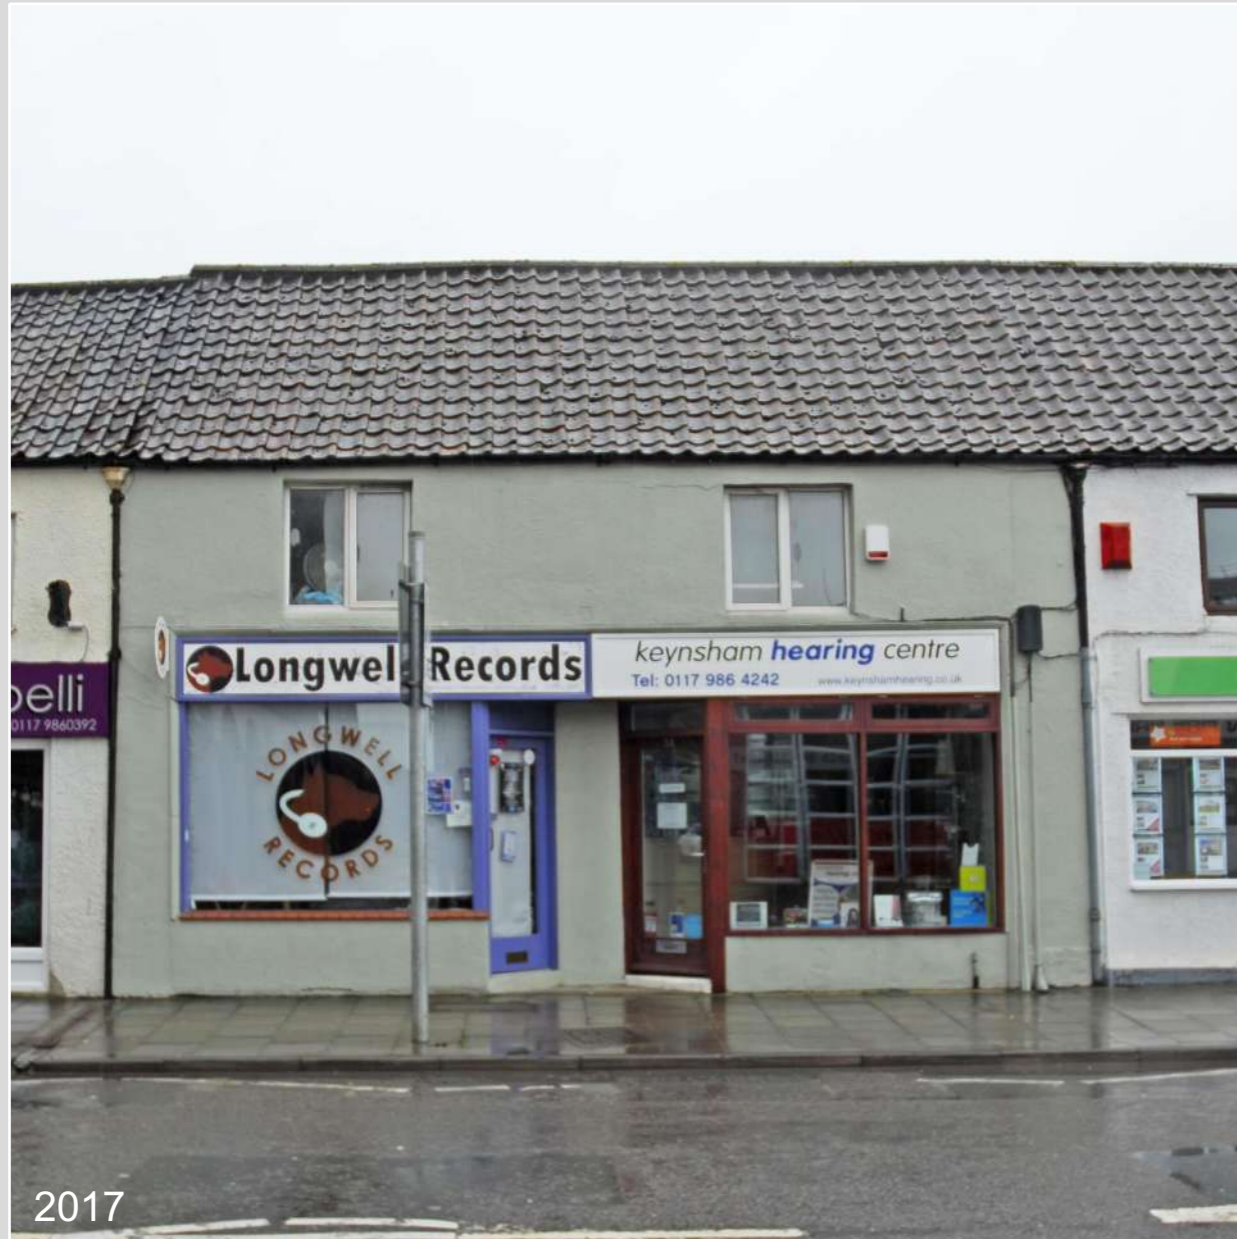
2017

In all likelihood this building is a conversion from a dwelling into shops. Consequently there is no historic merit in the shop frontage which is generally timber with plate glass and glazed timber doors. Until recently the building had a strong sense of symmetry in all aspects of its detailing. This has been lost in recent years by the reworking of the shop front joinery and change in stall riser to No 34. The fact that the building has been decorated as a single entity emphasises the current asymmetry.

The original upper floor windows have been replaced with UPVC windows without cills. The signage is simple and flush, consistently sized across the frontage and reasonably balanced extending only as far as the edge of the glazing line.

The building has clearly been created with symmetry in mind and therefore was intended to read as whole rather than separate 2 units. The building could be enhanced by taking the following actions:

- u PVC windows should be replaced with timber casements with symmetrical handing and cills
- Stall risers should be adjusted to be the same height
- Joinery shop fronts should be the same design with additional divisions to glazing
- Shop front joinery should be in a contrasting colour to the masonry and include all elements including sills
- Decoration of the elevation as a whole is beneficial
- Service cables should be removed /rerouted internally
- Signage should relate to shop front only and not extend to party wall
- Sign writing should be more traditional in form

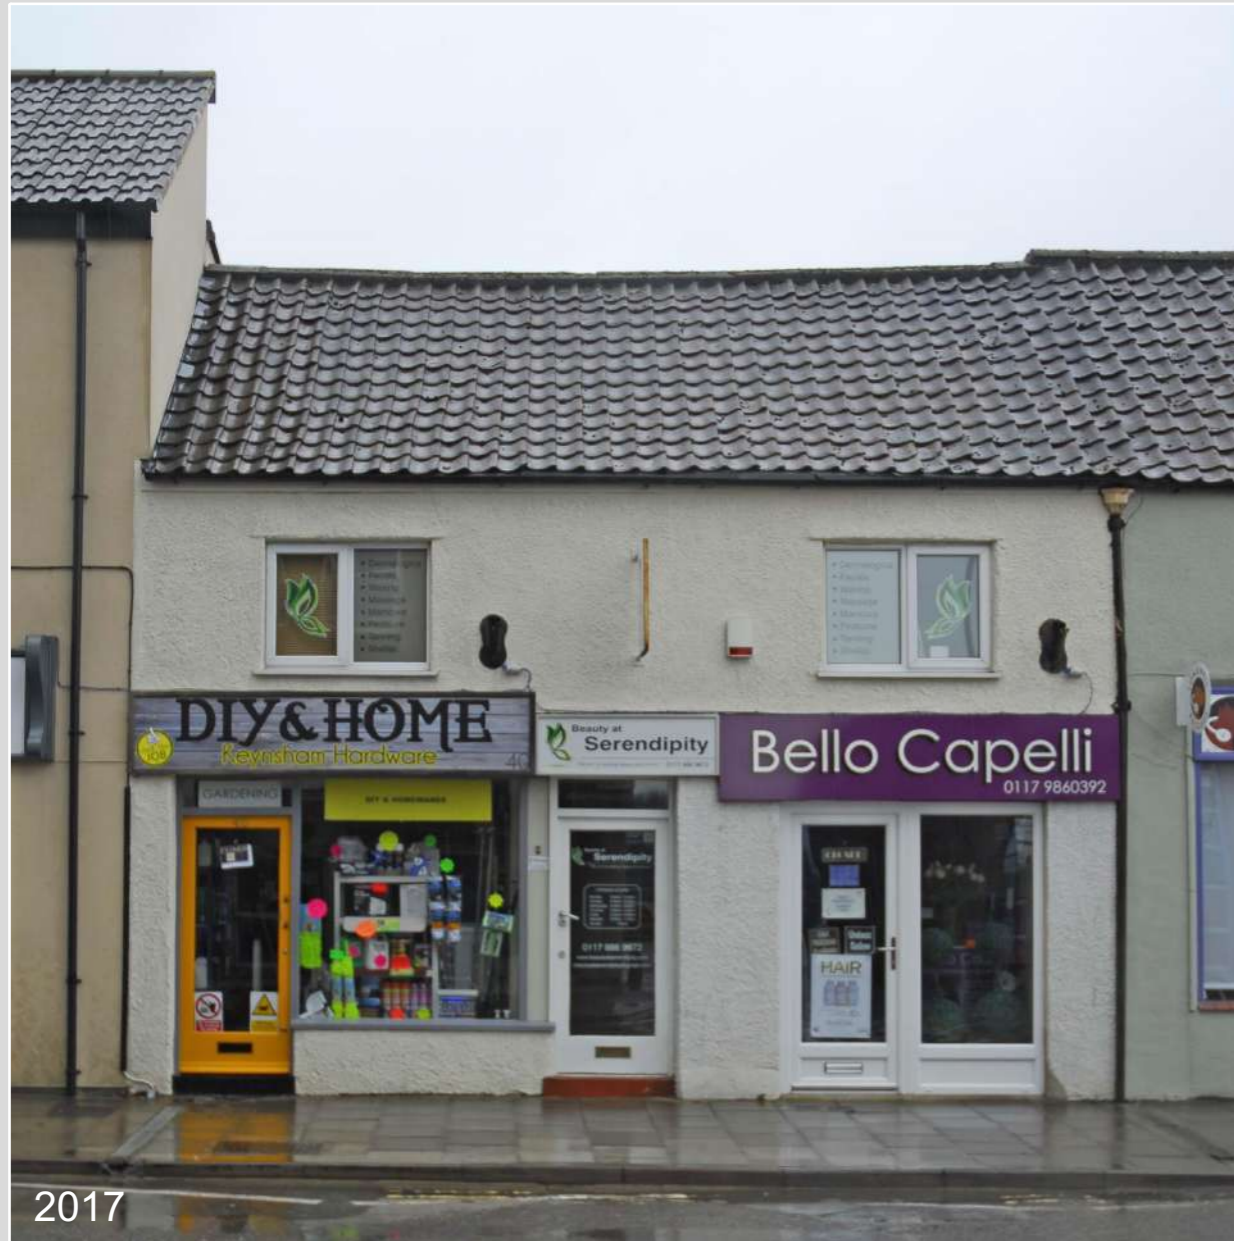
2017

With the exception of the windows which have changed from timber tripartite windows to double UPVC windows the roof and upper floor have retained its earlier form and detailing. At street level the historic form has completely changed resulting in a loss of vertical correlation between floors made more noticeable by the different treatment of joinery.

The ground floor shop fronts are generally timber with plate glass and glazed timber doors but change heights across the frontage unbalancing the elevation. This is further emphasised by the signage for each shop which also steps.

As this is a conversion from a dwelling to a shop there is no historic shop frontage to enhance. The division of the building into a ground floor business and an upper floor unit has resulted in a different treatment of each floor with no vertical correlation. The elevation appears overly cluttered due to competing signage and could be significantly enhanced:

- Replace uPVC windows with timber casements to the original design.
- Remove signage from upper floor windows
- Introduce planted shop fronts and door case across all openings to unify openings stopping short of the party walls.
- Contain signage within new planted shop front
- Alternatively add a stall riser to No 38 balancing the shop fronts
- Reduce signage to width of current openings
- Set signage level and change to traditional sign writing
- Decorate shop front in contrasting colour to masonry

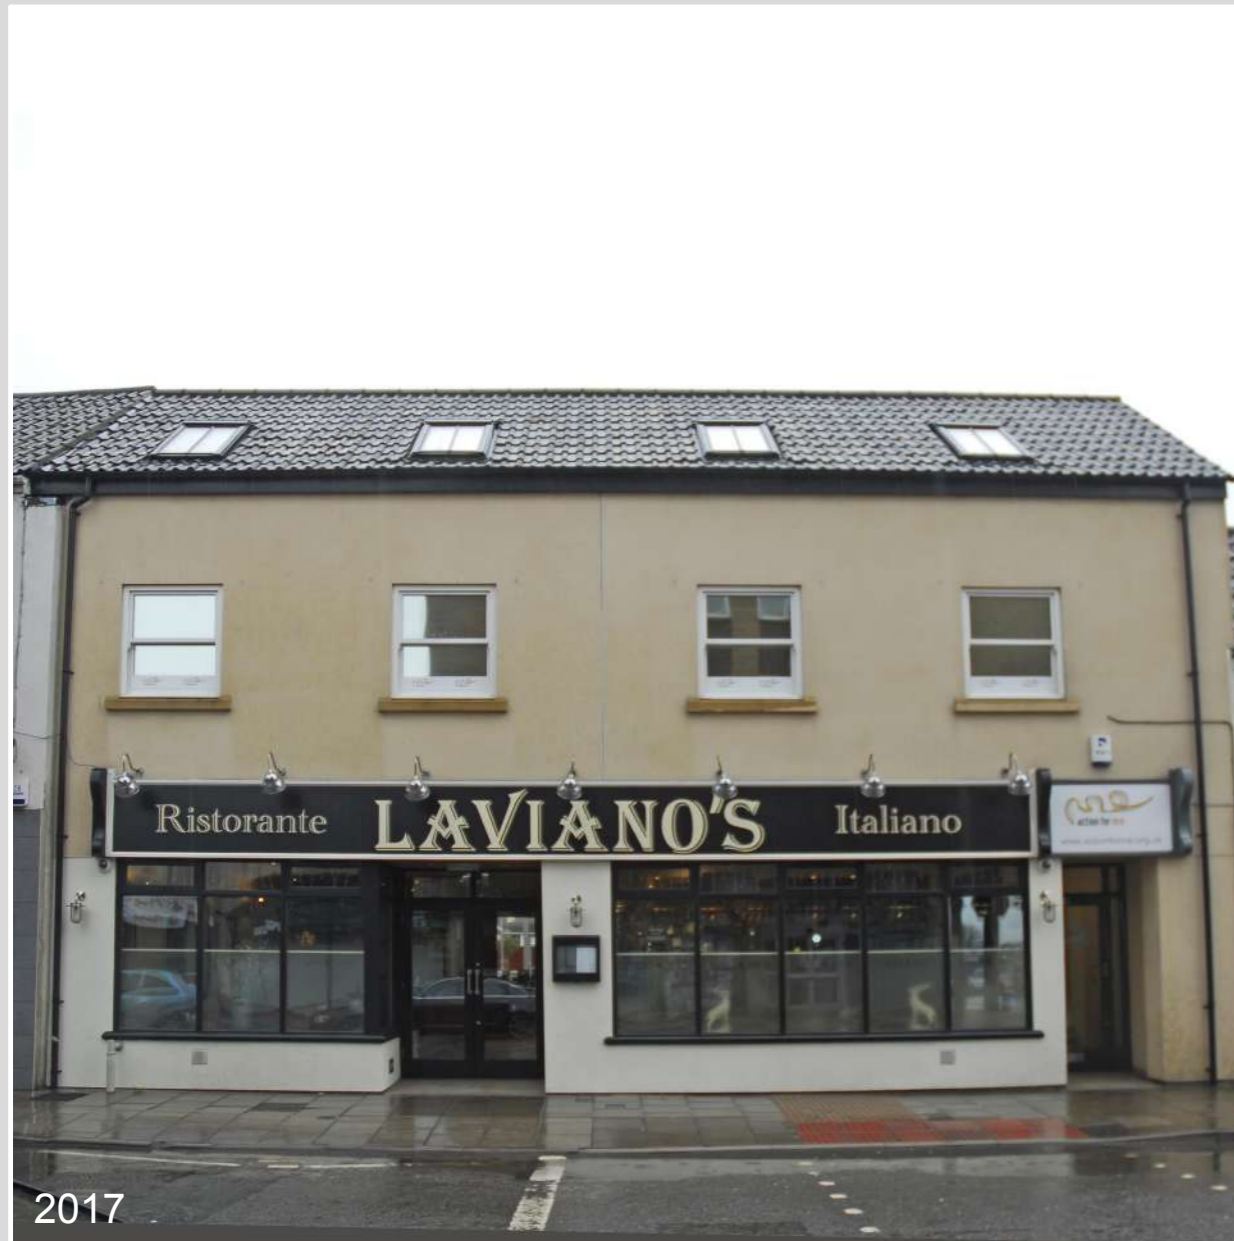
2017

The new building on the site lacks any architectural merit. The new development is mixed use restaurant and office accommodation at first floor level. Whilst the roof tiles appear to be double Roman the rainwater goods are plastic as is the fascia board. The first floor windows are UPVC with reconstituted concrete stone cills set in a modern render wall complete with unsightly expansion joint. The original high windows have been not been replicated but replaced with squat square windows which sit awkwardly in the elevation. The shop frontage is formed with timber and glass with recessed doorways with a large full width sign.

As with so many buildings in Temple Street any trace of historic shop frontages have been lost in the last decades of the C20th. The modern building that replaced the original shop frontage is significantly less characterful and lacking in design consideration. In particular the use of a modern flat render as opposed to rough cast flattens the elevation making it feel lifeless and monochromatic.

- Replace fascia with a design less deep in timber and painted lettering
- Replace uPVC windows with timber sashes

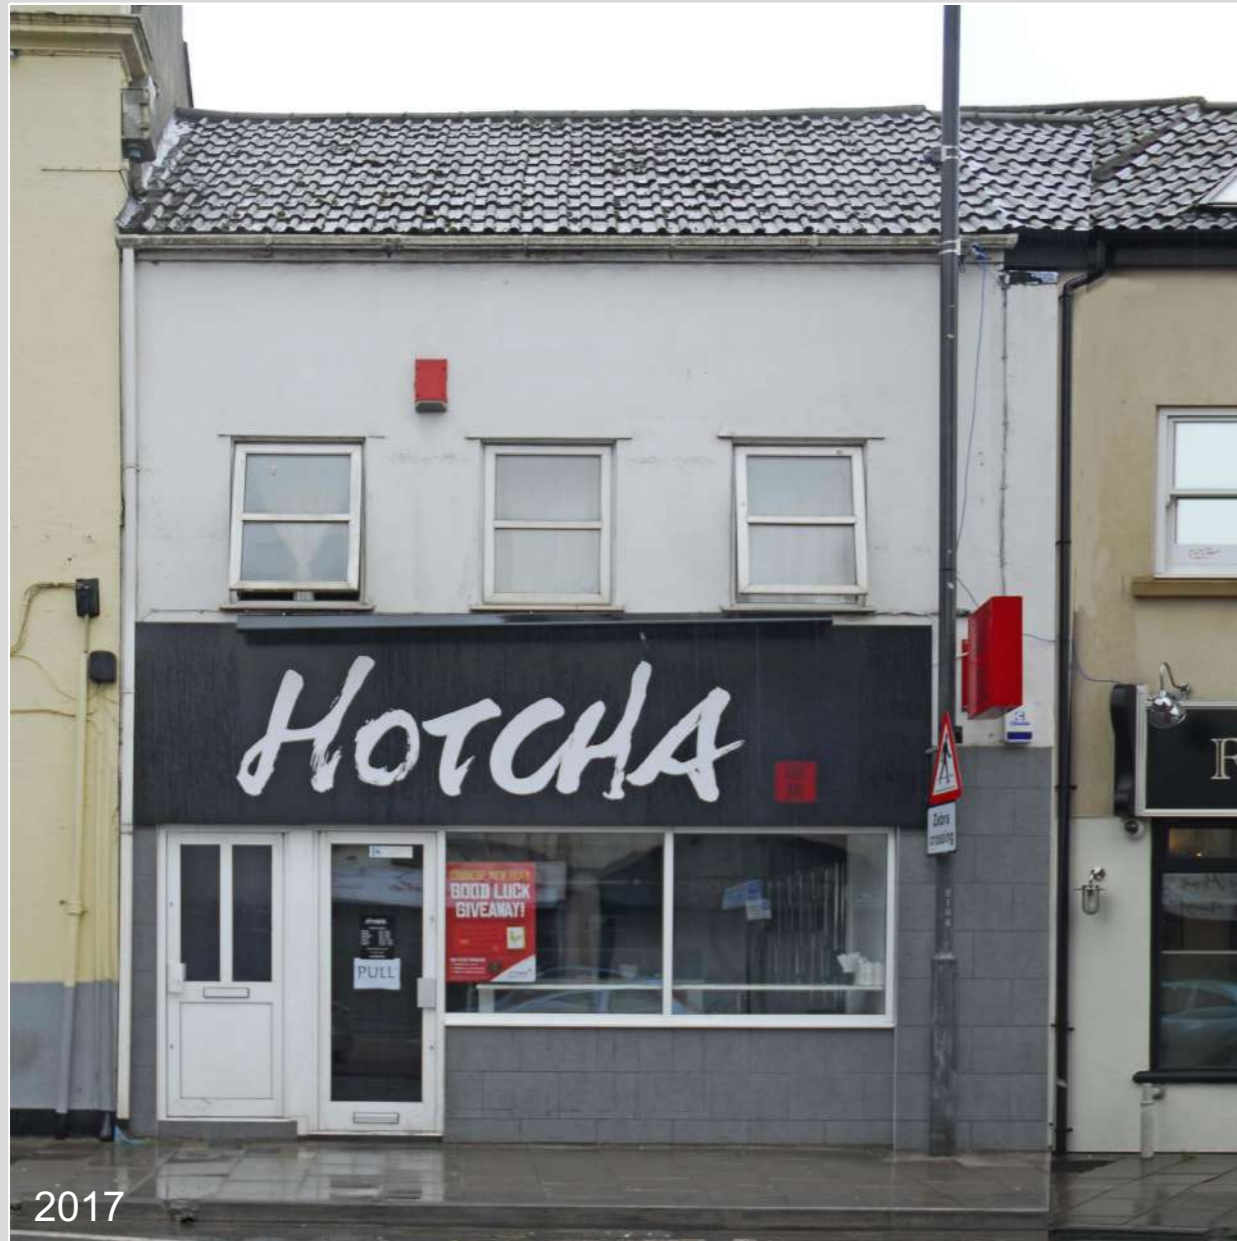
2017

The new building on the site lacks any architectural merit and significantly detracts from the setting of Trout Inn which is listed. The elevation is unbalanced and whilst the three upper floor windows have been replicated the raising of the eaves line to link through with the neighbouring property (44-42) has resulted in a band of awkward high level masonry. The use of plastic rainwater goods, uPVC windows and hard flat render has resulted in a lifeless elevation. At street level the elevation comprises 2 metal doors one serving flats above and the other the retail unit and 2 linked plate glass windows in a metal frame. The lower half of the elevation is clad in ceramic tiles which are completely alien to the street scape as is the signage which is disproportionately large.

This building affects the setting of the listed Trout Inn. The quality of materials and complete insensitivity of the elevation design makes this a negative contribution to the streetscape. Whilst a reduction in the street signage, the removal of the ceramic tiles would bring about a cosmetic enhancement the elevation would require more radical intervention to bring about architectural enhancement:

- Change first floor windows to multi pane timber sashes
- Replace plastic guttering with cast metal.
- Remove tiling from front elevation and take render to ground
- Install new planted shopfront with stall riser
- Alternatively reduce fascias signage so that it sits at the same level as the neighbouring properties and within width of shop front.

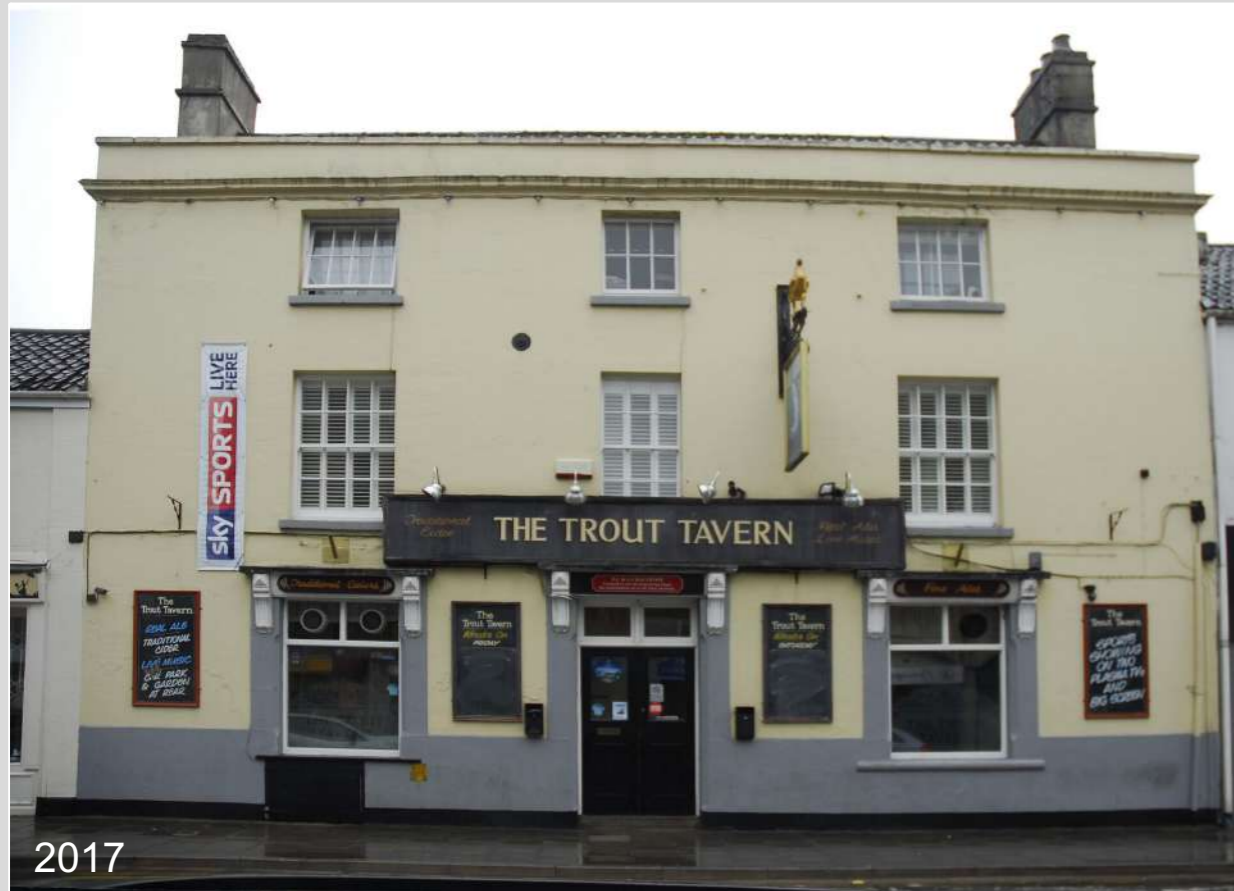
2017

The building presents a coherent frontage which is generally well maintained. Most of the original fabric is intact and where alterations have been made, such as to the windows at ground floor level, these have been well considered and don't seem out of place. There are a significant number of service routes on the face of the building which are unsightly and a number of large circular fans in the windows to the ground floor which appear redundant. The signage over the front door seems awkwardly placed and extends over the windows

In general this is a very positive addition to the streetscape. There are a number of alterations that would enhance the building and streetscape:

- Remove extract fans from windows
 - Remove unauthorised banners and chalkboards
 - Change main sign proportions so as not to obscure the windows and sills
- Consider use of individual letters for signage
Rationalising of services across the elevation

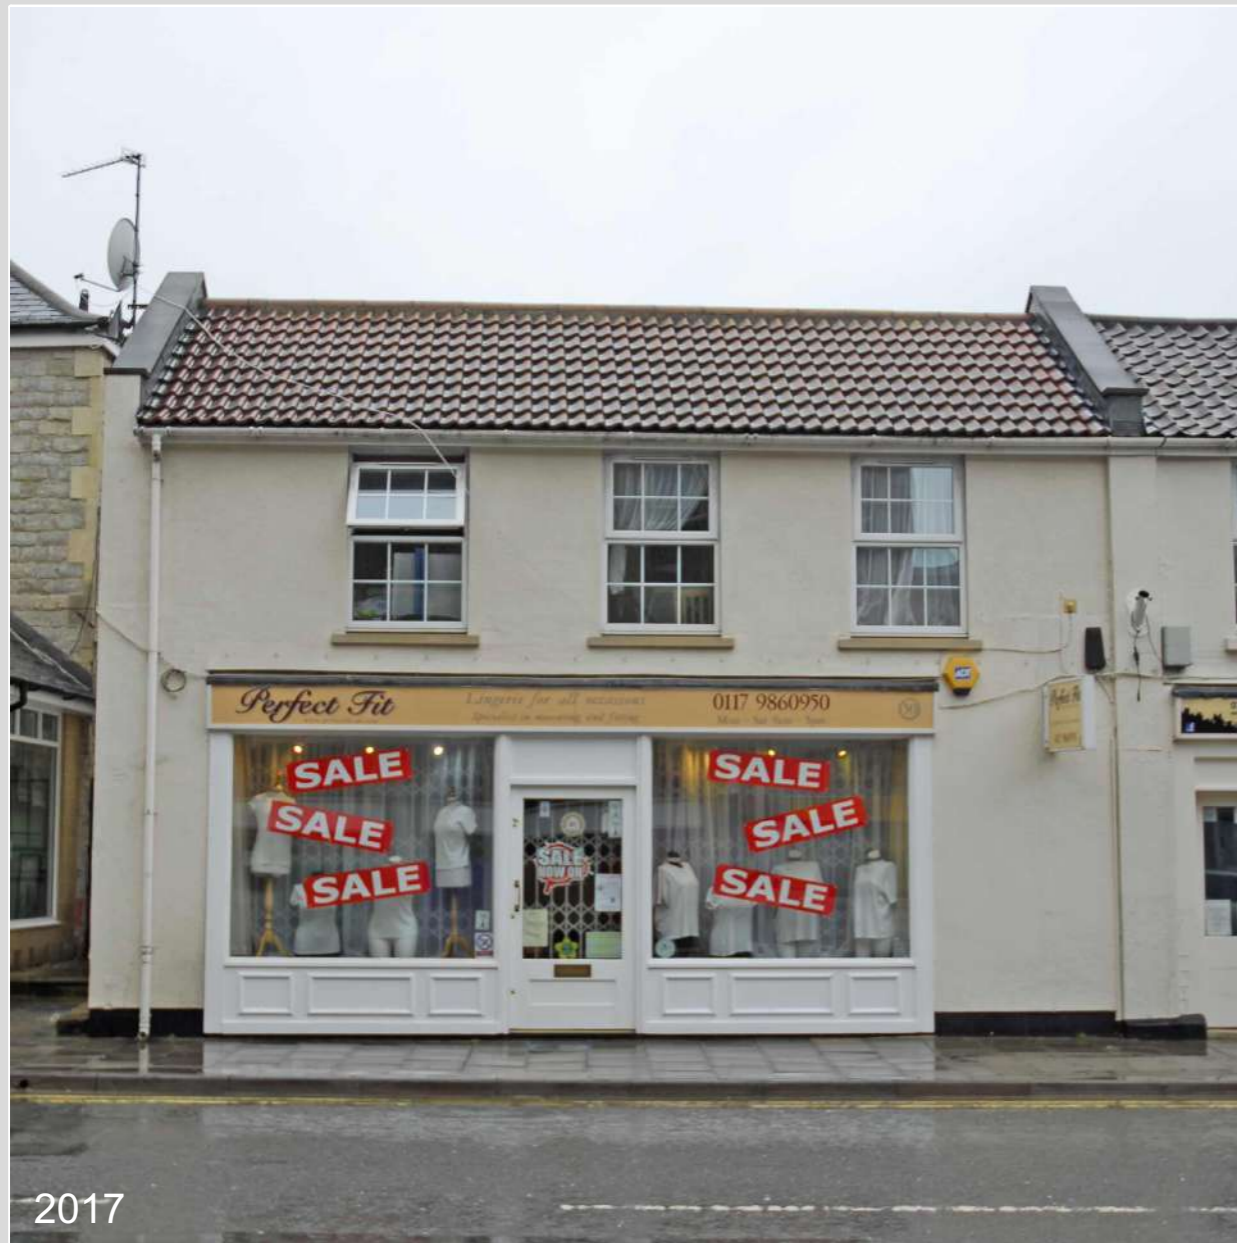
2017

As a new building the condition of the fabric is relatively good but the materials used are generally poor. The roof comprises ceramic ridges bedded on cement mortar over modern pantiles that are less refined than the originals. Raised party walls are capped in concrete copings. Walls rendered with a modern flat render with some texture. uPVC tilting sashes with reconstituted stone cills. There are numerous poorly ordered services, including a satellite dish and aerial on the southern gable connected by trailing cables across the face of the building. The shop front, although planted, is of unrefined design comprising a central door and windows either side with timber stall riser. The shop front does not relate to the windows above.

This is a new building and whilst it has no historic value it terminates the terrace and therefore has some strategic importance. It is reasonably well proportioned and has a generally positive impact on the street. Elements remain awkward and can be improved.

- Change windows to 6/6 timber sashes with reveals
- Remove services from front elevation
- Set planted frontage symmetrically on elevation
- Decorate planted joinery in contrasting colours to masonry
- Change plastic rainwater goods to cast metal
