Suitability of brewery buildings for re-use

Condition

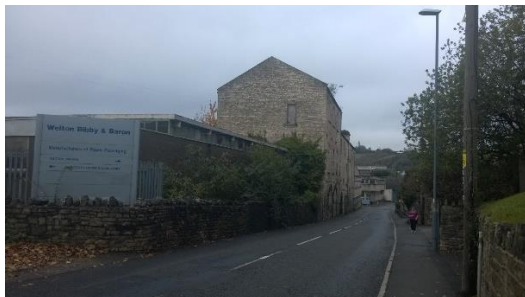
A secondary issue is the position of the brewery buildings directly onto Station Road. Repair and conversion works would require this road to be closed to all traffic for a period possibly extending over a number of months. Future closures could not be ruled out to repair and maintain the building in future.
